Bridge of the Month No22 October 2012 Leaths Bridge, Castle Douglas (demolished)

Leaths Bridge, Castle Douglas

Bill Harvey Bill Harvey Associates Ltd and OBVIS Ltd

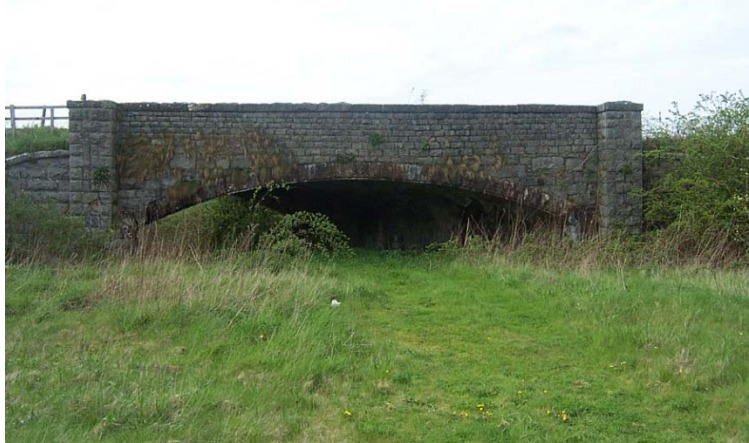
We will return to Leath's bridge another month to look at the outcomes of a test there but in the mean-time here is a simple review of the bridge itself. It is just to the East of Castle Douglas in SW Scotland. Long disused, it used to carry the A745 over the railway but the railway was closed and the alignment taken over for realignment of the road. The bridge was left in a loop and totally neglected for many years.

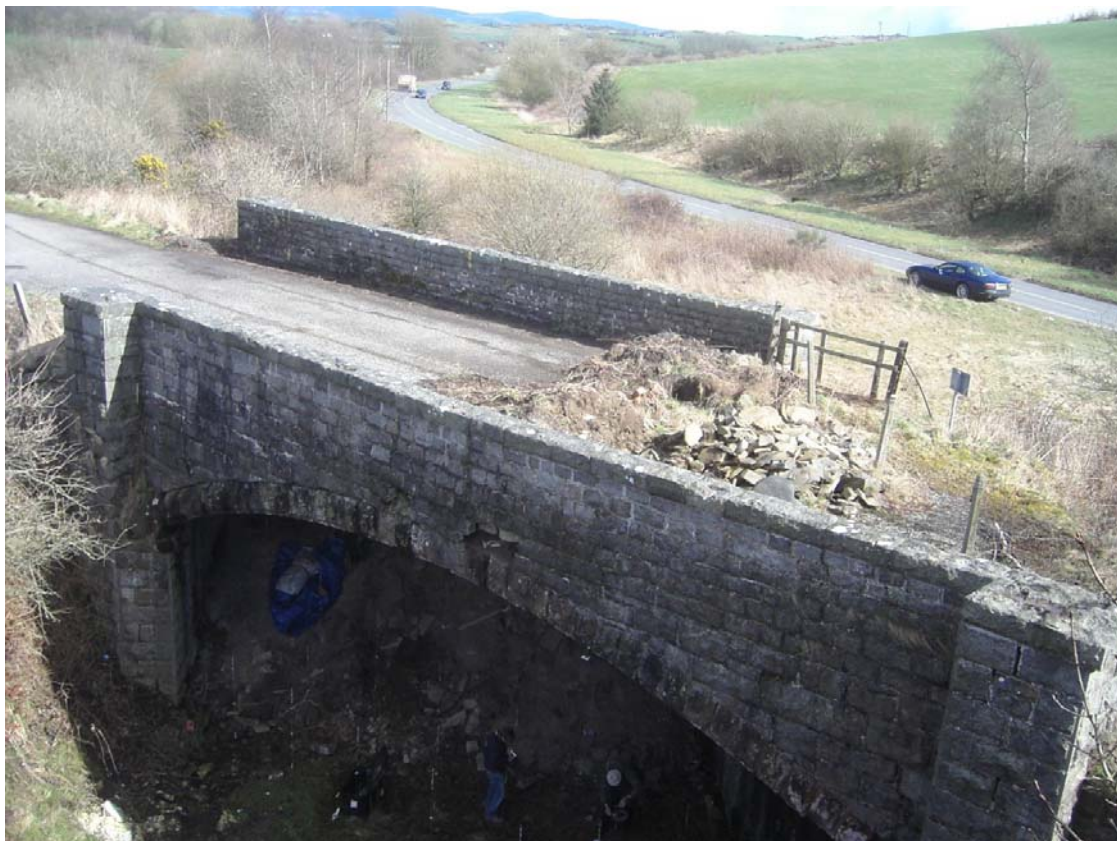
Since it was a bridge over a railway, I rather imagined it would have a round number span in feet but the number that came from a survey was just less than 28.3feet. This is mid-way between two “likely” dimensions of 28.25 and 28.333. This question was resolved when I realised that the skew is exactly 45 degrees. The skew span is 40feet and the square span therefore necessarily 28.285feet, very far from being a round number but not a leading dimension. The original rise seems to have been 5feet, which gives an 8:1::Span:rise ratio on the skew span. With such a small angle of arc and with considerable later distortion it is very difficult to determine whether the centres were circular on the square or on the skew but on the skew direction, the round numbers seem likely to be those used. The leading dimensions require a radius on the skew of 42ft 6in exactly, whereas on the square the radius would be 22ft 6.01in which is remarkably close to a “round” number.

The arch is both shallow and thin, typical of the construction of skew bridges by John Miller, though this bridge was apparently designed by his son.

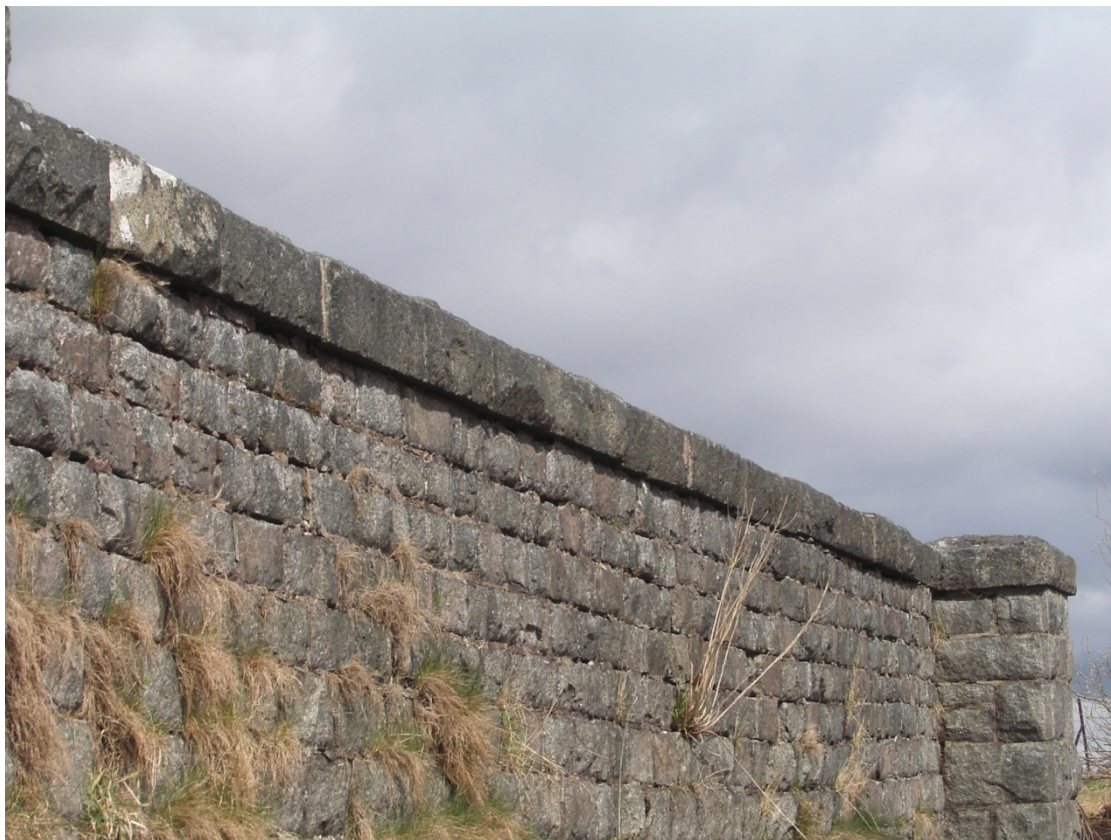
Note here how the beds in the wall sag in the lower courses and are gradually made up again.

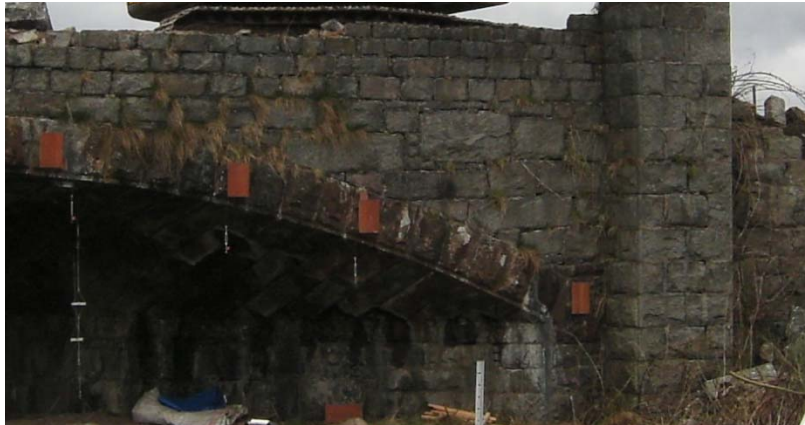
The down turn in the more random coursing of the spandrels is obvious here. Also note the spalled points of the skewbacks.

The bridge was demolished at the end of our visit. Note here how the three stones still stuck together show the twist built into the individual stones so that the mortar beds are constant thickness. Note also the teeth on the skewbacks and the way the bottom edge of them has spalled off. Similar damage is also evident in an earlier photo of the complete bridge above.

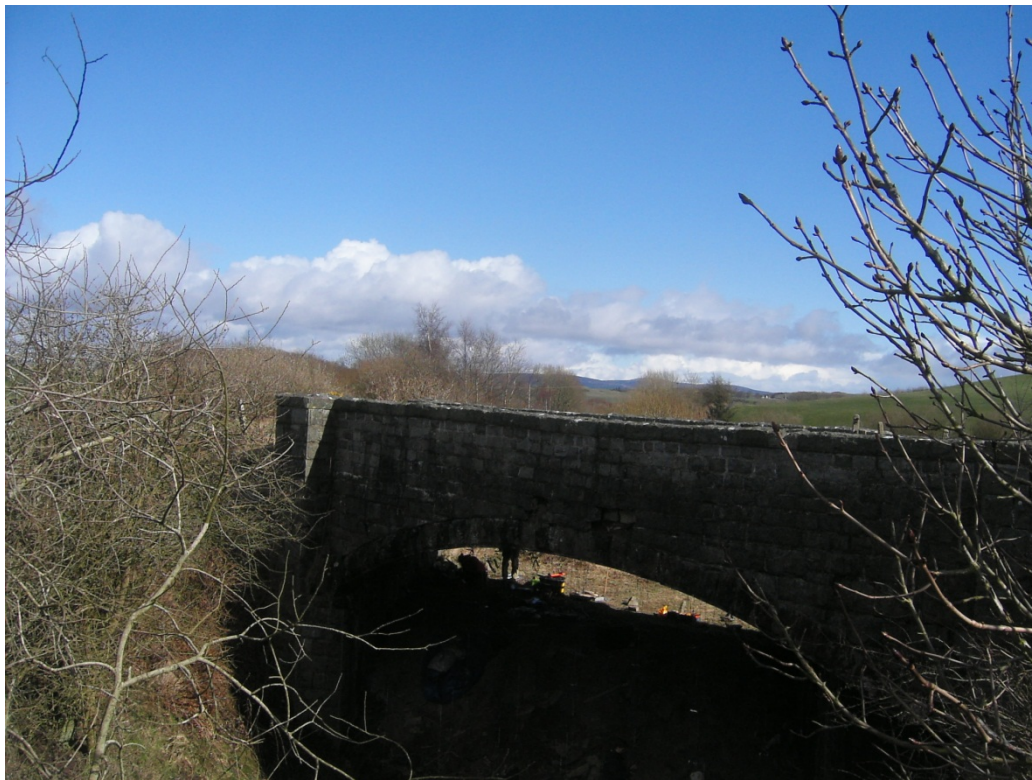
From this level it is obvious that the cope stones have a sag despite all the efforts of makeup. One might think this would be a result of abutment movement but we will see later that this is not necessarily the case.

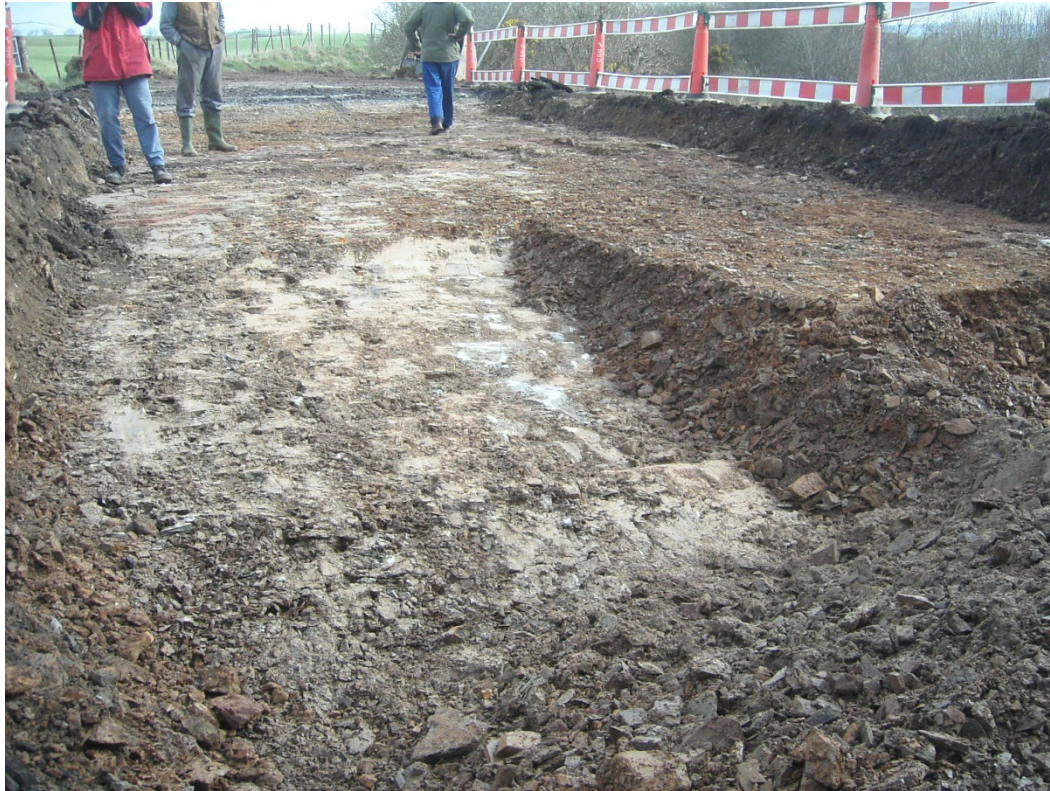
Once we began to dig the fill off the arch, the internal construction became clearer. The sloping face to the left here is effectively concrete, though made with shards of stone and mortar.

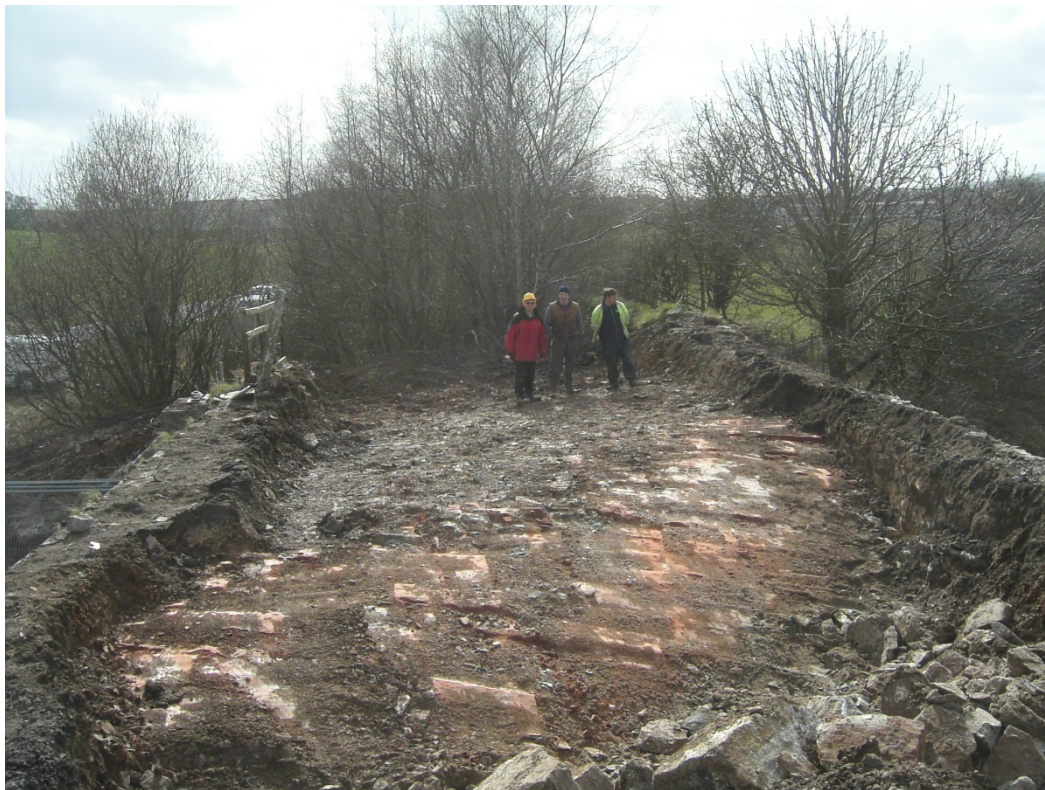
As the concrete was removed, the general condition of the arch extrados became clear.

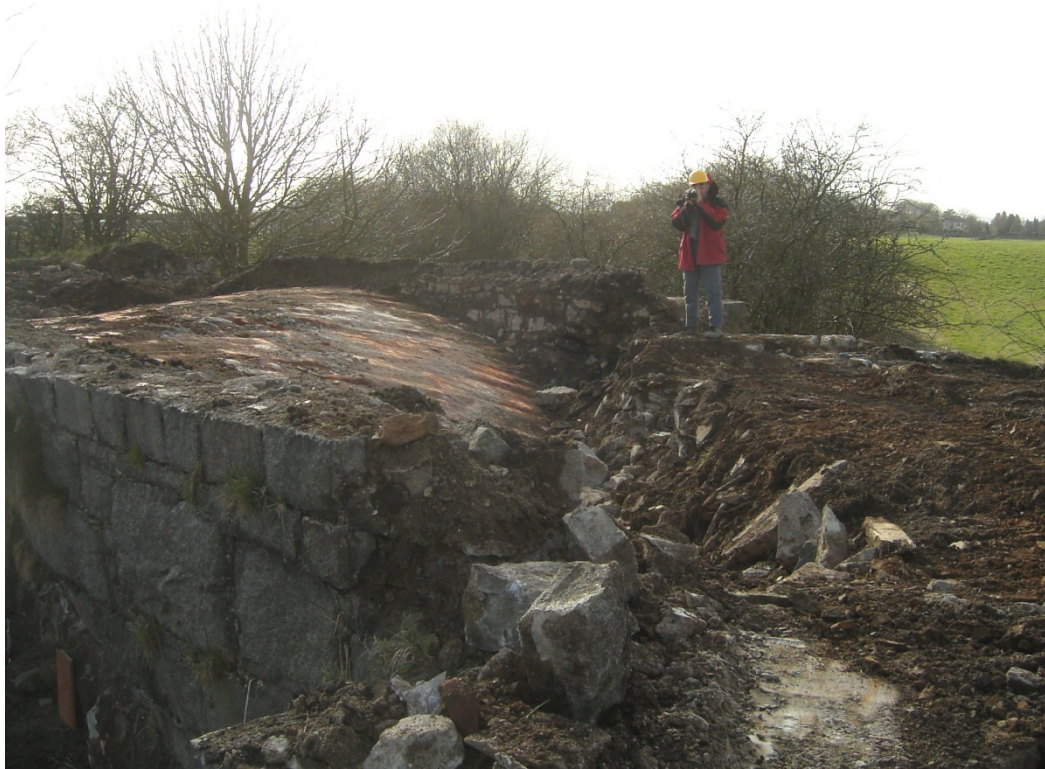
This shows more clearly the nature and depth of the haunching. Readers might wish to turn back to the July 2012 edition and consider the implications for the Bridgemill bridge, built in the same year barely 50 miles away.

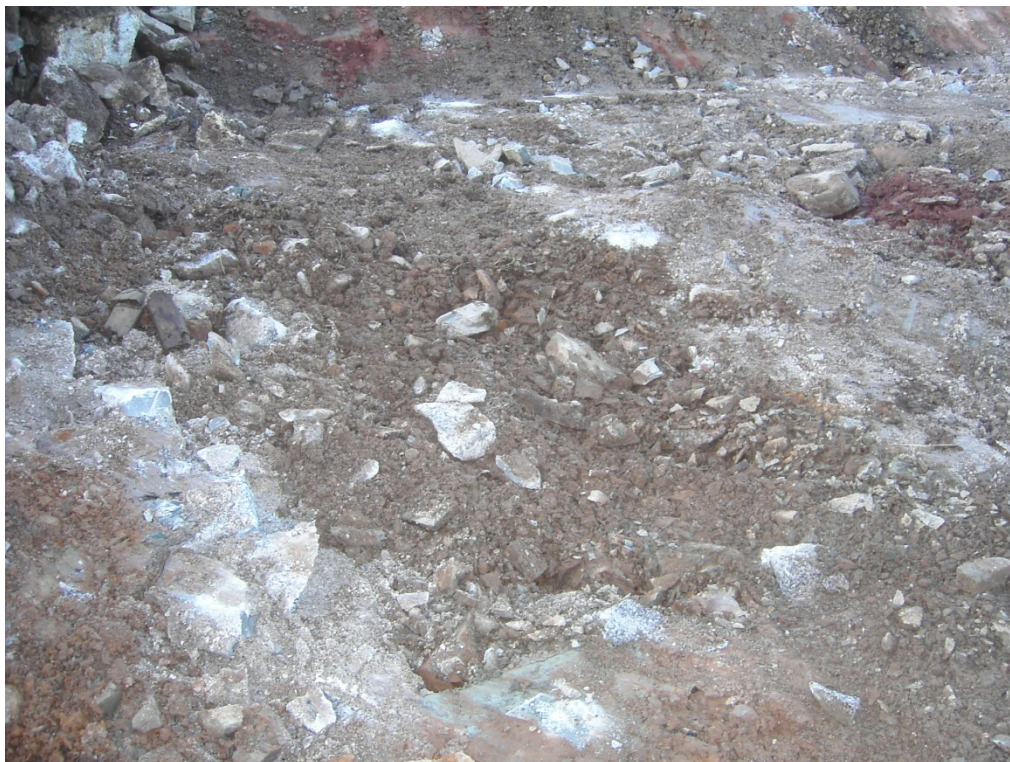
Once all the haunching was removed we could see the great depth and the hollow construction of the abutments.

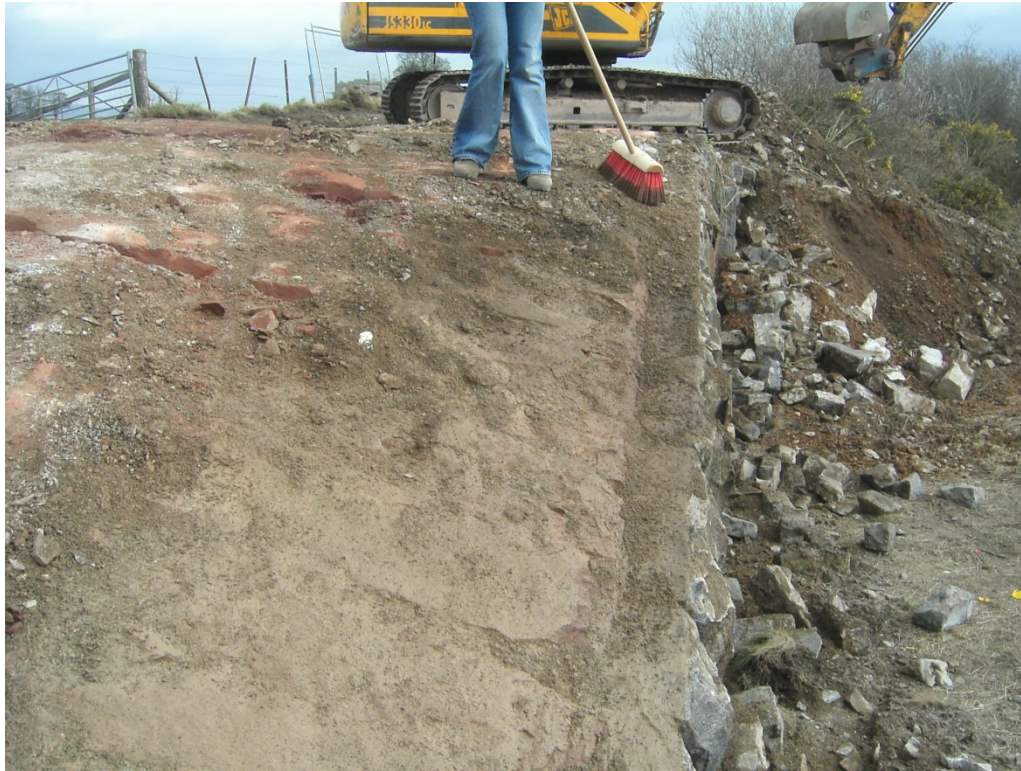
This very small shoulder supports the surface skin of the spandrels. Behind that dressed stone is a random rubble wall.

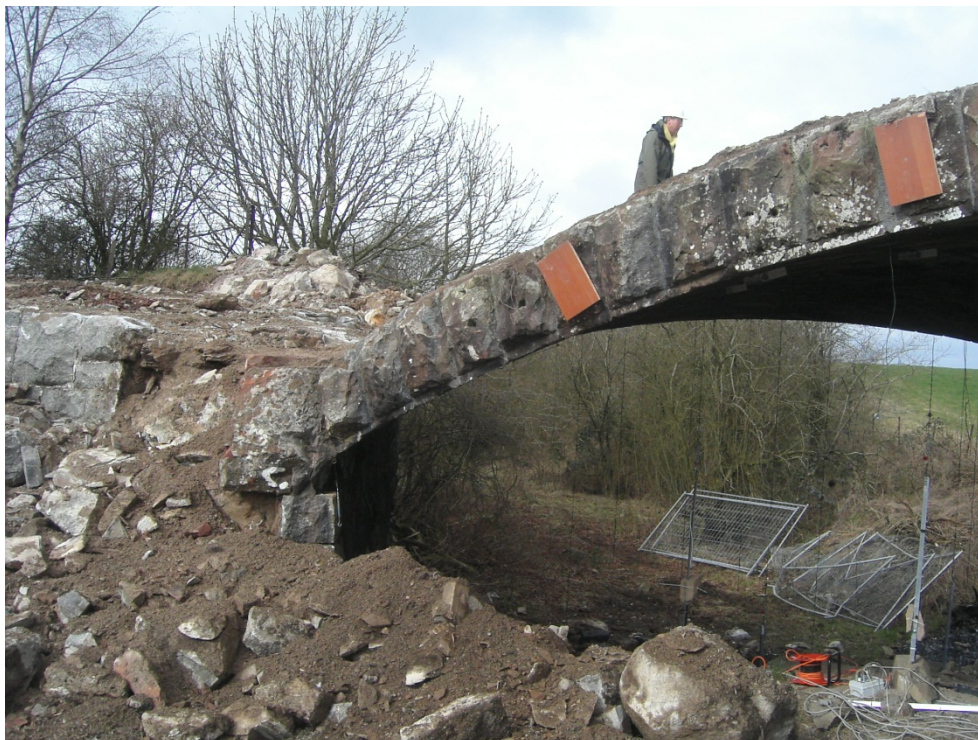
The very shallow depth of the arch itself is made abundantly clear by this edge view.
