Bridge of the Month No30 June 2013 Bannawell Street Viaduct, Tavistock

Tavistock, Bannawell St, Viaduct

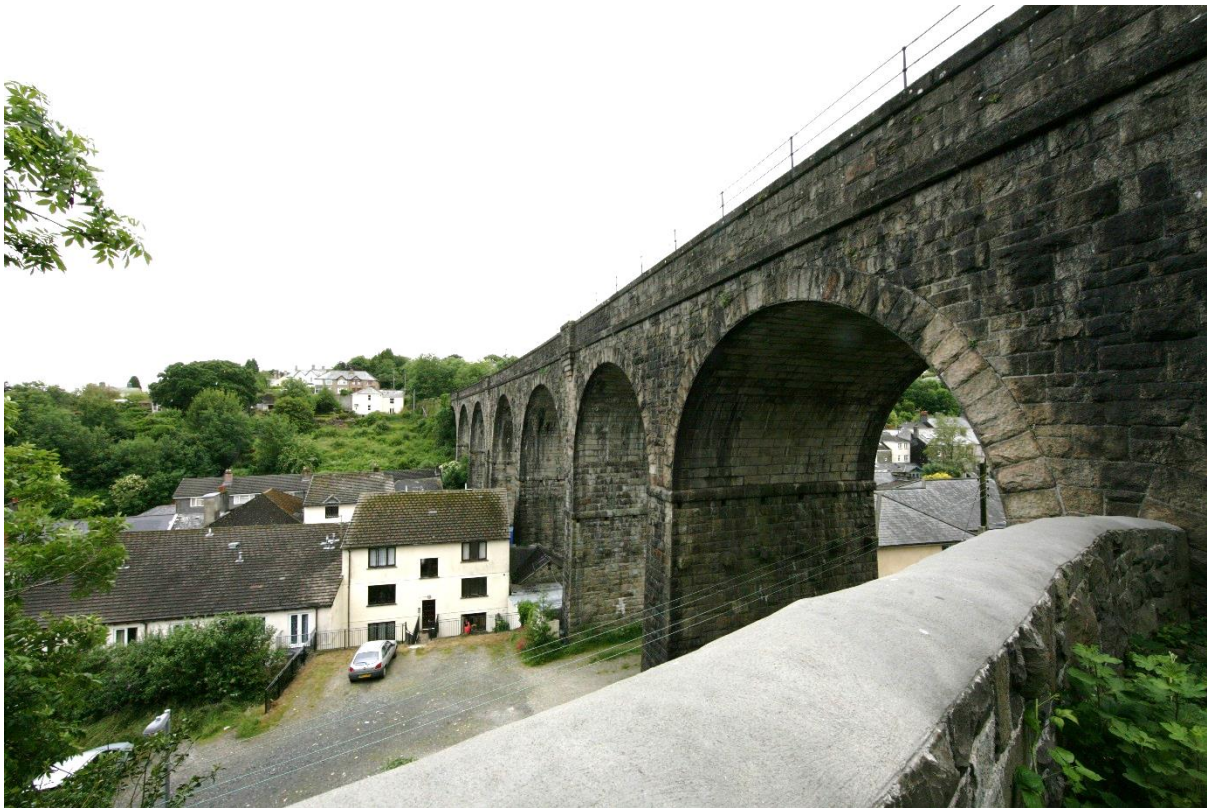
What can be seen here is 5 spans at 50ft (15.24m) and 2 at 32ft (9.14m). There is another 32ft span off camera.

One thing I found very noticeable is the almost total lack of vegetation on a bridge that has been uncared for since 1968. I don't think I have seen a working railway bridge with so little. One assumes that the basic granite construction just provides no nutrients, but what about the mortar?

Point number 2 is that this is a granite structure in general but the arch (and presumably the pier fill) is poured concrete.

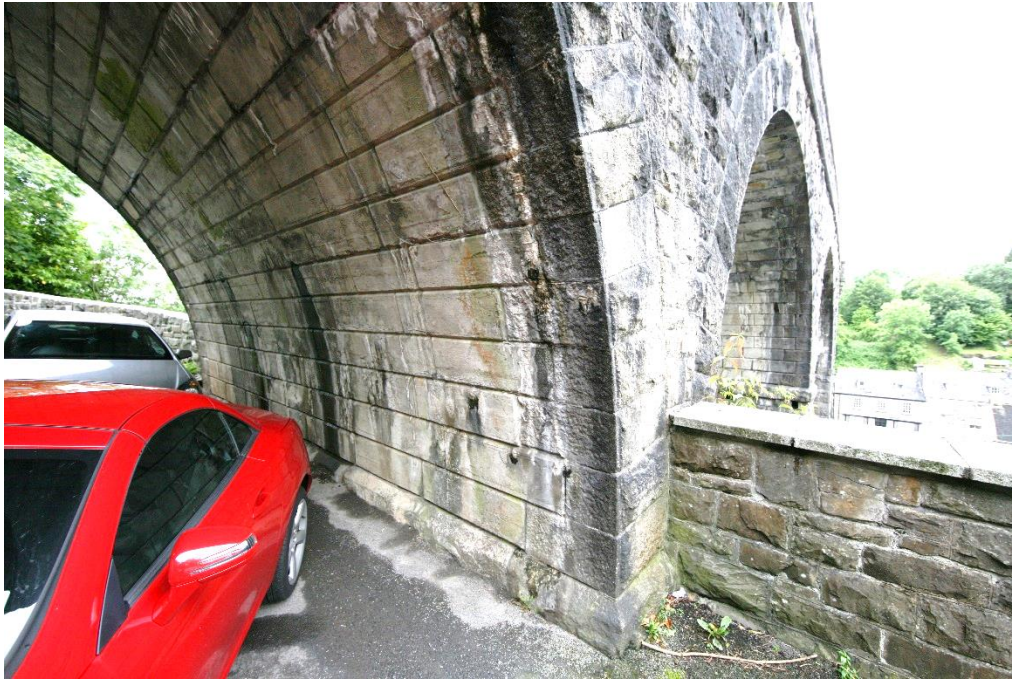
Here you can see the board marks on the concrete. The “joints” are simply fillets fastened to the shutter. I am often asked about the need for hinge formers in concrete arches and the answer from here is clear. The arch doesn’t care. A V groove like this is probably enough of a stress concentrator to ensure that any cracks form in the joints.

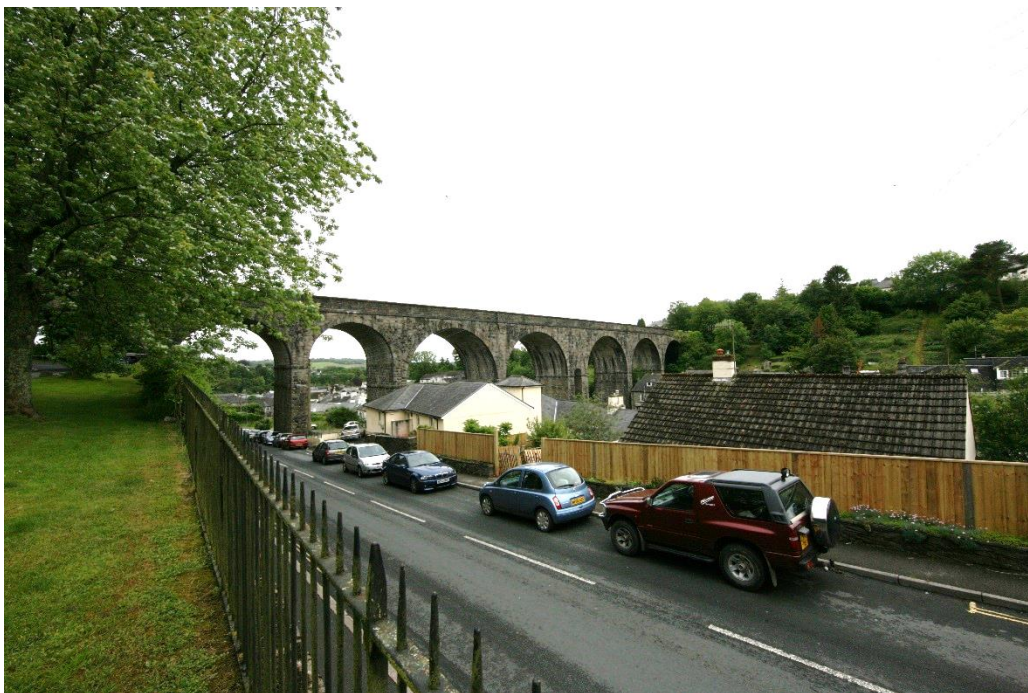
The next feature that I noticed some years ago when passing through Tavistock, but never properly understood, is the double pier in the middle of the valley.

At first sight one thinks of a king pier but it isn’t that because the two legs would not work compositely. It turns out to be a function of the pre-existing road layout below. Looking over the parapet provides a worthwhile view.

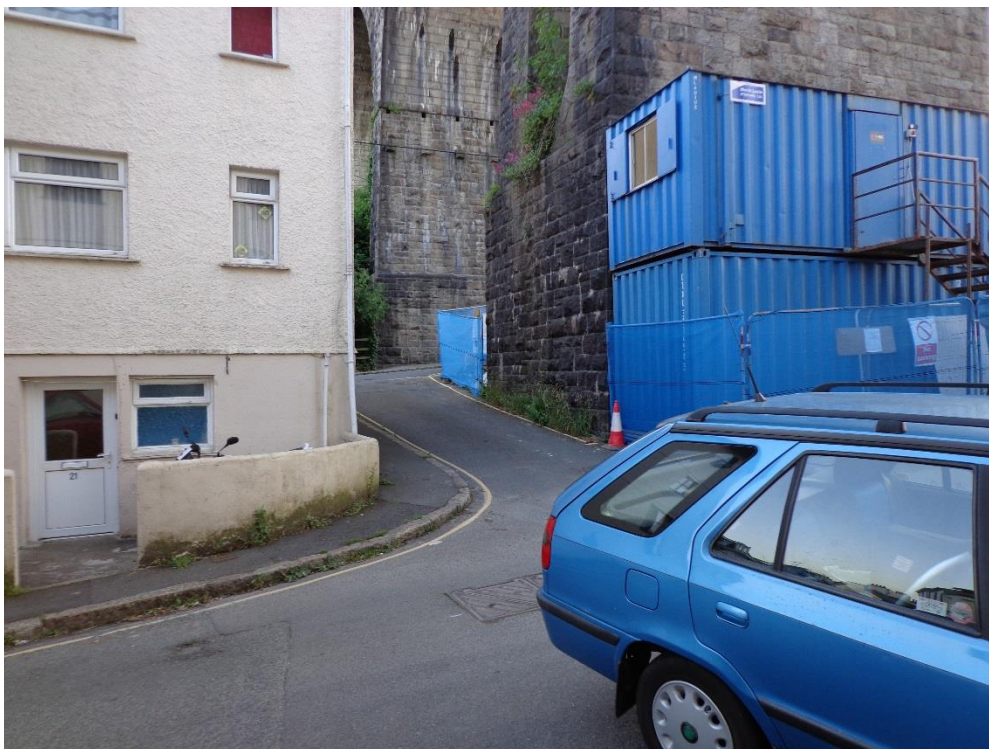
Looking through from Taylor Square to Bannerwell Street showing how the span fits there.

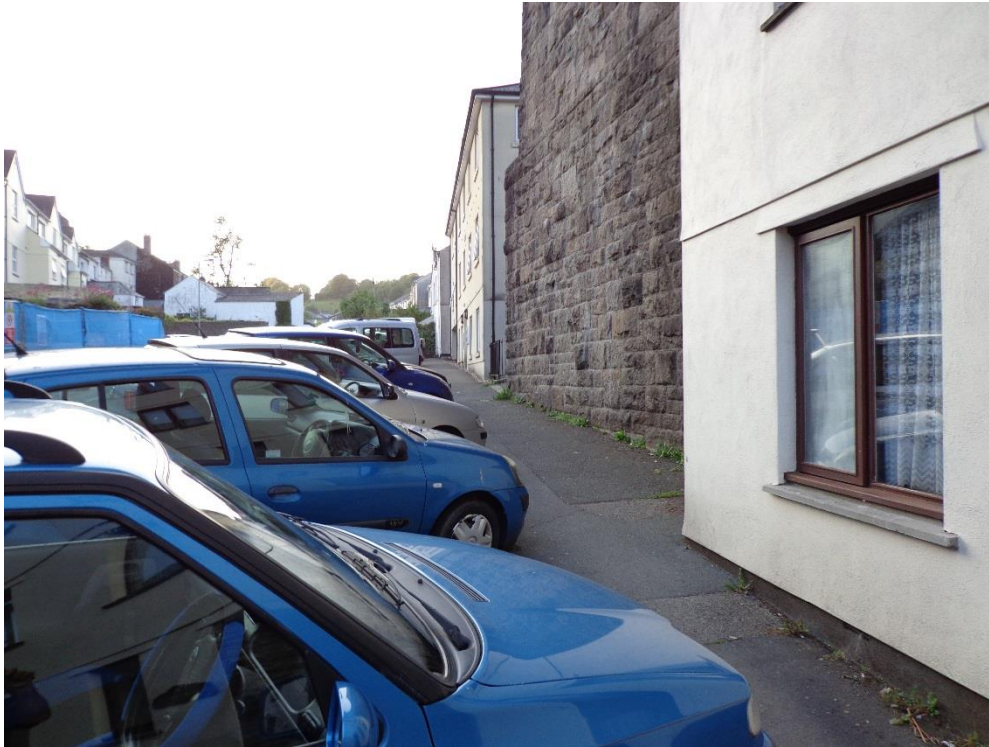
Here (in Taylor Square) again the pier sits on the back of the footway.

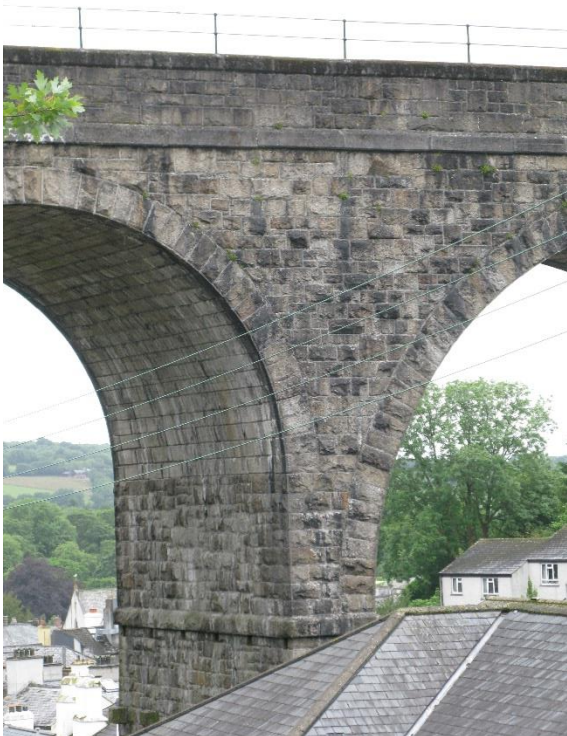
Here you can see how the 32ft arch springs from a point 10ft above the 50ft one. The granite of the pier is carried up to that springing level.

The change in span was dictated by similar considerations to those which required the split pier. The road to the station rises through one arch and turns back through another. A 50ft span from this pier would have landed in the middle of the road while 3 spans of 32ft fill the gap and allow appropriate access.

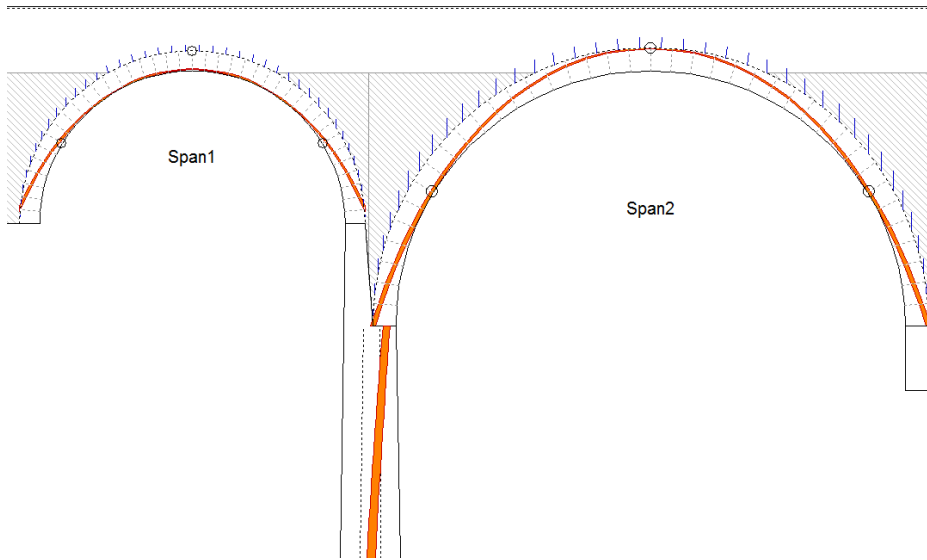
In plotting this I see a constraint in Archie that I hadn't noticed. The program batters the piers from the springing point on both sides, rather than coming down vertically on one side to the springing level on the other. That is clearly not the case in the bridge in question.
