Back to the Lake District and the [Sedgwick Aqueduct](#) (disused) on the Kendal Canal.

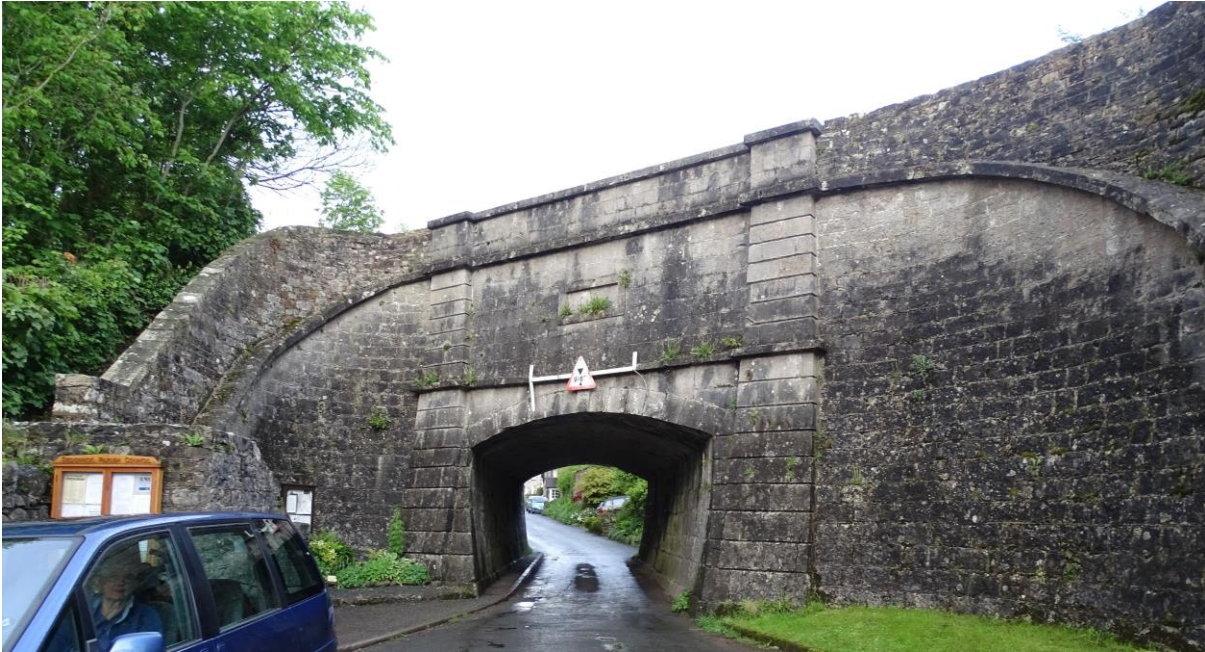
There have clearly been some changes here over the years. It is unlikely that the canal level has been raised but the aqueduct was probably built without a parapet.

The arch itself is very flat, but the advantage of aqueducts is that the load never changes.

The sweeping curve of the abutments suggests that there might be an invert, and with such a depth of fill, and the potential for water penetration, an engineer might well do that.

To the right, there is a huge extension to the wing wall.

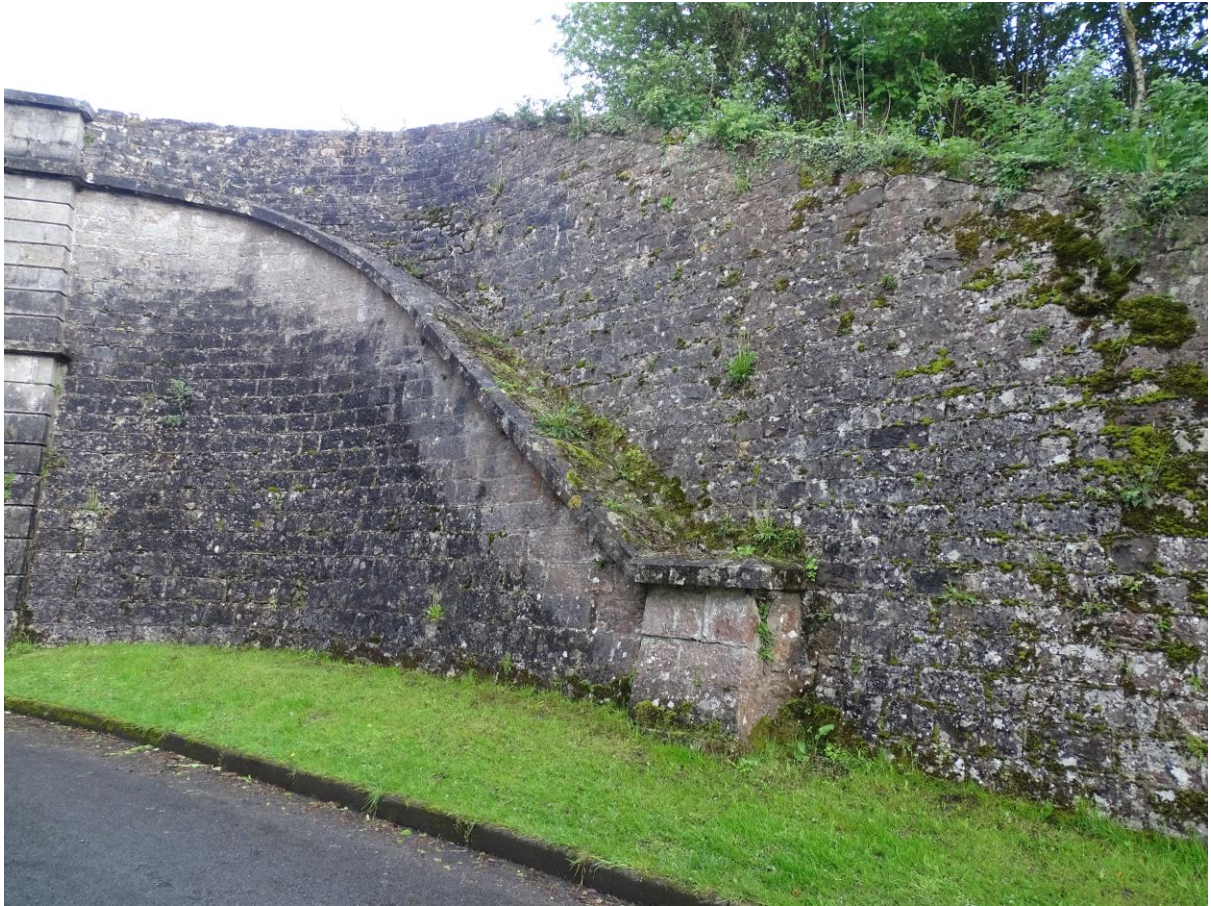
The arch has a substantial skew. This photo also shows the batter on the buttresses.

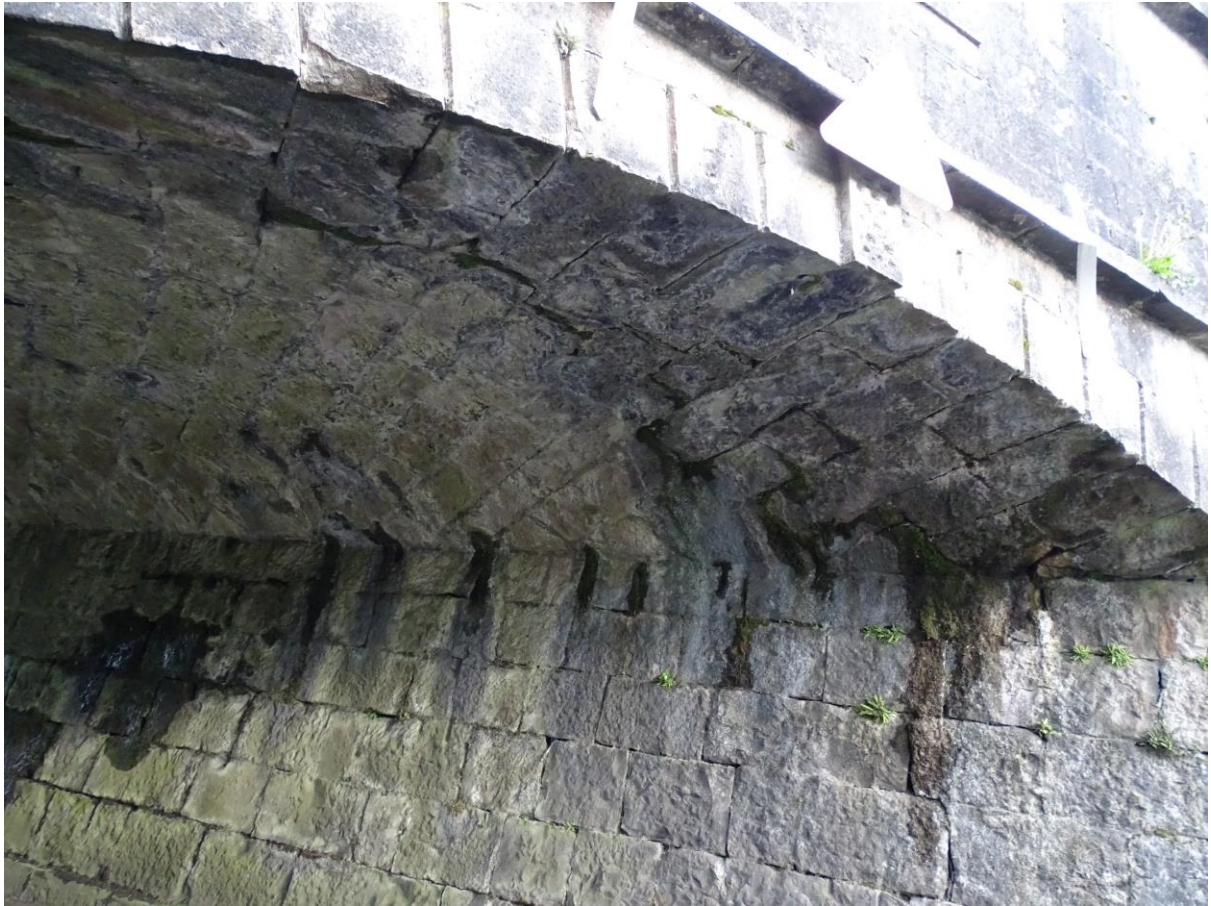
Despite age (nearly 200 years after all) and neglect, the structure remains in good condition generally.

The joints are so tight that they almost look dry. Notice, though the slight crack spiralling away from the edge in an effort to follow the square line.
