Bridge of the Month No50, February 2015 Warwick Castle Estate

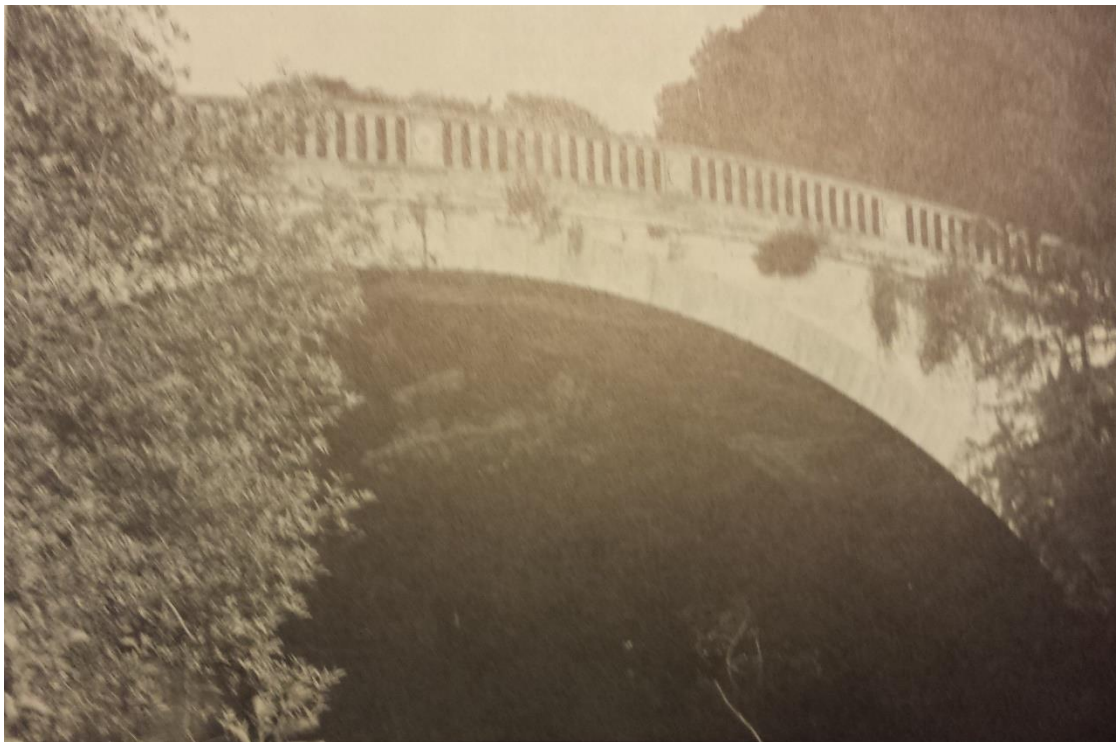
“The Warwick Bridge is large and high, but very delicate. Warwick is the only bridge built to his design which has a really difficult gradient, but that was probably consciously accepted, for the bridge’s chief purpose must have been to decorate the park.”

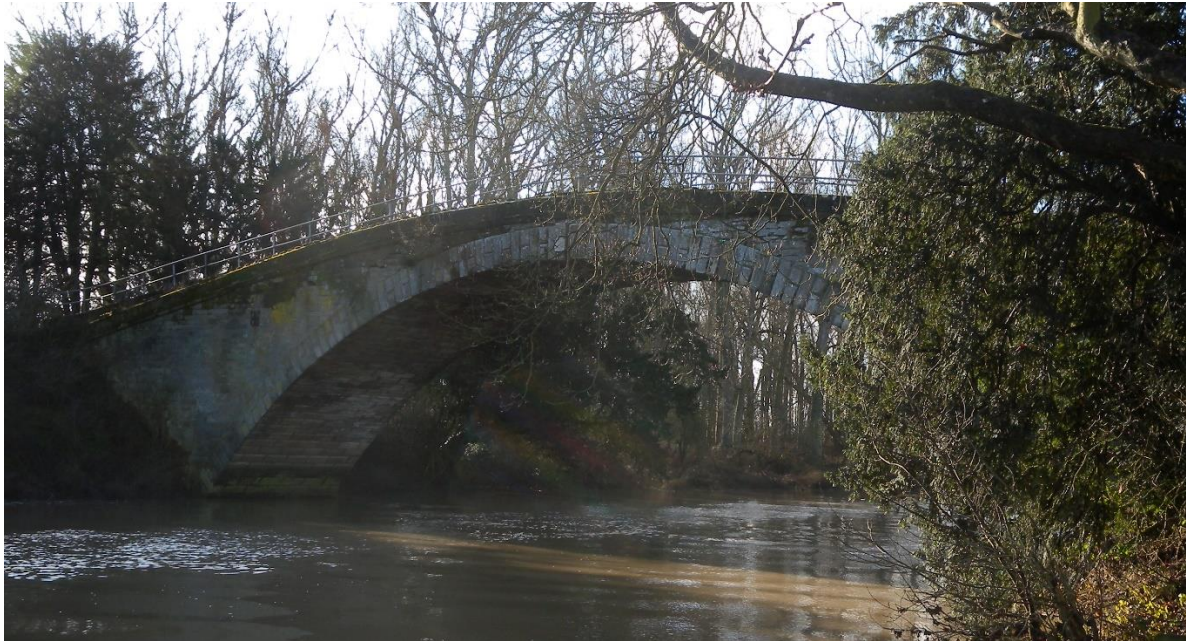
But back to Warwick Castle Estate. Ted's great work was first published in 1979. His photograph, reproduced in a different era of printing, shows a bridge in remarkably good condition at 220 years. By the time I first saw it in the late 1980s it was in a much sorrier state. Entropy has taken further toll since then, though I haven't been back since about 2006 when there was some talk of me doing an assessment.

This looks bad enough, but the other side is even worse.

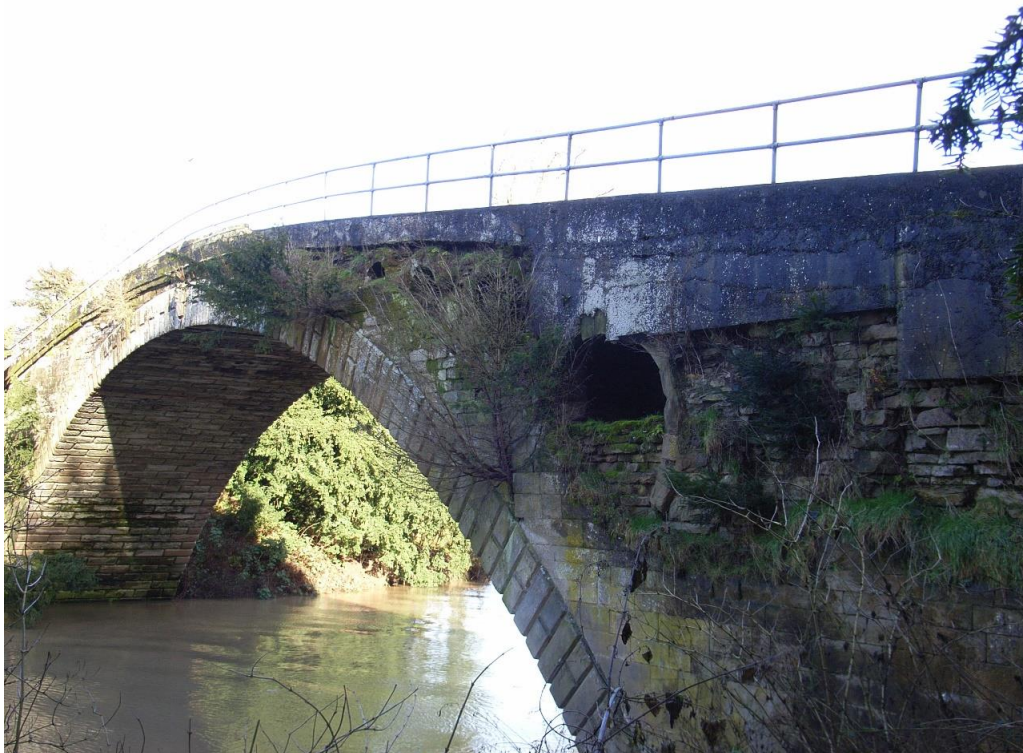
The main thing to note here is the voids in the fill. I think there are four of steadily increasing size towards the abutment. They are there to tune the line of thrust to follow the curve of the arch and were probably developed for Edwards' bridge to which I will return as soon as I can get there.

In the meantime perhaps we should think a little about how a bridge might get into this state. It is likely that the parapets were either "quarried" for use elsewhere or simply toppled into the river in an act of vandalism. The latter seems more likely as that might also lead to the destruction of part of the spandrel wall. The crude concrete patching is surely better than a bridge of this quality deserves, though it was no doubt an emergency response to the danger of losing a vehicle over the side.

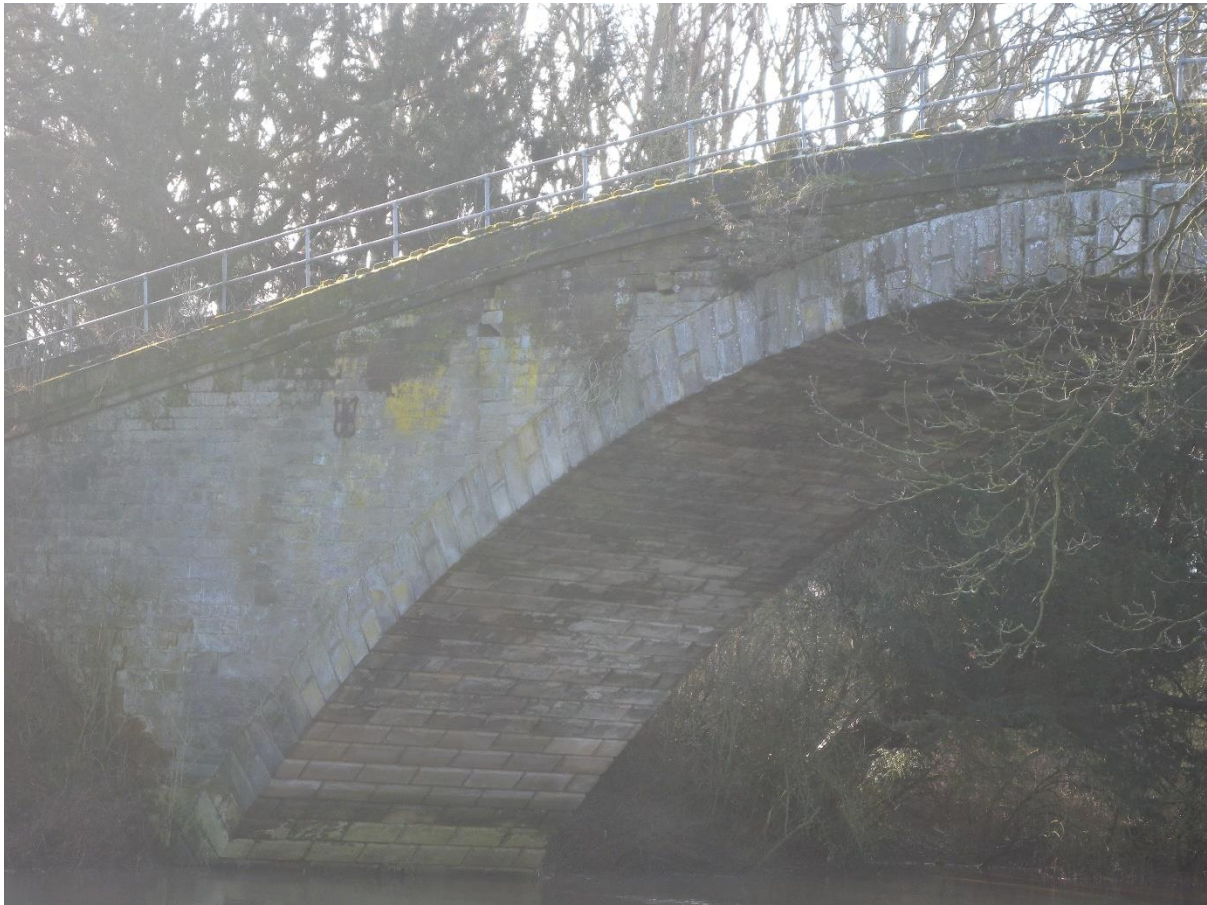
This one is greyed out but I think at least one void is visible through the spandrel

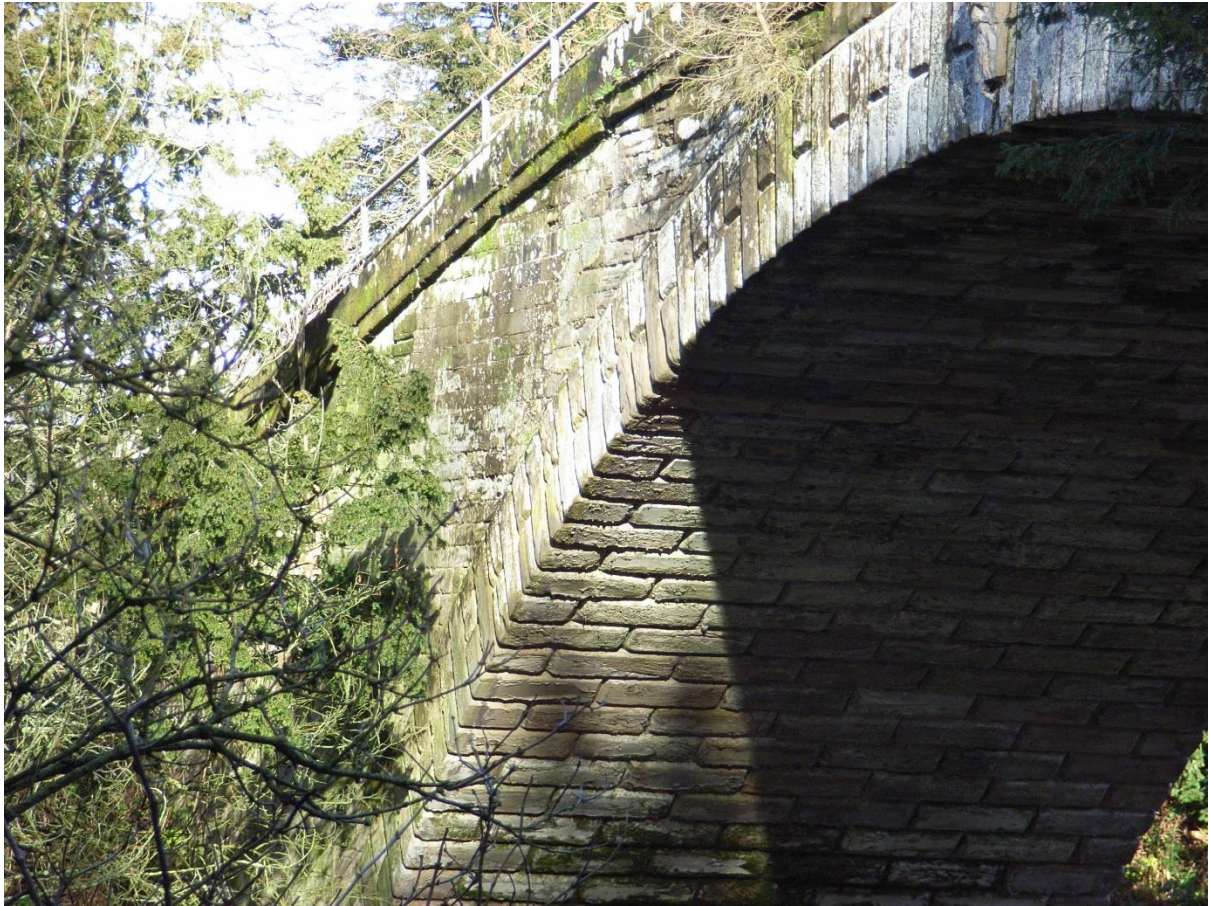
General weathering of the stone is visible here
