It is long past time I got back to reviewing bridge tests. It will be clear that I am doing this in no particular order. The bridge at Preston on the Weald Moors is a classic of the canal era. A stone, three centred arch, slightly skewed, supporting brick infill and spandrels. The spandrel walls were both tilted and curved, creating a very stiff structure. The various records of the test do not describe the structure in detail which is quite hard to forgive. One reason for writing this is that “I was there” and I see a real need to put some stuff on record.

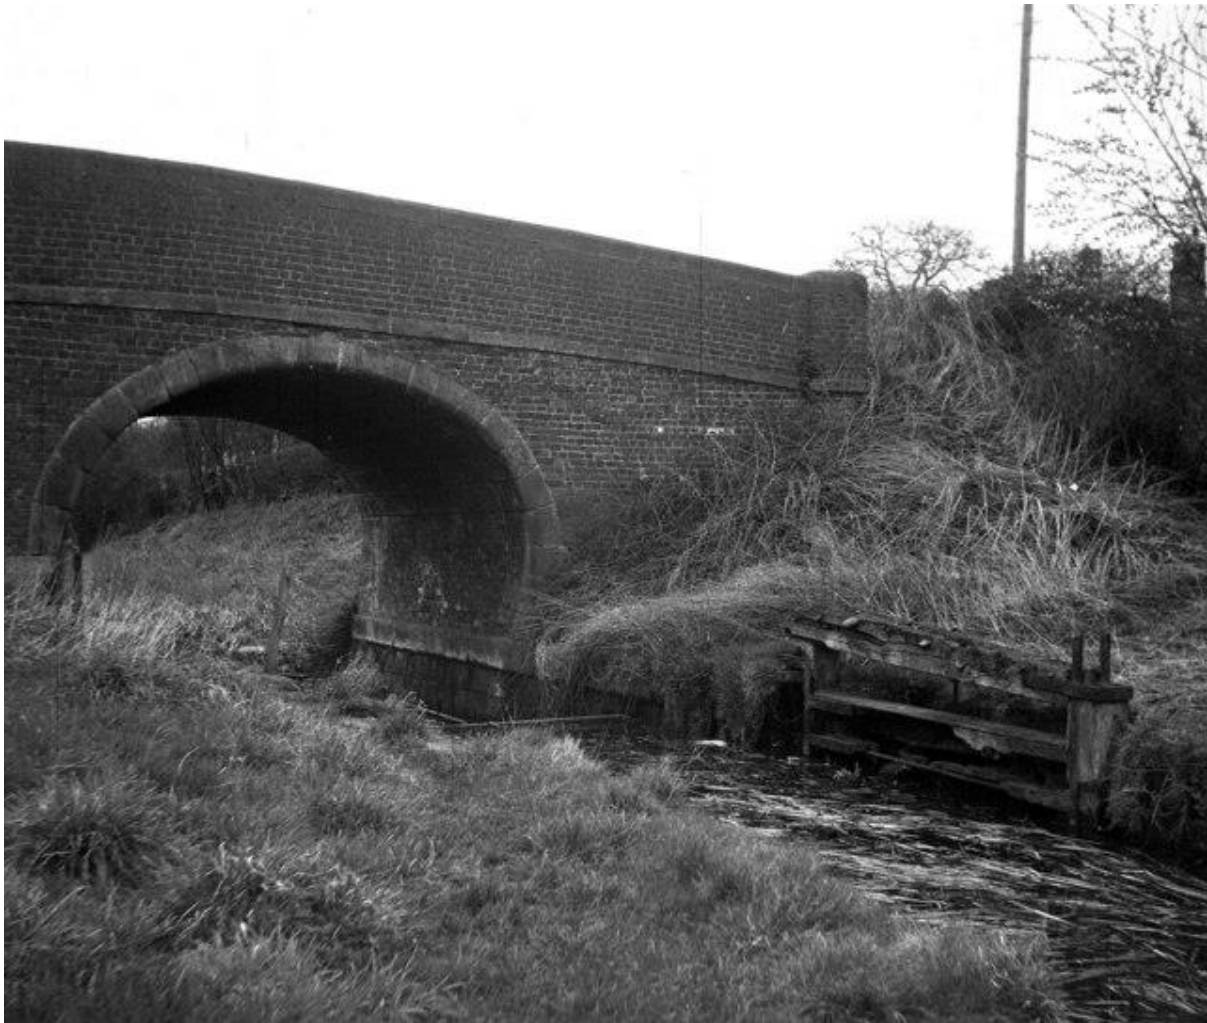
This picture shows the bridge in 1964 when there was still water in the canal. By the time of the test, that was long gone as can be seen below.

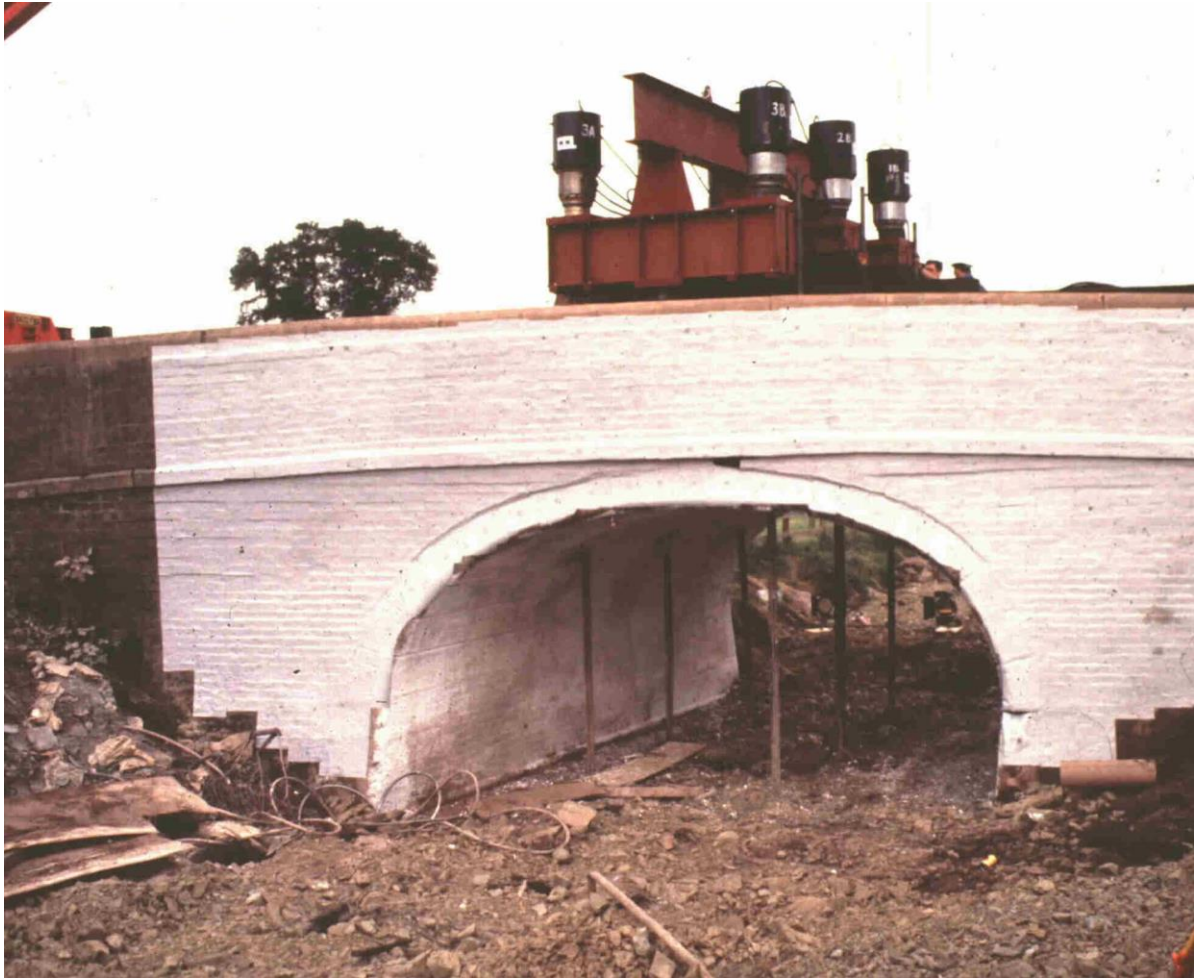
The test report gives the span as 4.95m square 5.18m skew. That is (near enough) 16ft 3 in square span 17ft skew span. Unusual for the skew span to be the round figure in this application. The skew of 17 degrees is presumably computed from those dimensions. The rise is quoted as 1.64m which is also an odd dimension at 5.38ft. Well, that last is just nonsense. 16.5 by 5.5 would be 3:1 which sounds more likely, but that leaves the question of whether the shape is really an ellipse, or three centred. Three centred would be more suitable for a canal bridge because it would give a higher shoulder for a horse to pass under on the towpath.

Looking at the string course in the view above, it is obvious that there is a modest drop at mid span so the rise is reduced to some degree.

The next picture shows the shape a little more clearly, but also shows different voussoirs lengths in mid span and at the ends. To me, there are 5 wider voussoirs at the ends and 11 narrower ones in the mid span. There would be no good reason for doing that if the radius were changing continuously, so it seems likely that we are looking at a 3 centred arch. Now we need to try to reconstruct dimensions. If the original span really is 16ft then what radii might be expected. Let's begin by assuming 16 ft radius. If the rise is actually 5.5ft, then we might guess at side radii around 4ft to 5ft.

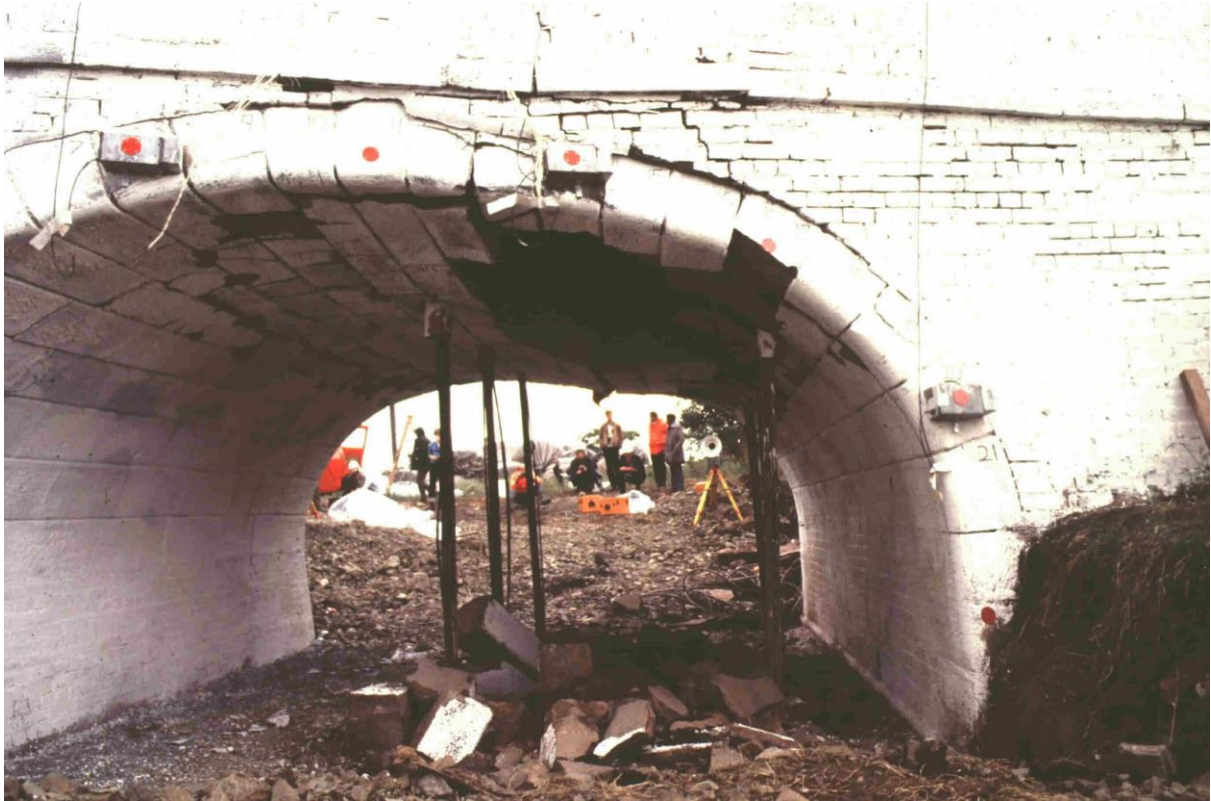
Anyway, here is a picture of a partially completed test. It raises the really interesting question (interesting to me at least) of why the most damaged masonry is on the soffit, right under the load. Here you would expect wide cracks on the soffit. In fact there is a pile of masonry on the floor but no fill has followed it down. That is because the upper shell of stone is still complete. The stuff on the floor has fallen out because the stone split on a ring line and the flexing of the arch was enough to let the wedges fall out.

There is also modest crushing at (or near) the points where thrust touches the intrados 6 joints up from the left and 3 up from the right.

And, of course, there are cracks running round the ring. Notice the one on the right which is taking off the skew corner of the bridge and which continues, more or less, round to the left, still on that line.

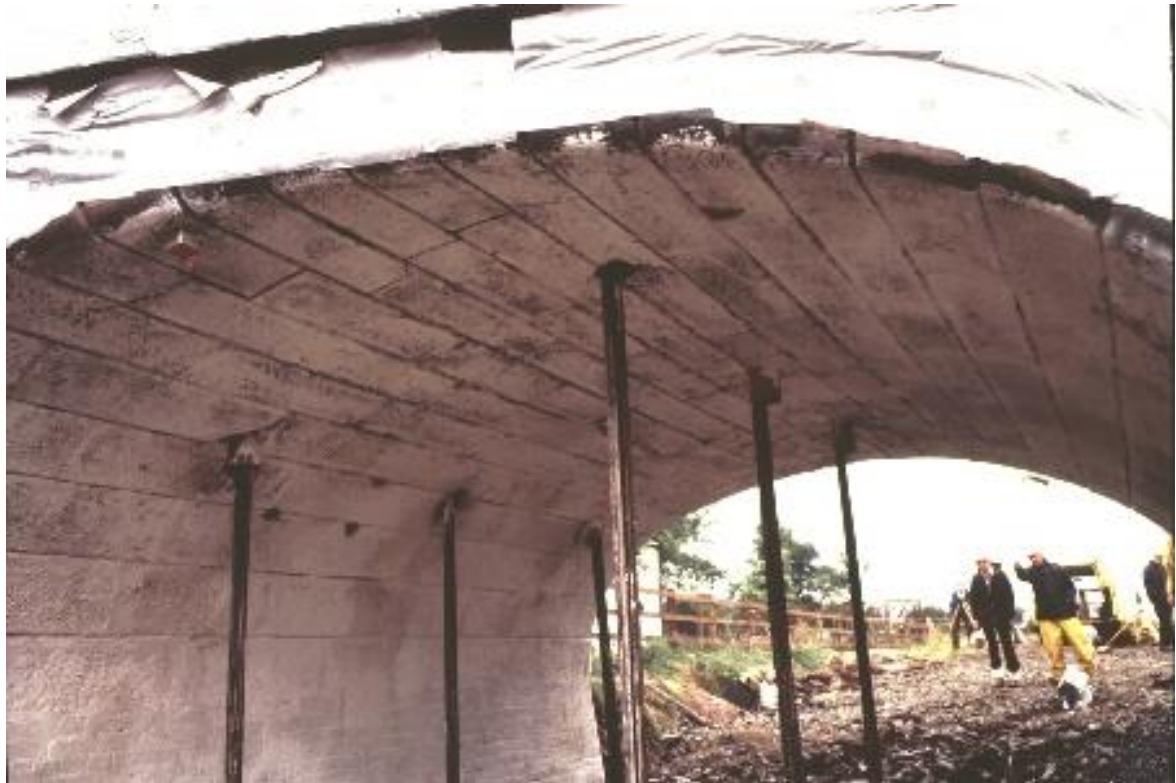
Almost hidden behind the nearest ground anchor cable is the mid width survey target used for deflection measurement.

At this, relatively early, stage of loading there is already the beginnings of crushing and hinge formation at the joint beyond the cables but no sign yet of one to the right. The edge crack along the skew line is already evident. Interesting, though, that it is beginning under the load and working outwards. Could it be driven by the skew end of the load pad?

From this view, there is no indication of a crack under the load but at such an early stage it would be too small to see anyway.

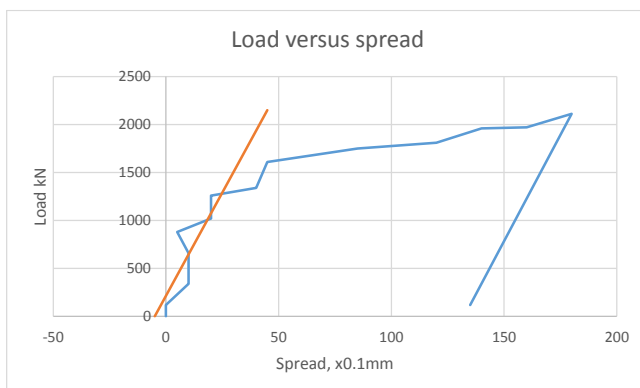
Of course, the spread is measured on the arch face but with substantial backing we can reasonably assume that the face and the centre are moving by similar amounts. Graphing progress of the peak spread shows a pronounced change of behaviour at around 1300kN total load. The red lin on the

graph projects the recovery line back to the origin. The increments of load are really too large and the available accuracy of measurement too little to allow division of the “curve” into segments but I would suggest that somewhere around 800kN the abutments begin to behave in a way that is not sustainable. Any load factor on behaviour should be based on no more than that.

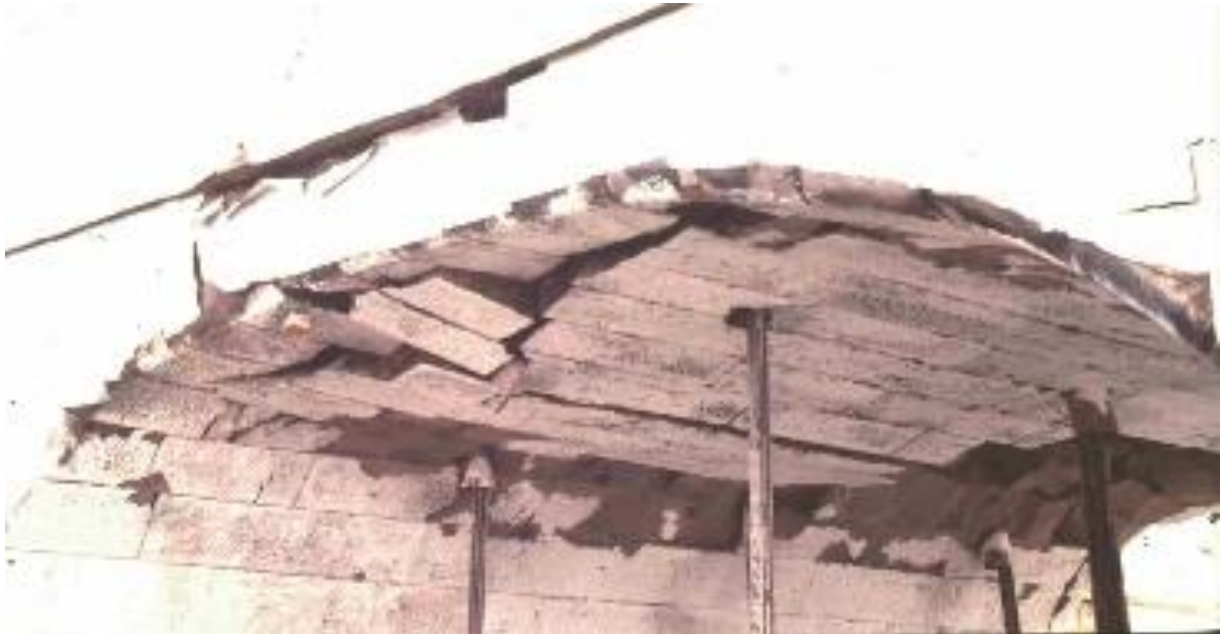
From this angle, the skew splitting is more evident, though the continuation back to the abutment near the load is not so pronounced, because that is the strong direction. Note that here, the main crack under the load is wide open but has still not resulted in splitting of the stone as seen above. And just how much deflection is there at that point? It is certainly more than the 80mm maximum recorded on the central target but by this stage the central target is gone and the edge ones are no longer following the arch. An estimate says 150mm of deflection but the rotation in the crack is still quite modest.

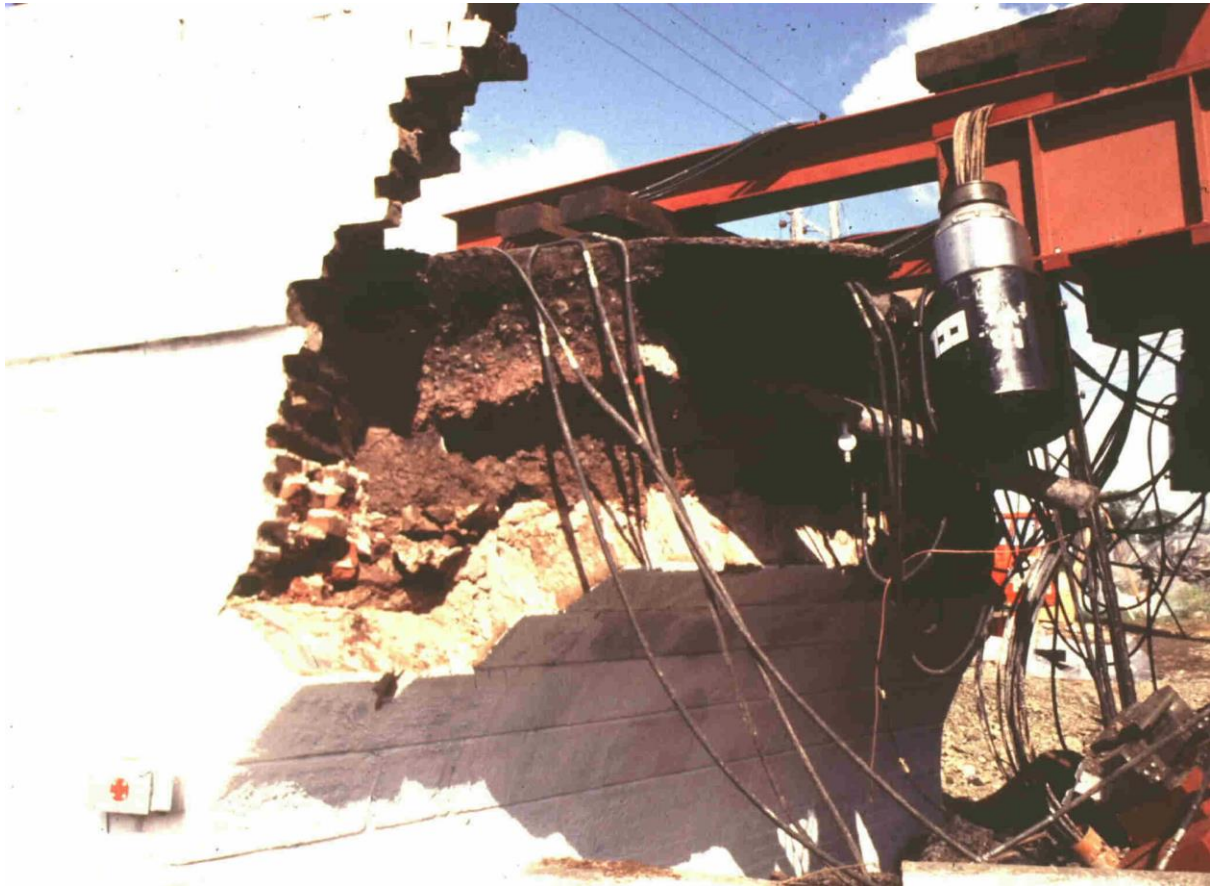
The bright sunshine for this photo makes the contrast extreme and obscures the details of construction but the level of backing is clear, reaching well up the 5th voussoir. The point at which the spandrel becomes the parapet probably coincides with the top of the string course and that would imply that the wider wall passes right over the arch so that the corners of the load pads are sitting on it. The string course is stone and shows clear articulation in the phot with all the rubble below the bridge, so that ties together. Better photos might show string course damage in different places on the two sides.
