## Bridge of the Month No54, June 2015 Irthlingborough

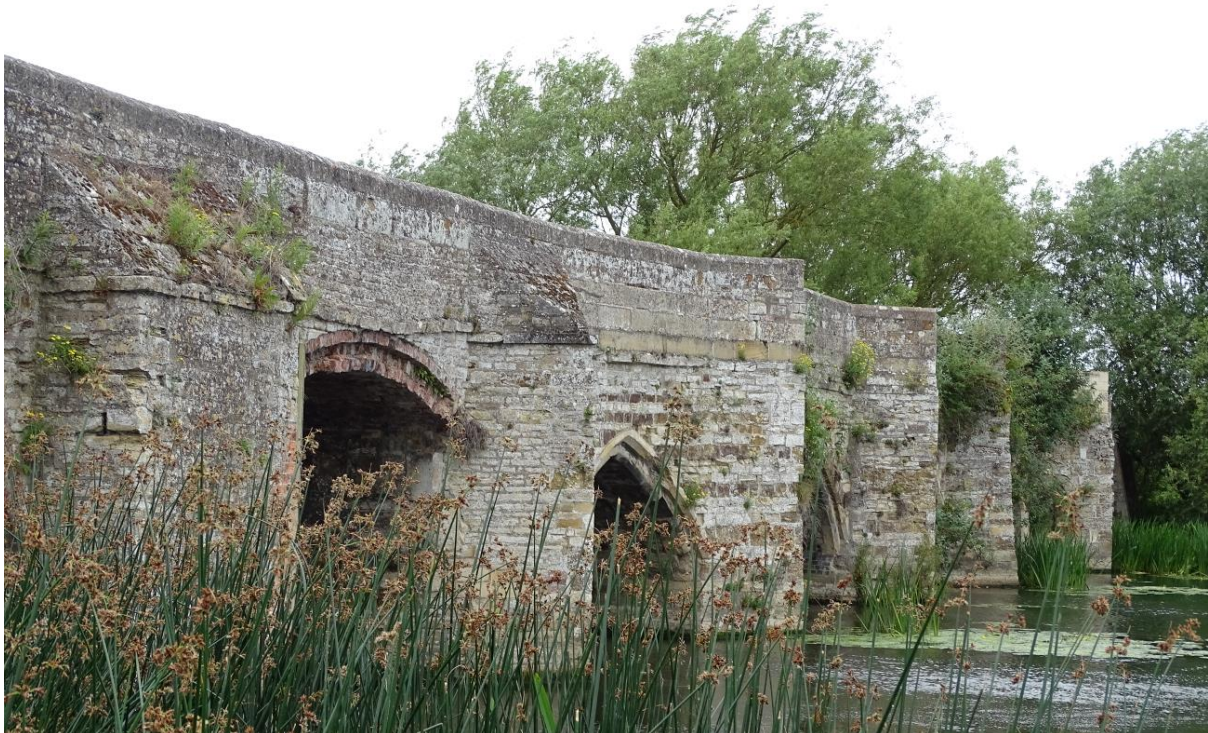
Looking from the SE corner (below) it is clear that there have been many changes over the years including a high level very flat brick arch presumably put in for navigation. Through to there, though the arches are all pointed and ribbed and the cutwaters look at least similar. The banding in the masonry is surely intended.

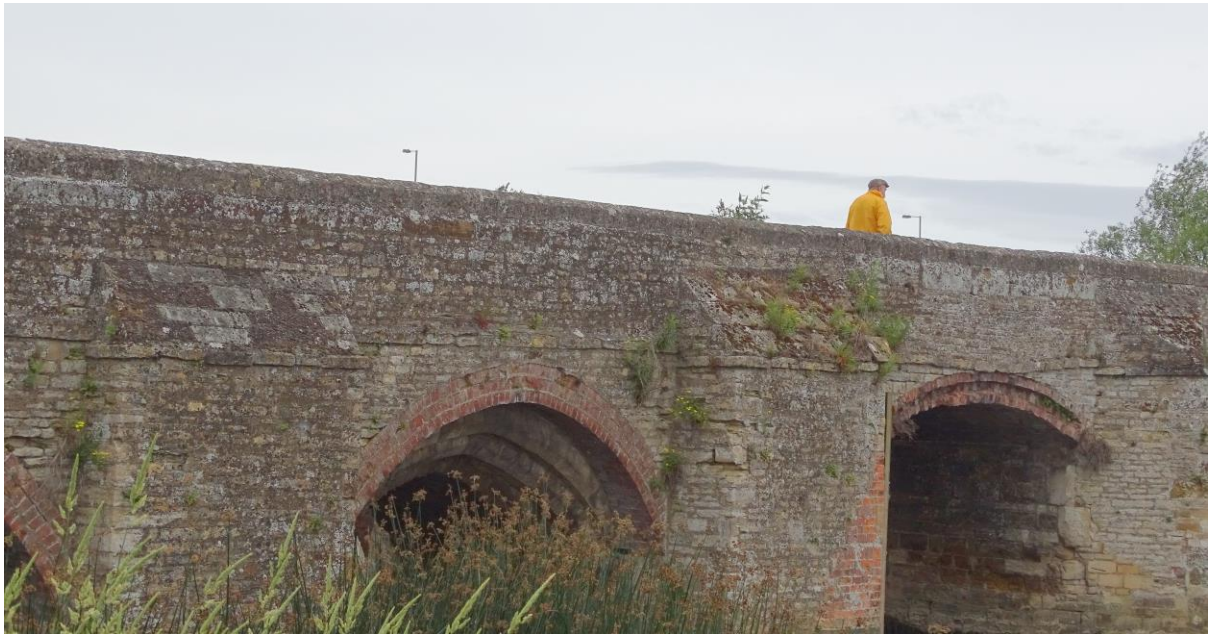
To the south of the high span, the ribbed arches return but have further brick arches in front of them.

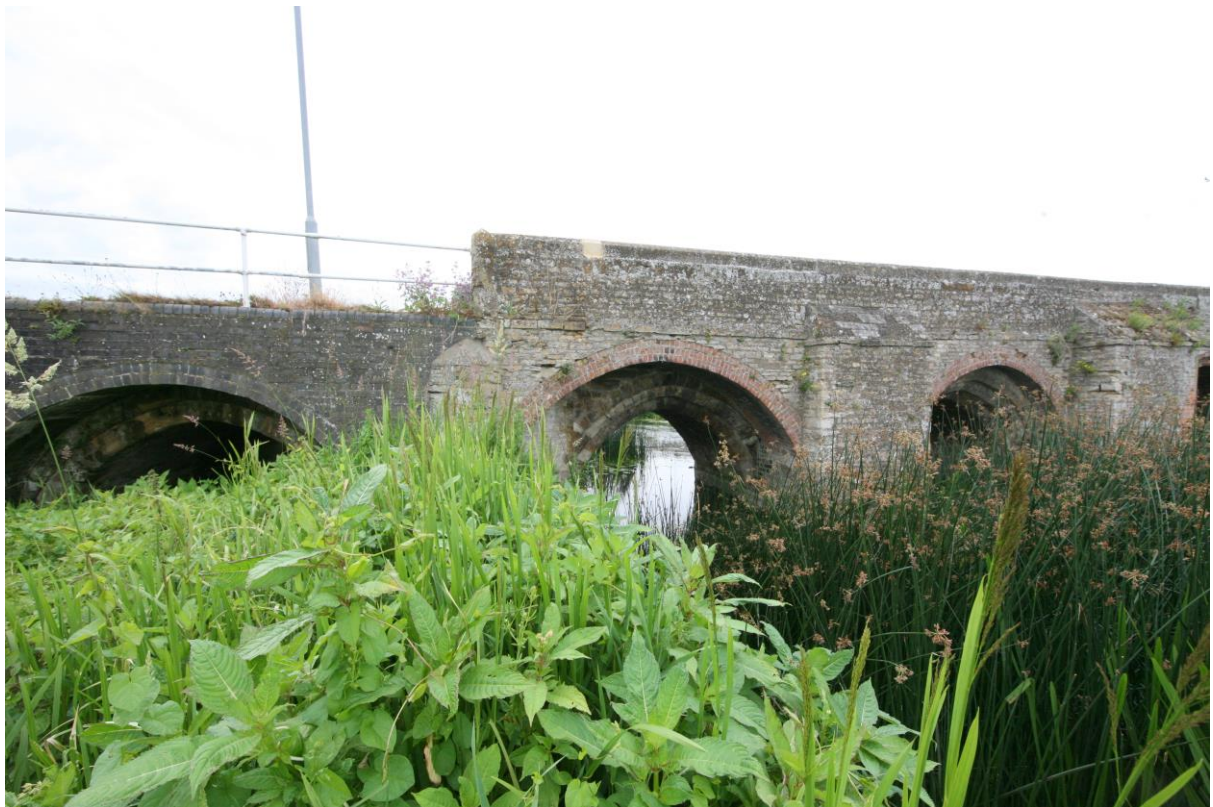
And the further south we go, the wider the new part is.

Well one thing I had never thought of before is the way those extensions spring from the sides of the cutwaters. That means the span gets greater, the further from the original bridge. Then on the outside edge there is a wall adding a bit more weight. The result is slow creep causing the extension to tip gently away from the parent arch. No wonder there is commonly a crack in the pavement along that line.

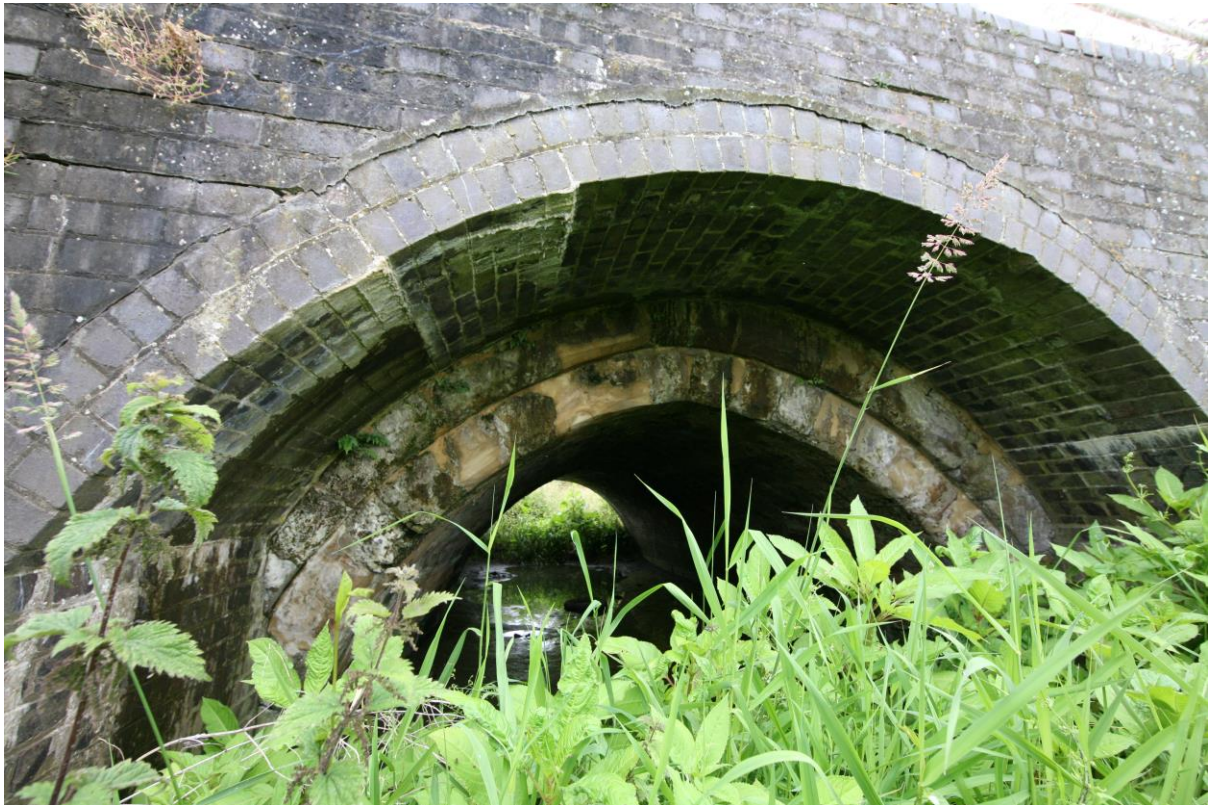
The brick extension in the flood relief zone is wider yet, and here we can see through to a substantial widening on the other side.

Some engineering notes due here. Notice that horizontal crack in the spandrel wall that matches with a line of lime on the intrados. There is a second such line (crack further up and a third over on the other side).

Above the horizontal crack the wall is leaning out slightly but I am almost certain, too, that there is a bit of articulation in the arch itself.

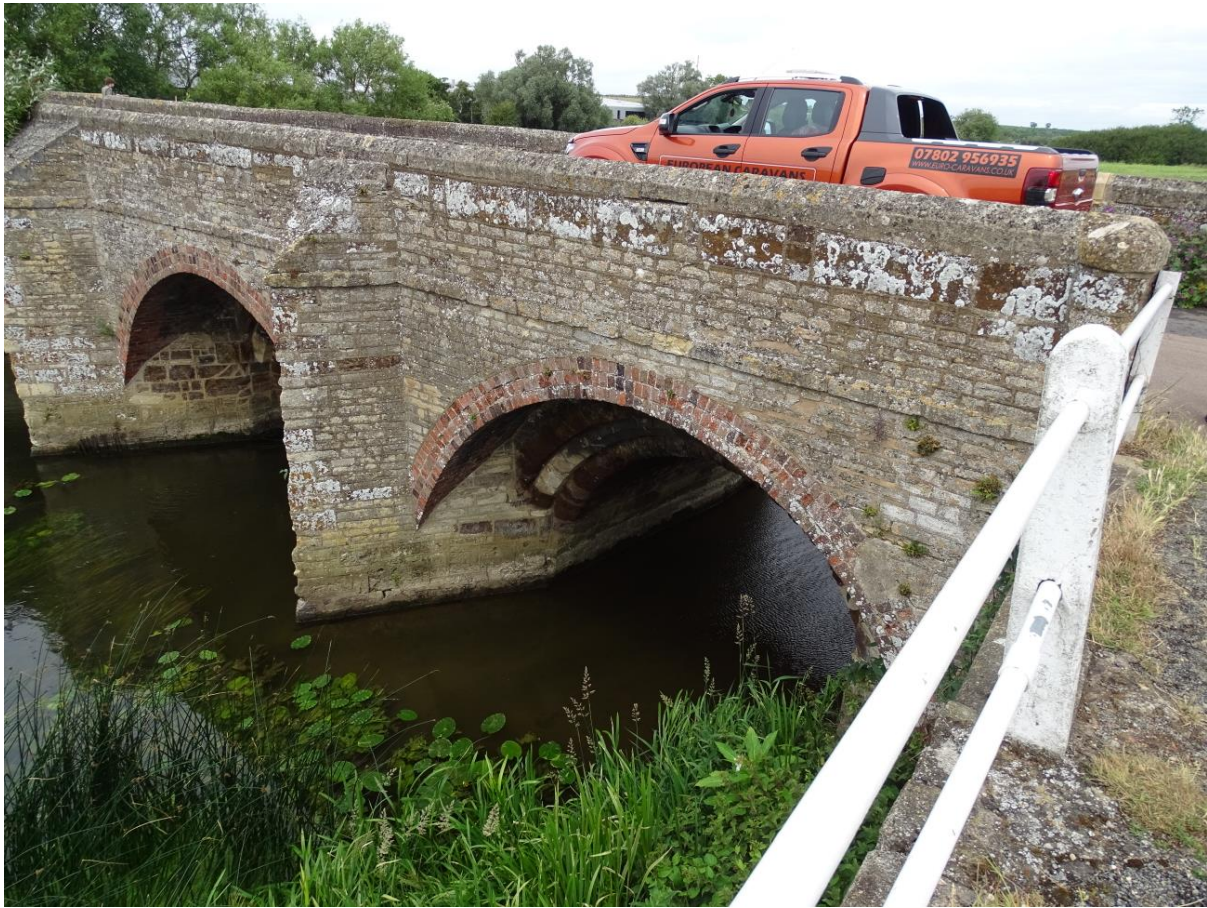
Here on the west side, standing on the very wide extension we can see that the old arch has also been widened but on this side they get wider to the north. The band of stone immediately below the copes on here must be different. Tremendous growth of lichen.

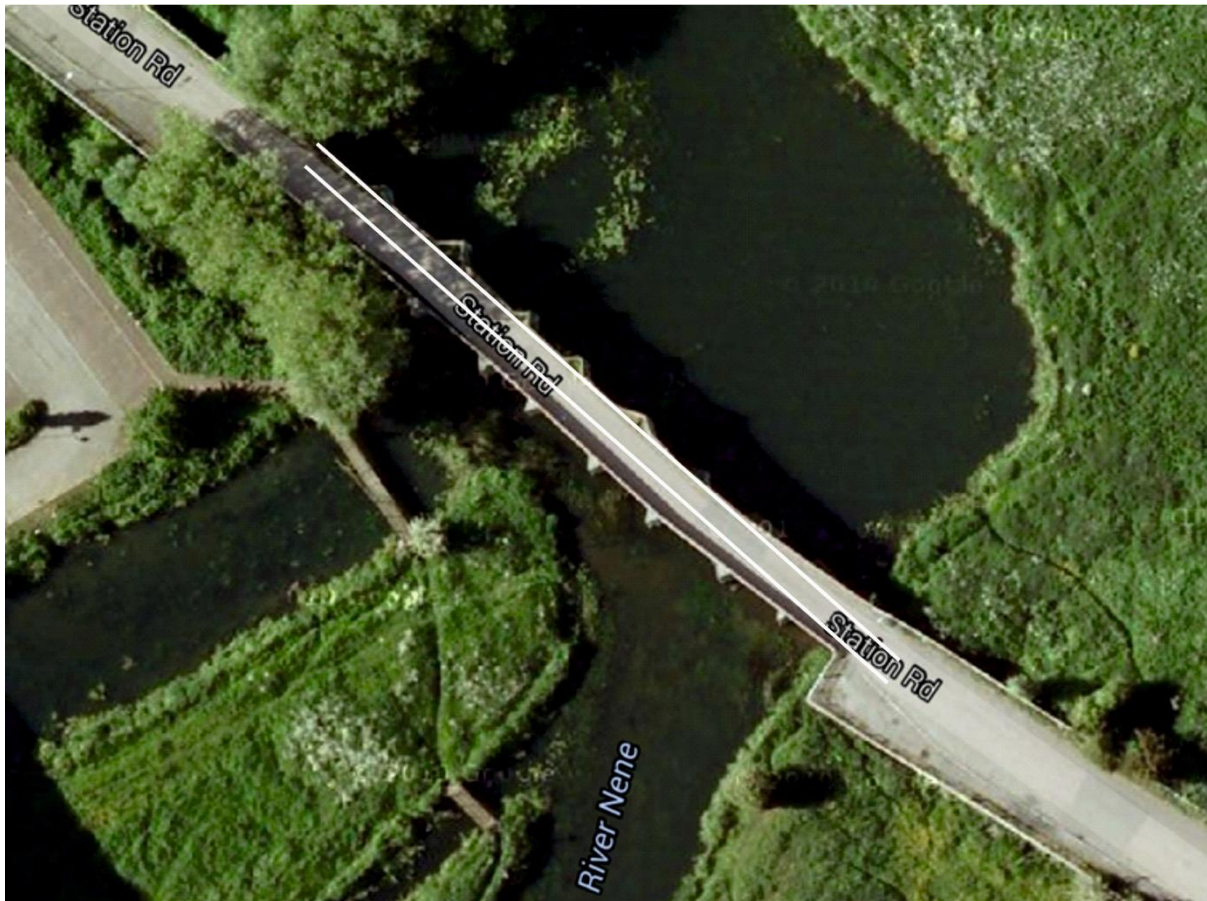
That is because the kink in the bridge is new. The white lines below show the original bridge (approximately). Have a look at the bridge from the top of the bypass at <https://goo.gl/maps/1U5Ws> and you will see that we have only looked at the main river crossing and ignored the long causeway running up to it each side. One day I will get back and give the bridge the day it deserves rather than 20 minutes or so.

First thing to note is that the road has been widened on both approaches as though the bridge was to follow. Indeed on the south side it is actually bridge that has been widened. At some point, though, they decided to build a bypass and there is a 1930s reinforced concrete bridge climbing to some height over the river to the south west. Then there is the fact vthat the parapets run straight and parallel through five spans from the north then the refuges disappear and the bridge takes a modest kink. We will see that from below shortly.
