Bridge of the Month No56, August 2015 Gt Barford

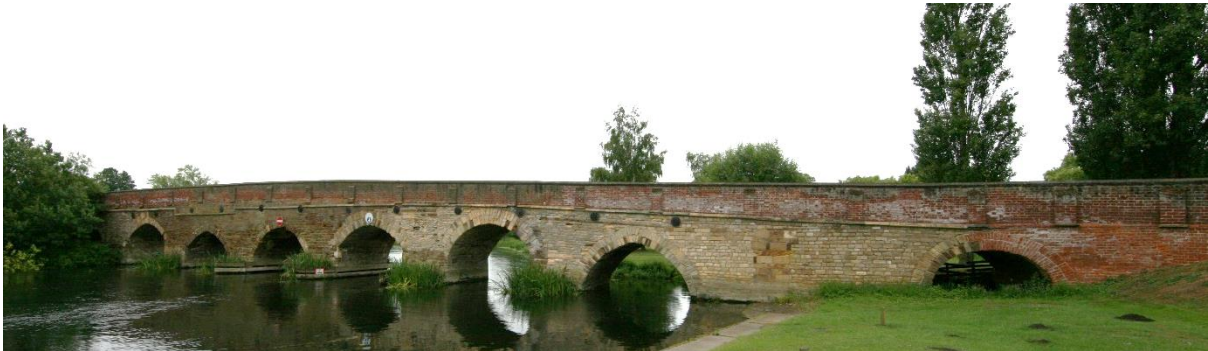
This view from downstream shows only a few of the arches. Even here, though, the multiple patching is evident. It seems likely that the low span second from the left is more or less original. The lower string course actually corresponds with a shadow string course over span 2 (from the right).

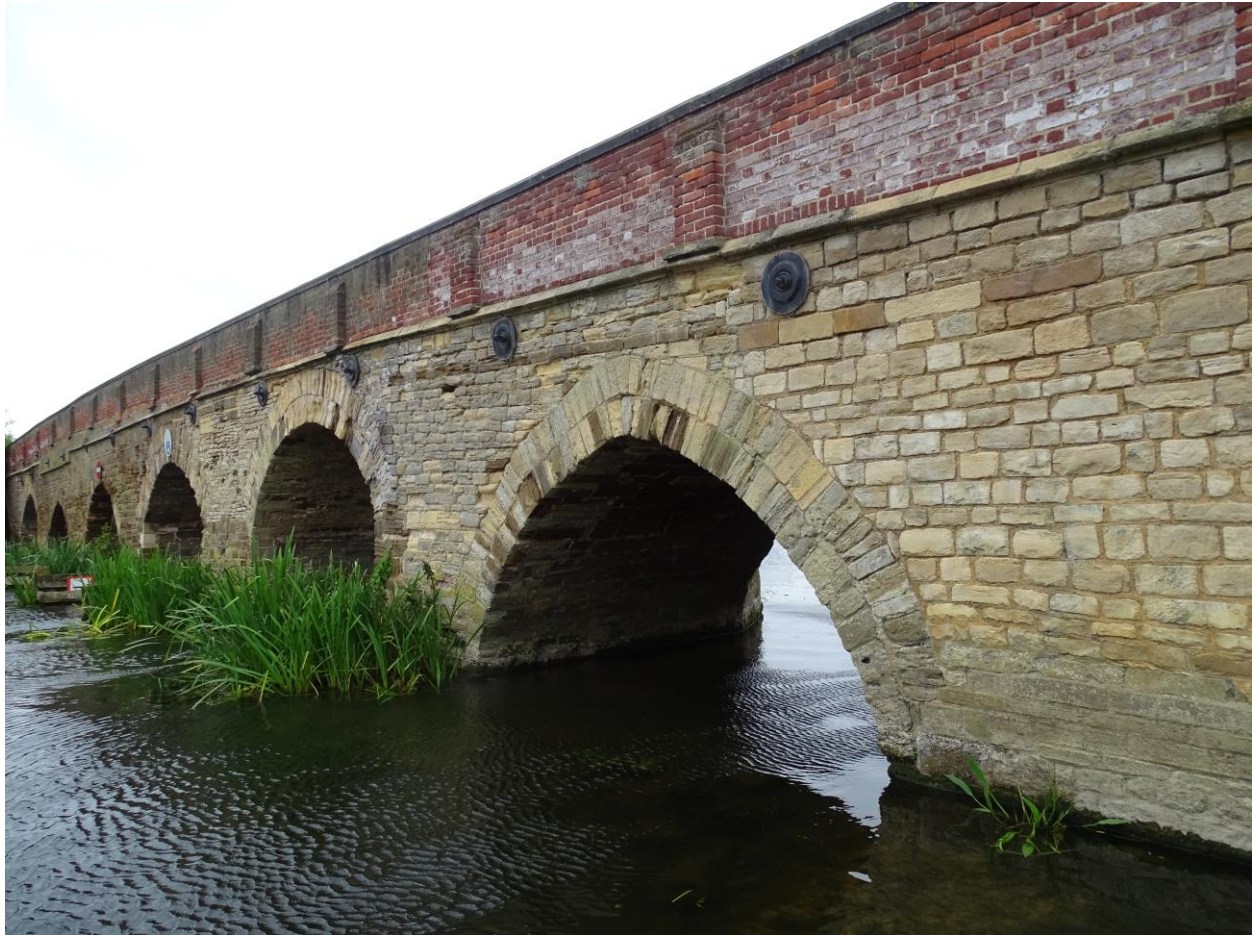
Looking more closely, these two spans both have single rings and are set very low. The right hand one is slightly higher and has a very irregular shape so perhaps it, too, is a replacement. Note how much higher the adjacent spans spring.

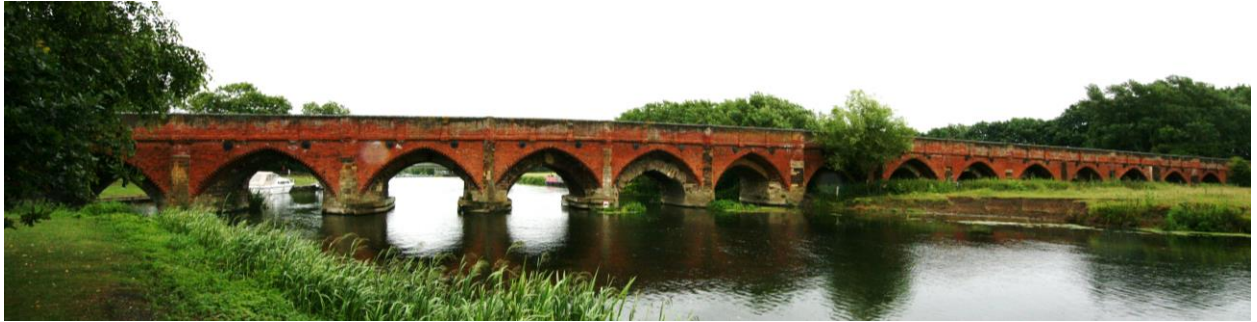
This near span, though double ringed is set very low and pointed. The two rings spring from different levels and I am tempted to think this has actually been under-ringed rather than rebuilt. Looking at that dark band close over the arch, it could be an old string course that has just been snapped off.

A large part of the near spandrel is obvious rebuild. The next two spans are double ringed but circular arches and set quite high. The brick parapet is surely later. One wonders what the buttresses are supposed to do when they have no base to lever off.

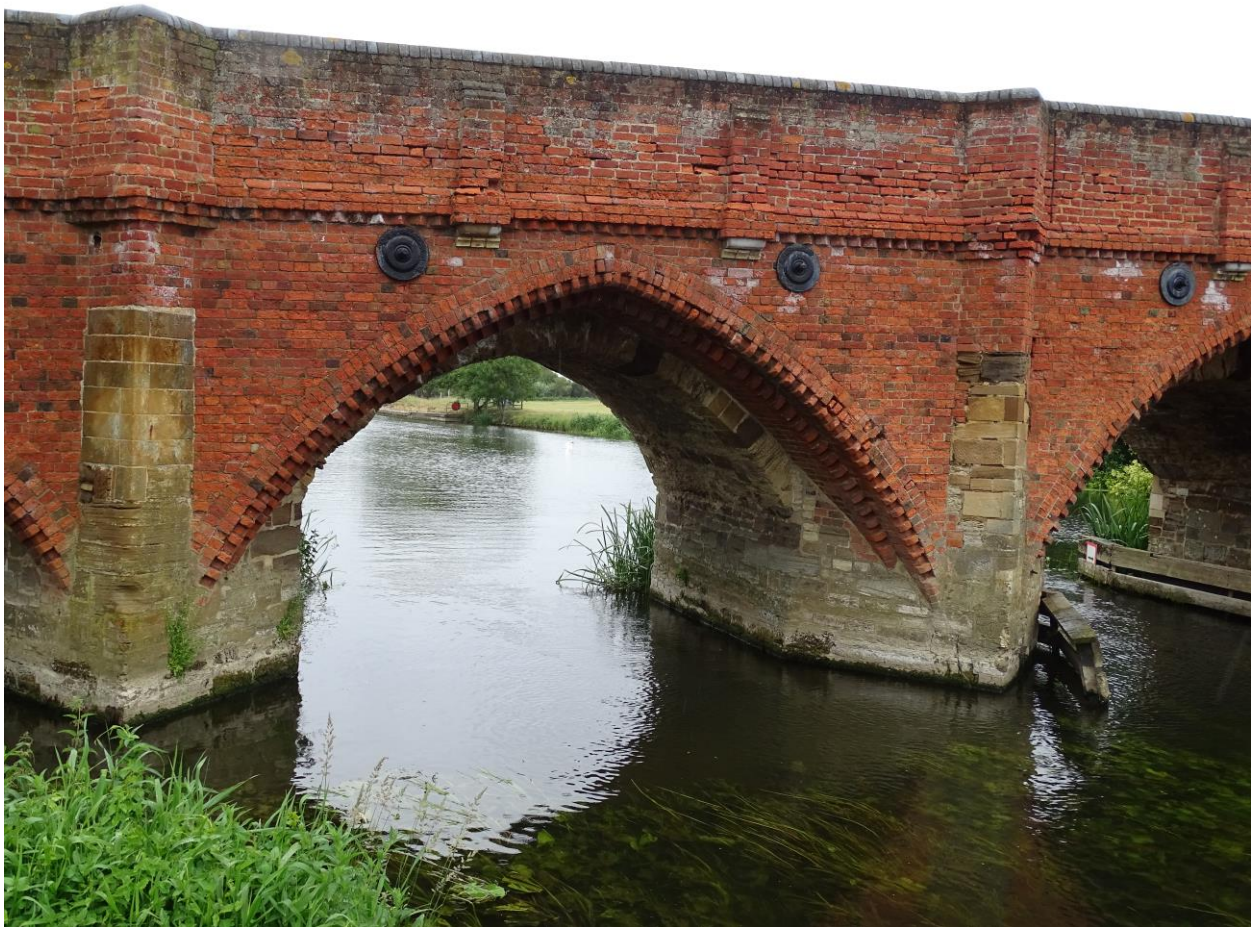
Looking from upstream, this is obviously a much bigger bridge. Eight more spans visible to the right here. And also, of course, widened on this side. Let's look closer at that.

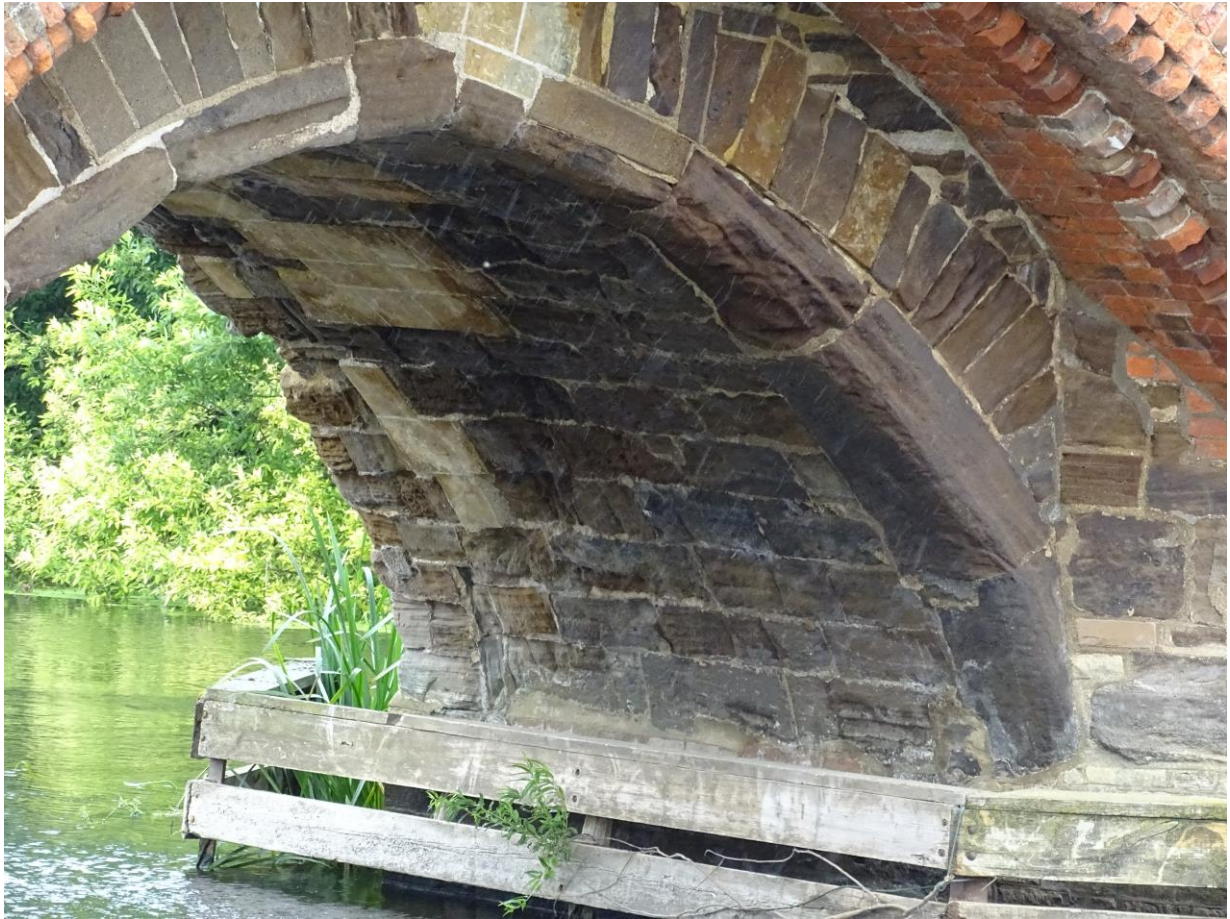
So the widened section sits entirely on the old cutwaters. Here is something I had never thought of before. The further out on the cutwater, the bigger the span. The stress levels are therefore going to be bigger on the outside edge and no matter how low the stresses are, creep is likely and the widened section will slowly lean out from the rest. The height of the main arch springing above the water is also obvious here.
