Having returned to the scene, I wondered whether there would be another similar bridge on the line. Google Earth doesn't help a lot because street-view doesn't extend to cycle tracks and disused railways. However, [the next bridge East at Malvern Road](#) proved to be very interesting. It is also a flying arch but is skew and has been widened with two concrete rib arches.

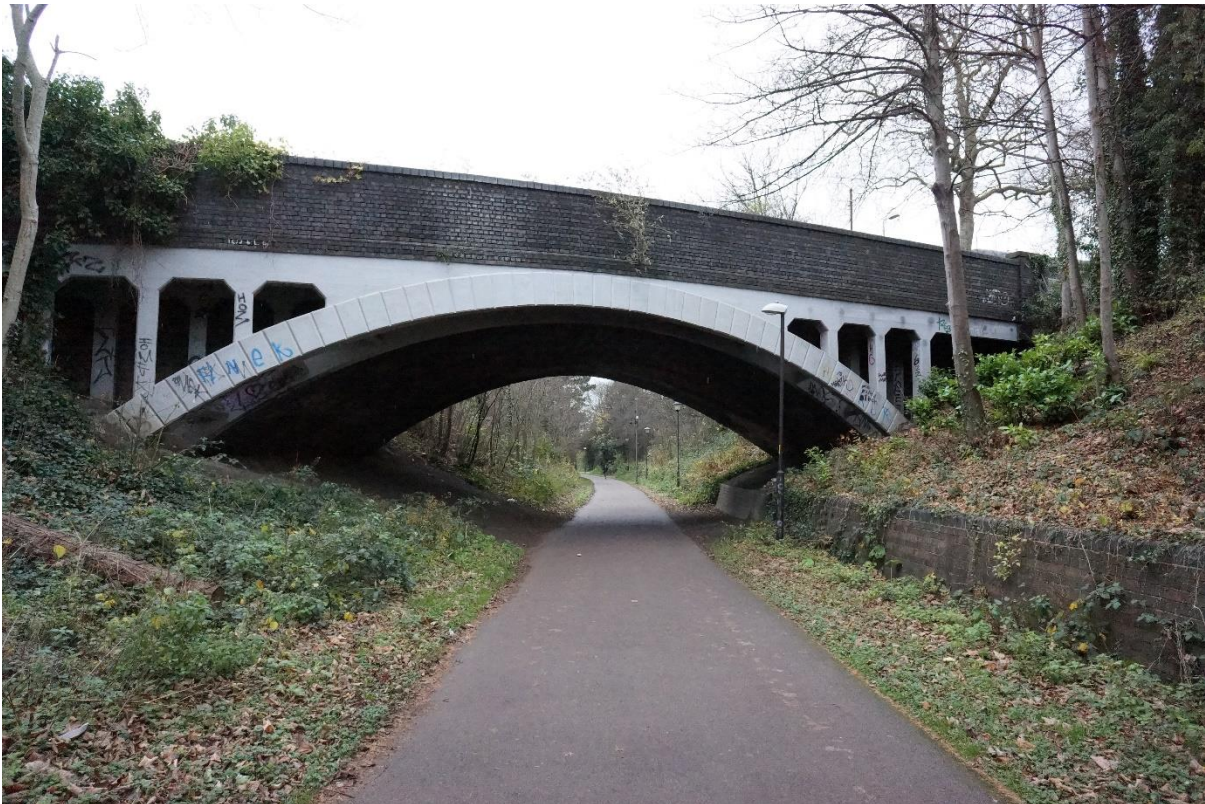
The ribs were all I could see from a distance so I thought perhaps the whole arch was gone. As you can see from here, though, there is a similarly distorted brick arch behind.

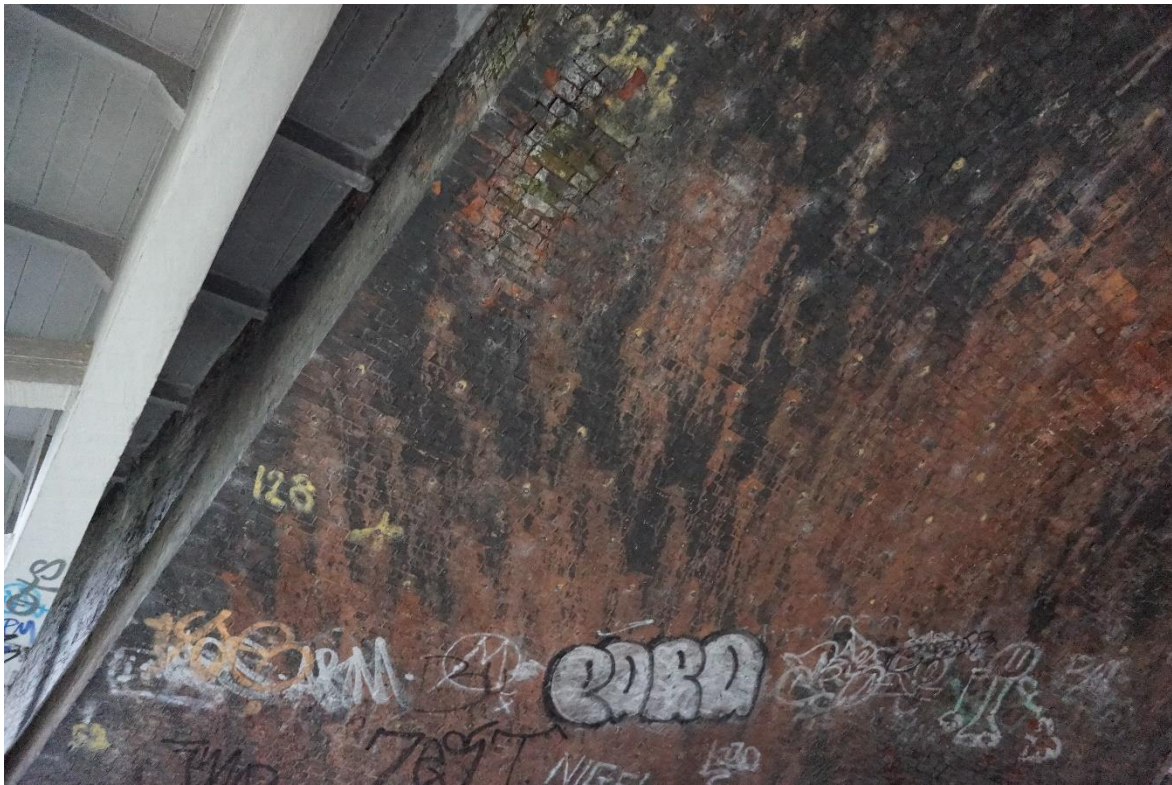
As you get underneath, the concave face of the spandrel wall is emphasised by the straight plan of the concrete rib.

Notice also, the regular pattern of mortar dots marking places that have been pinned through the ring.

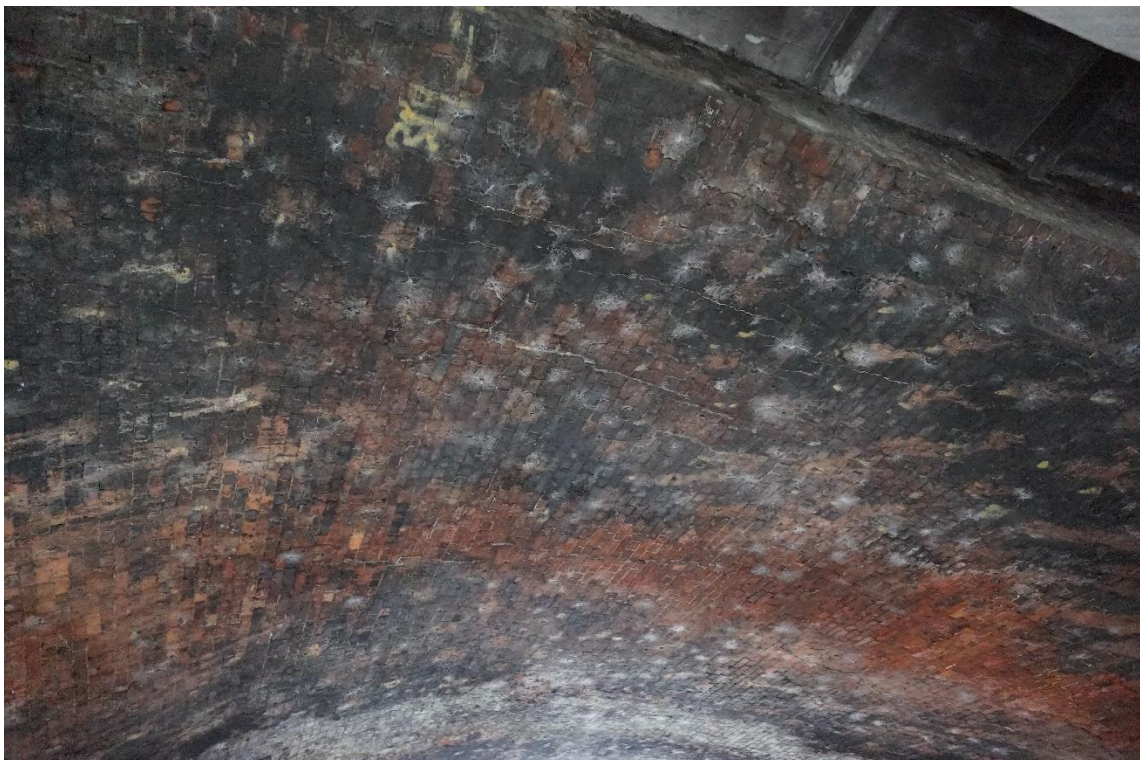
Striking in the view below are the cracks marked with chalk. They seem more or less parallel to the edge. There are more than can be seen here.

We have also come across a number of skew arches (like this one) that have systematic cracking in the skew direction at a number of places through the width. The number of these cracks is particularly perplexing and we are working on understanding them. The first ones we found were carrying railways but.....

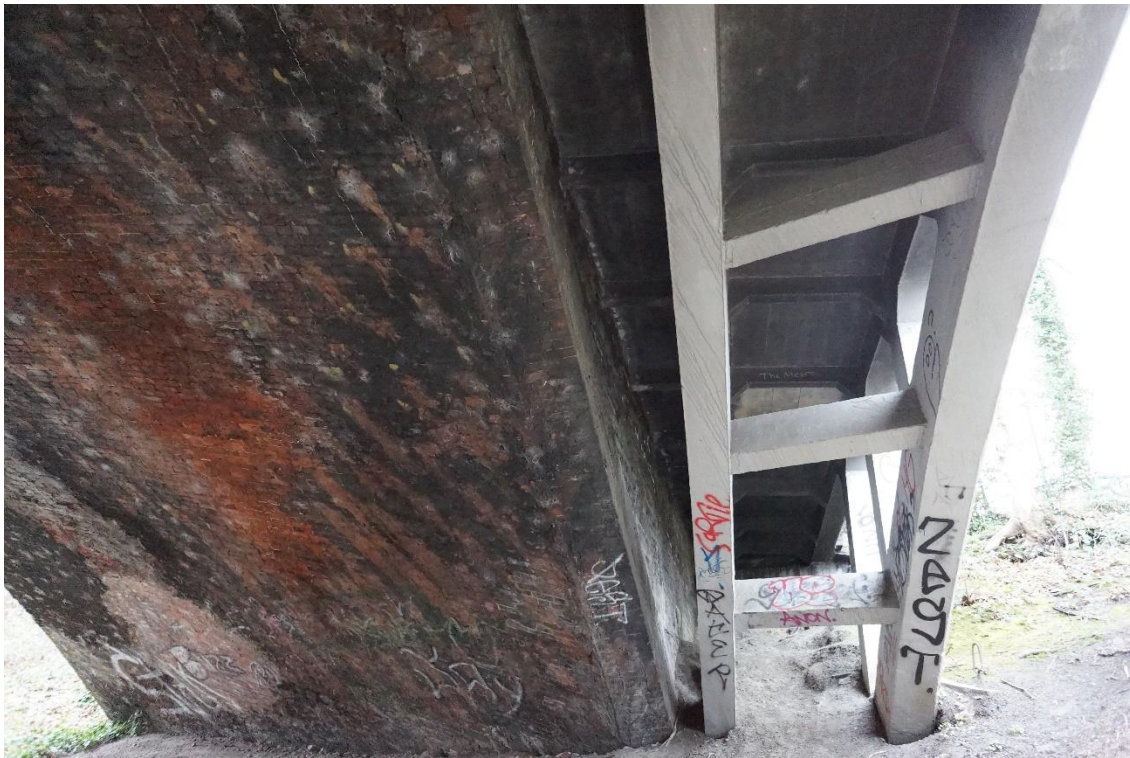
The wide angle lens (16mm on an APC frame) distorts the picture below a little, but it does serve to show off the bevel on the acute edge of the arch. One day I will find out how that was done.

Notice how it twists from being in line with the arch at the crown to quite a steep angle at the springing.

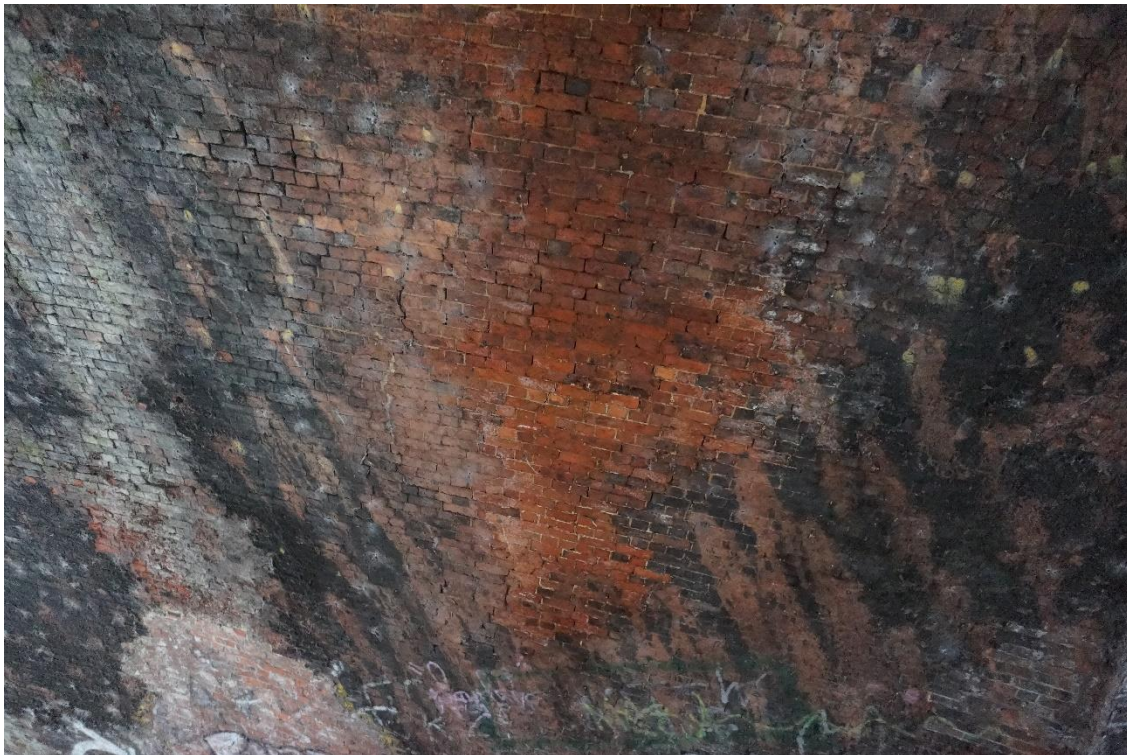
The pic above shows areas of considerable mortar loss and some consecutive perpendicular joints that come very close to alignment, creating a line of weakness on which a crack might form.

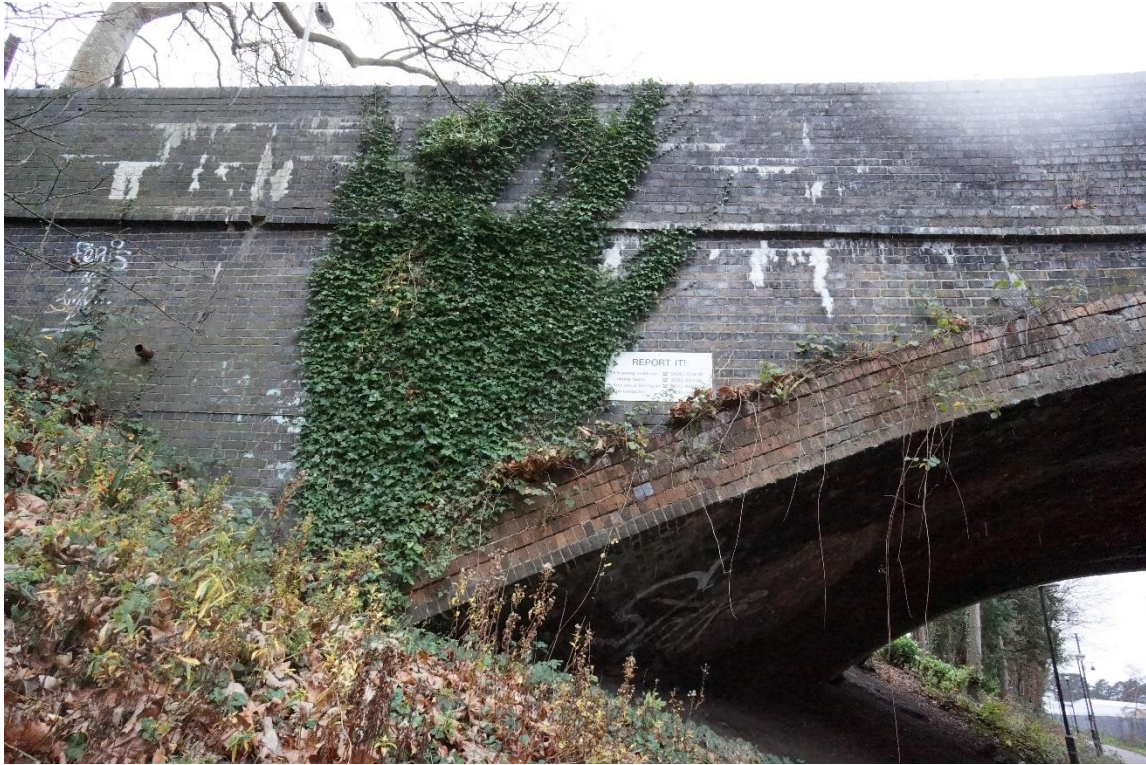
As at last month's bridge, there is a horizontal crack in the spandrel and some degree of ring separation near the end of it. Note the drain, which must come from the top of the backing, though the crack is below. The crack is quite substantial.

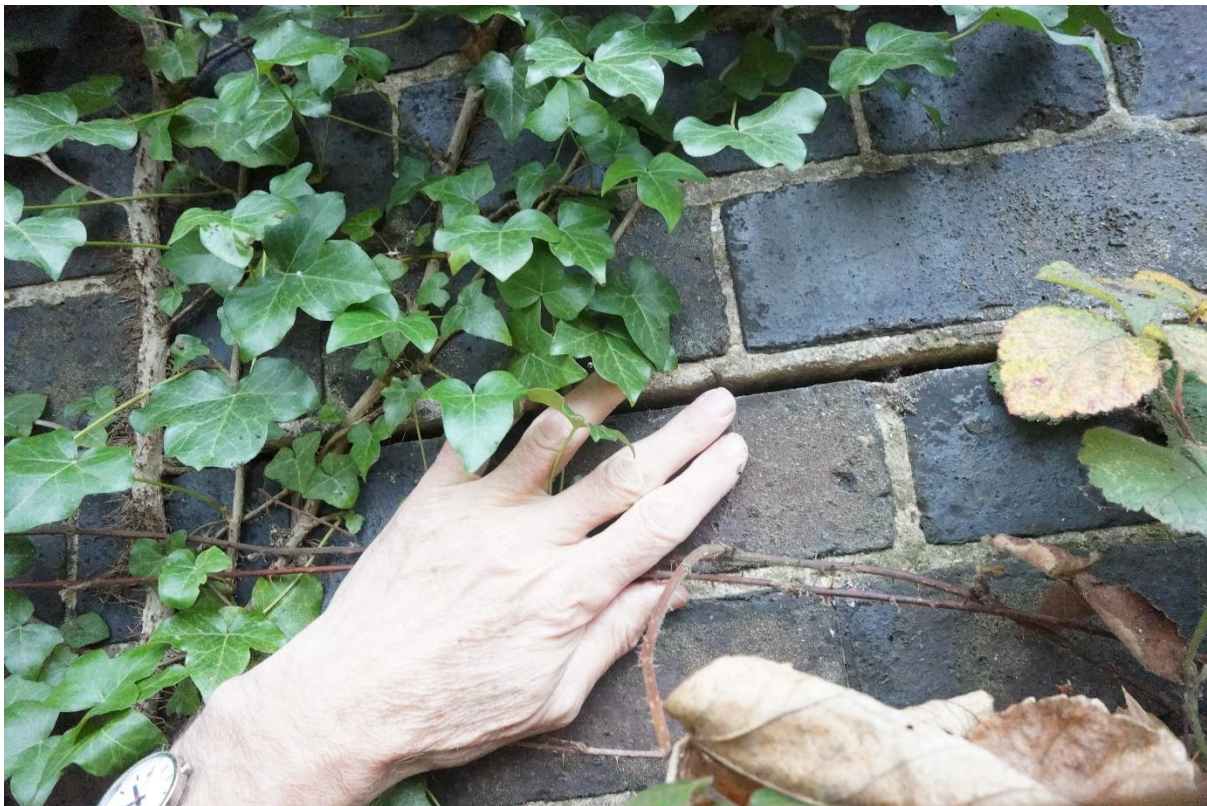
There has certainly been some loss of continuity in the ring.
