Bridge of the Month No65, May 2016 Bittaford, Railway Viaduct

I stopped half way through the collection of bridges in Bittaford, so here is the big one.

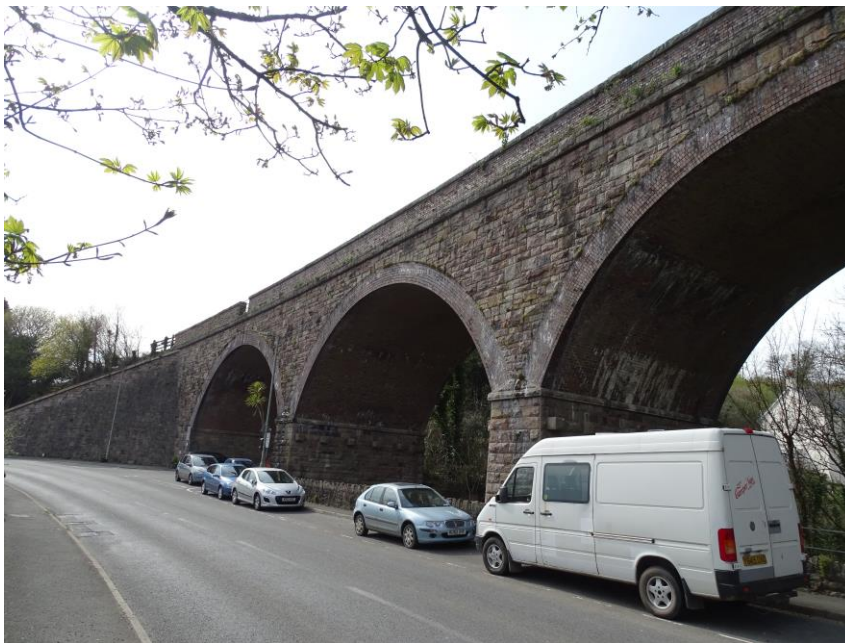
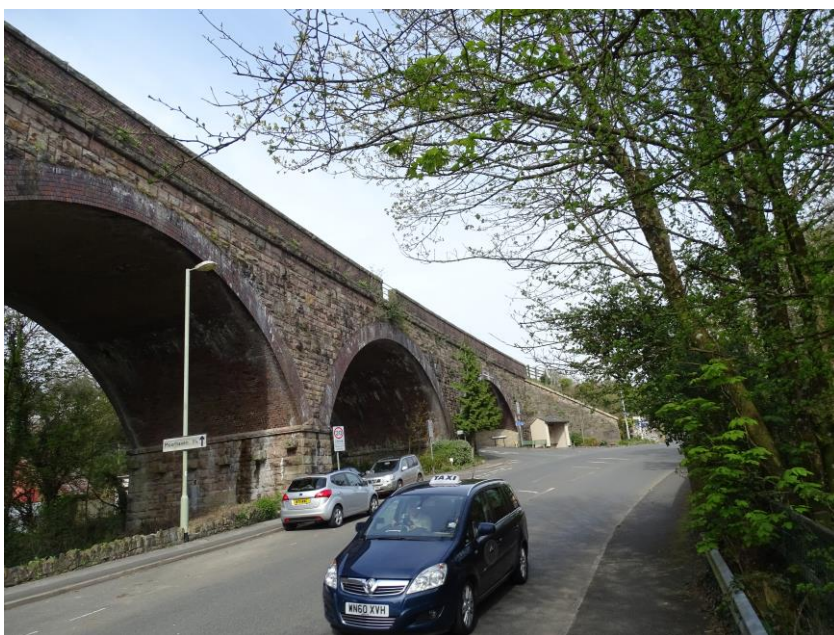
From this level, it doesn't, look so grand, but those legs go down some distance and the spans are actually 15m, with 8 rings of brick in the arches.

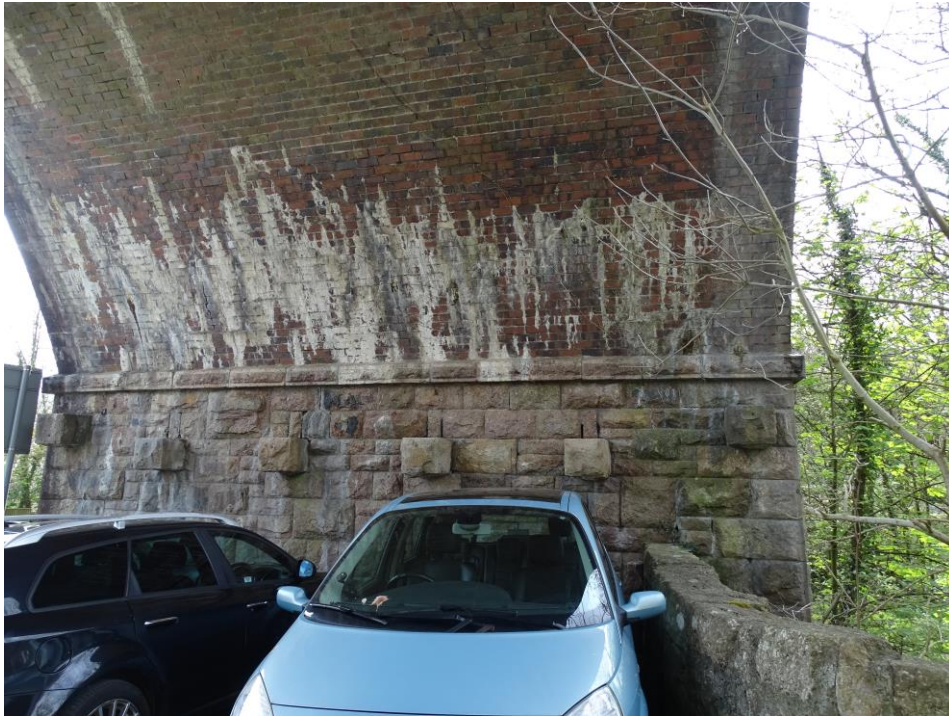
Here we see the corbel stones positioned to support the centring, four across the width and one each end set about a foot (300mm) higher. That implies either different centres or something odd in the seating system. The outer ones, especially, are very close to the top and would not support any serious weight without a good deal of material above. But then the arch is built from the bottom up.

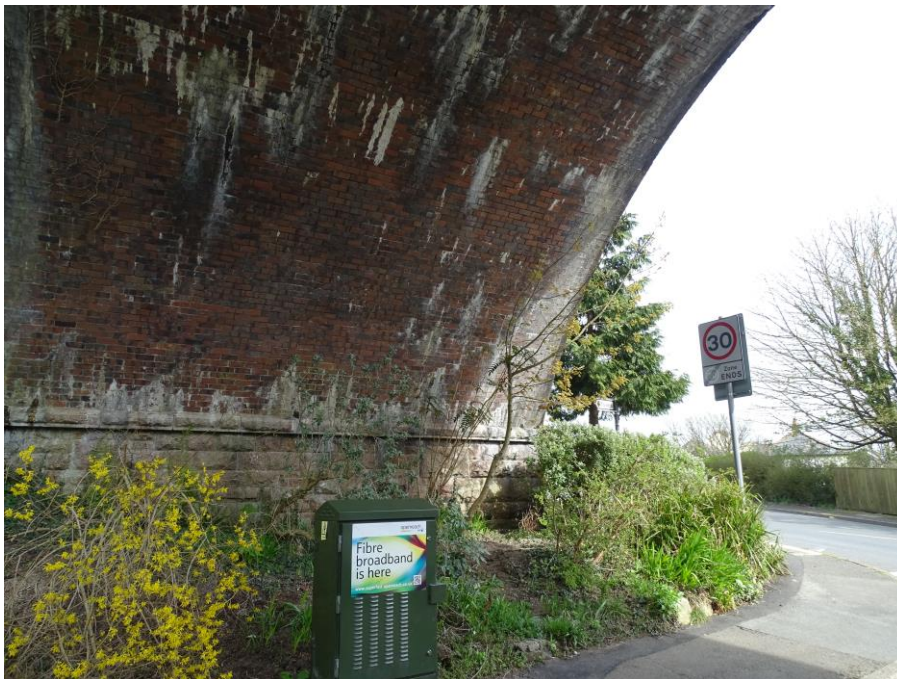
Looking the other way, there are no corbels at all, but the ground is close, this is the abutment.

The water marks are different on the two sides of the span. I wonder why that would be? Here, though, there is one very clear line of lime runs and then further runs from above.

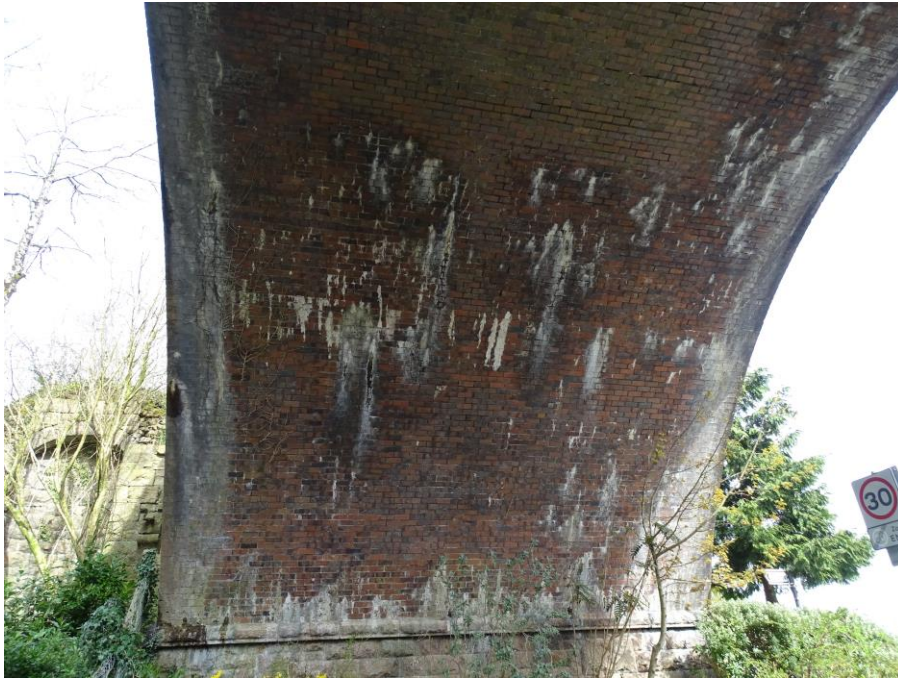
This slightly higher shot shows two obvious lines of runs in the abutment end. The lower one is the more pronounced and surely represents the top of solid material behind while the upper one might be the top of arches over the internal spandrel walls.

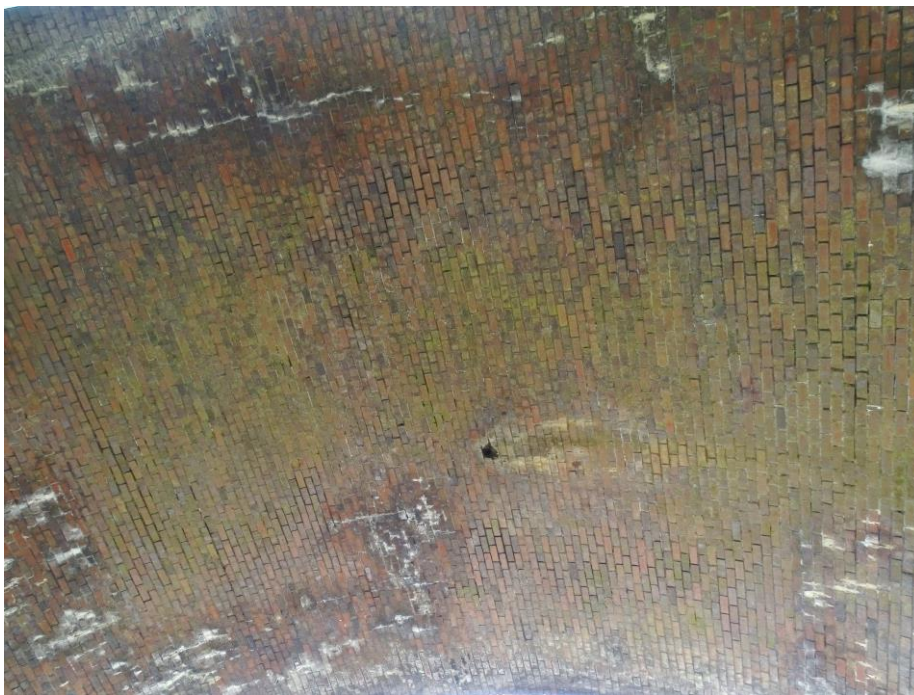
Looking straight upwards shows a drain at the centre of the crown and lime runs roughly equidistant each side. These rings are thick so the top of backing is likely to be further back from the crown, though why, then, is there a drain at the centre? Does the backing actually slope downwards? I have seen drawings of such bridges in Austria.

The minimum backing one might expect is level with the crown intrados (though we know that GW Buck working in the North West stopped at about 2/3 height). Oh, and, despite 8 rings of brick that looks remarkably like a spandrel crack developing.

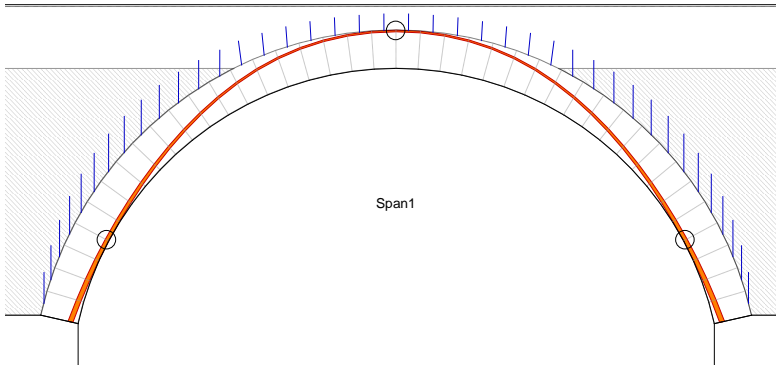
This wouldn't explain the water marks or the drain, though.

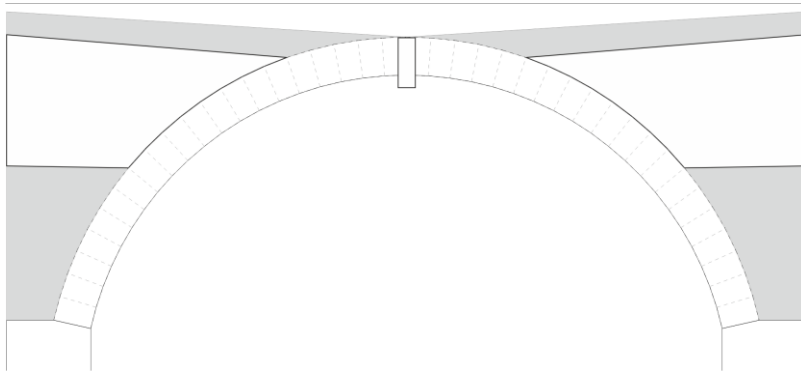
To suit the water marks and drain hole, hollow backing with the upper surface sloping down towards the crown would be needed, as here.

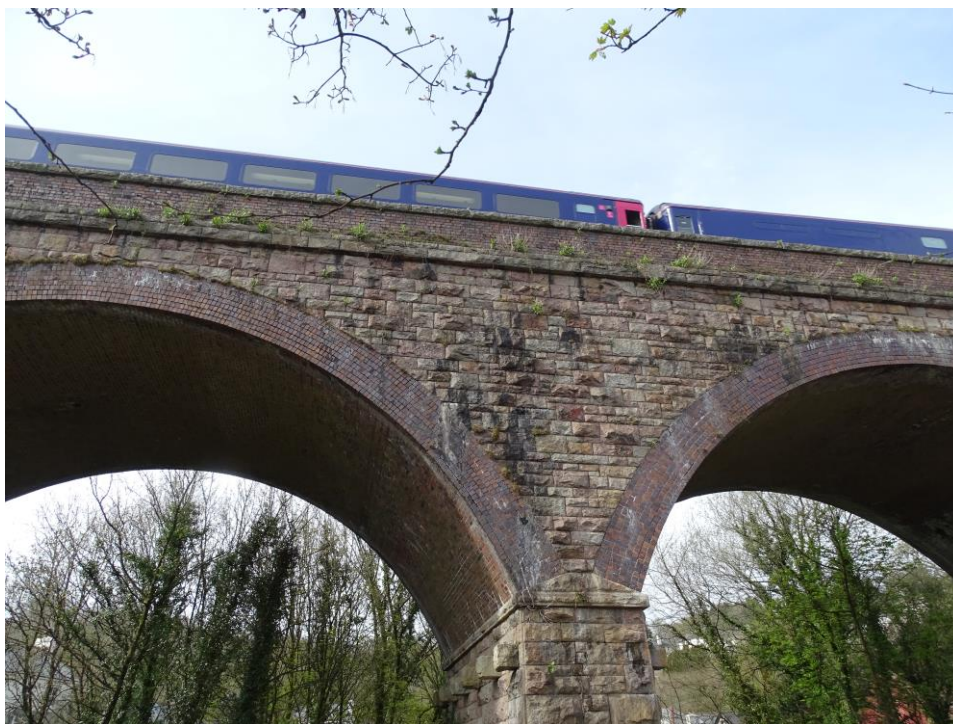
Now that is interesting. Two spans along, the corbels are all level. There is no sign of a drain coming out through this face or on the other side.

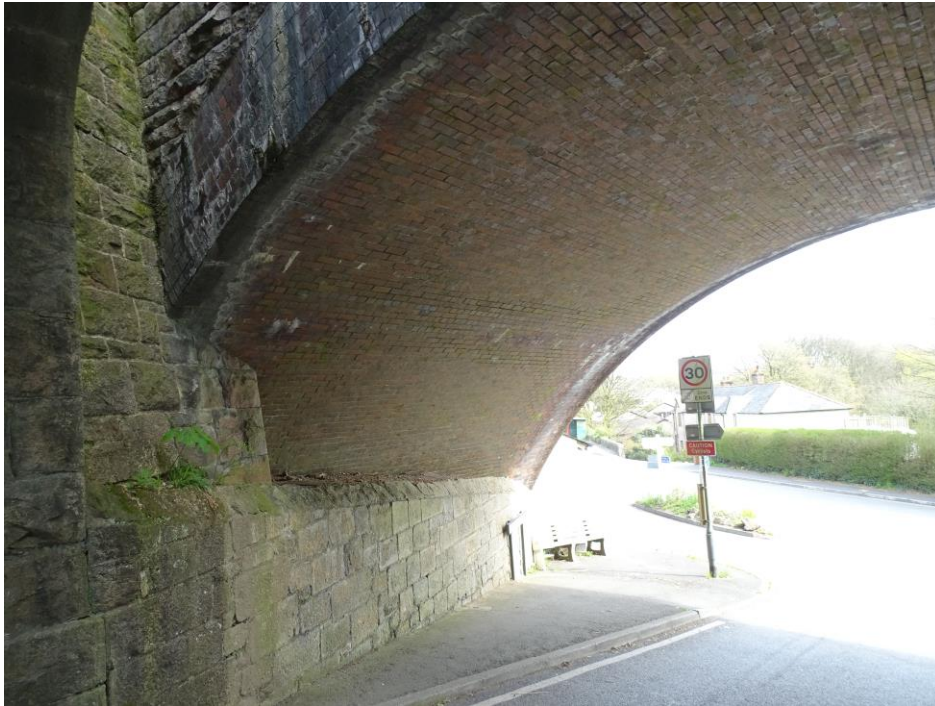
This oblique shot from below shows bands of brickwork with solid and eroded mortar. The erosion almost certainly corresponds to areas where there is water penetration from behind.

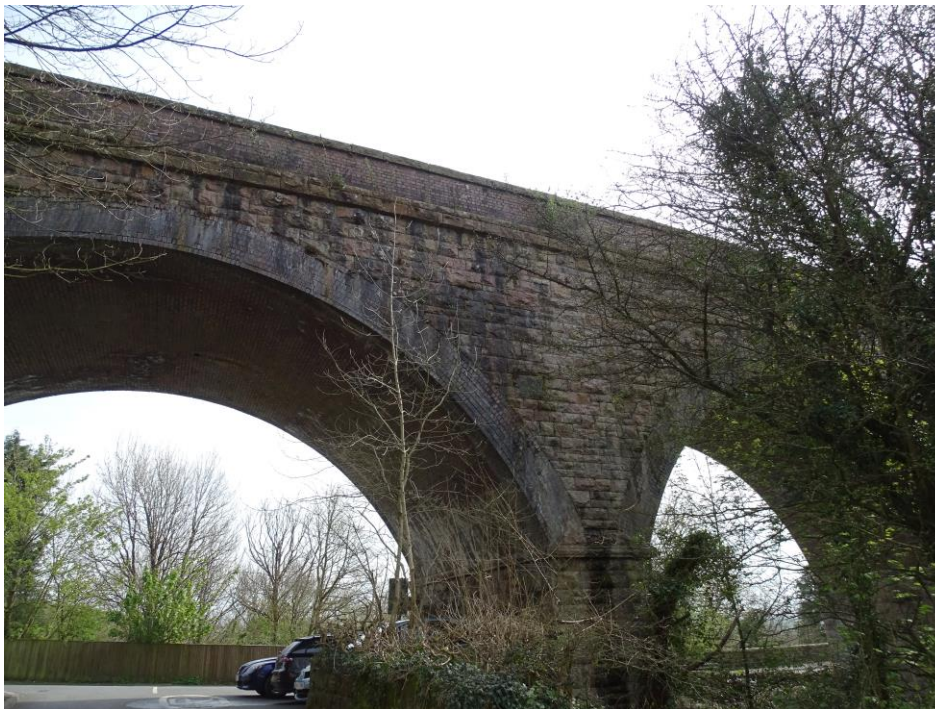
This view of the north side shows no drains either but it does show dark staining below what is presumably a more or less waterproof layer through the bridge.

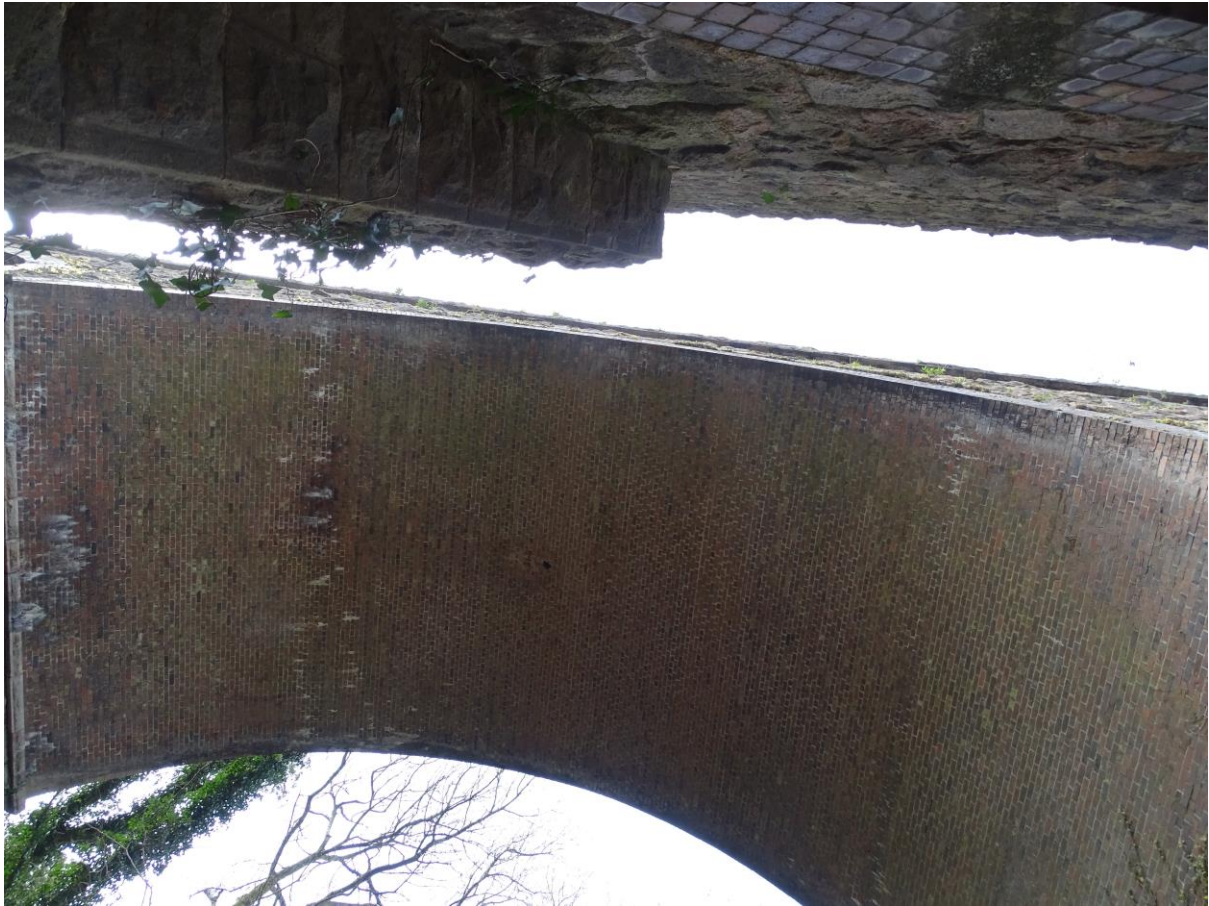
From a lower viewpoint we can see most of the arch soffit in a single view, though it is slightly distorted by the camera inclination. The drain hole must be slightly off centre because the wet patch is all to one side (the left in this view). The water/lime runs do not appear to be symmetrical either. Perhaps when I have a little more time I will be able to look in more detail at that. On this trip I was really aiming for the bigger viaduct at Ivybridge and got distracted on the way.
