In the meantime, a suitable bridge since I was able, in my great tour to dip aside, to Kirkby Lonsdale. It's here <https://goo.gl/maps/sEGDtssD5QH2>.

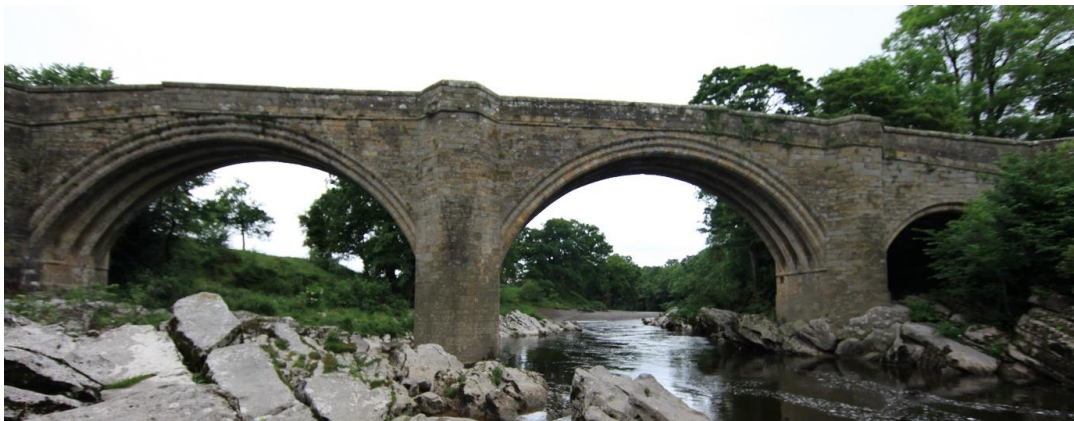
The stretch in this picture, taken with a 14mm lens on a full frame EOS5DMk2, is obvious but it is the only way I could get a full view, scrambling over the rocks in quite a steeply sloping bed.

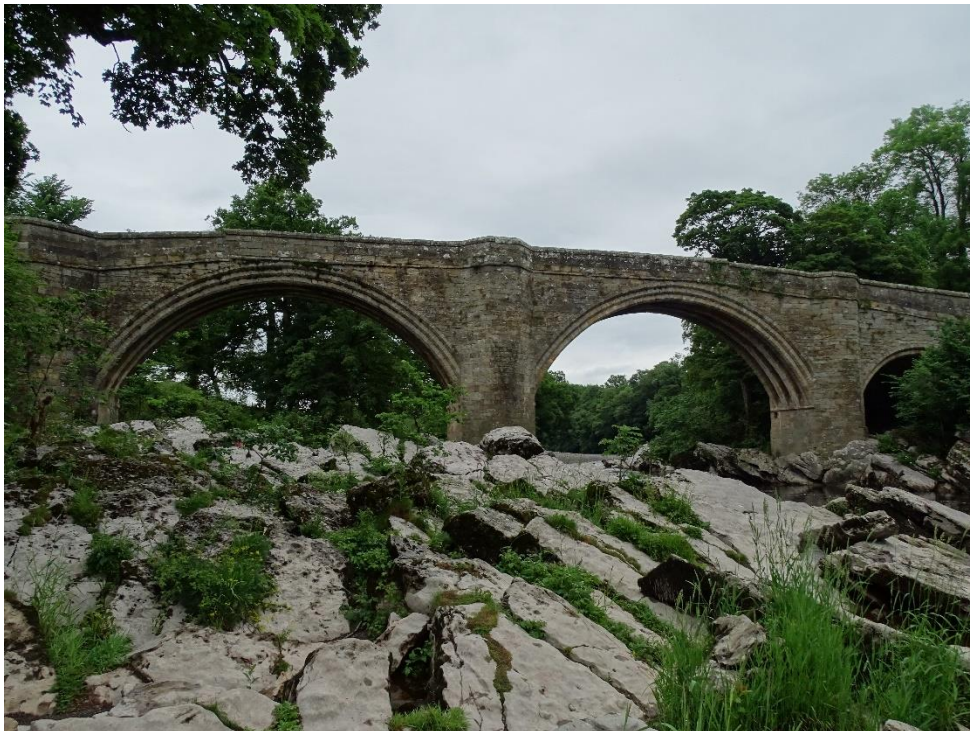
Actually, this view from further away with my Sony HX400V works well. A prominent feature from here is the break in the parapets which looks almost like the sort of lip you get in Google earth stitched pictures.

The bridge is magnificent. The main spans around 17m and about a third of a circle. I didn't get chance to measure but that is perhaps a 32ft or 32ft6 radius.

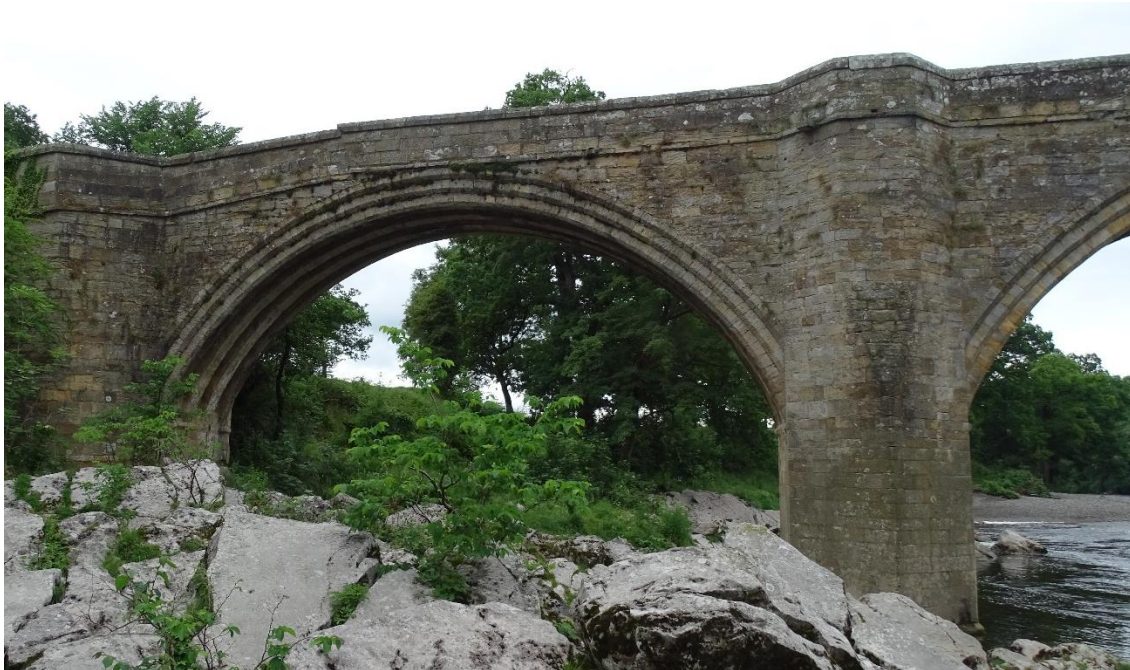
The disjoint in the parapet and string course is even more prominent here. This is the downstream side. Cutwaters on the downstream side were not common in the south at this time but were clearly (rightly) seen as important here. The sharp edges taper away to a flat higher up but extends to the top to provide a pedestrian refuge. Only 12 feet wide and originally with a pronounced hump, two passing carts would have filled the bridge.

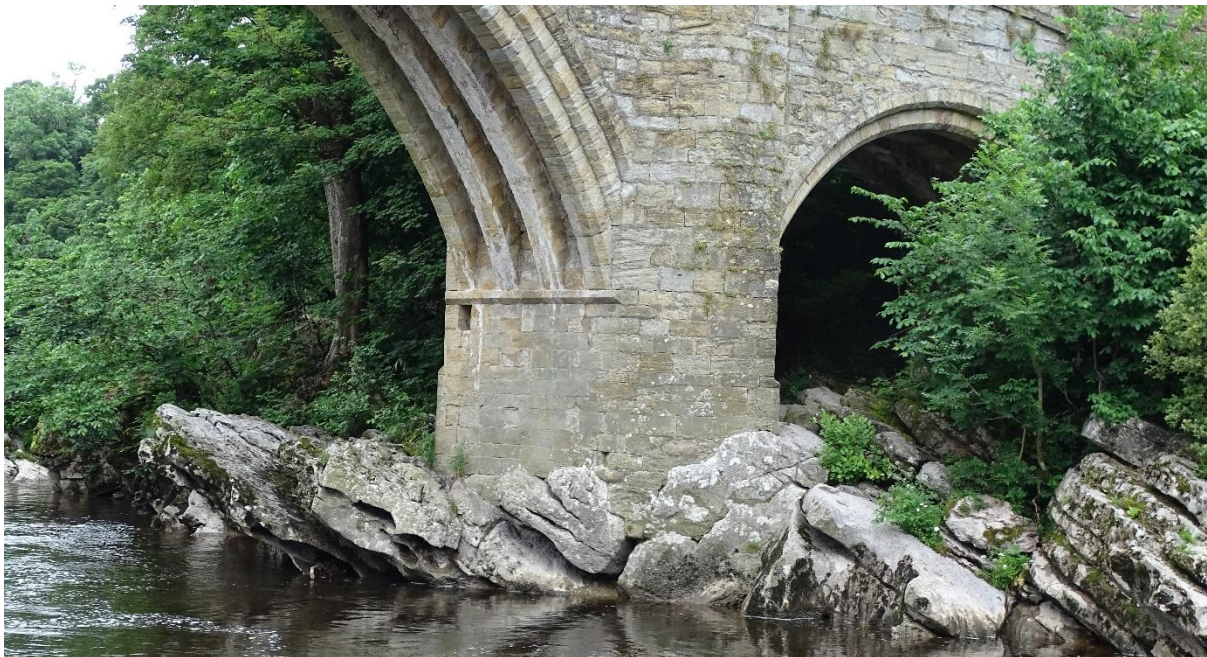
The foundations are slotted into the original stone bed.

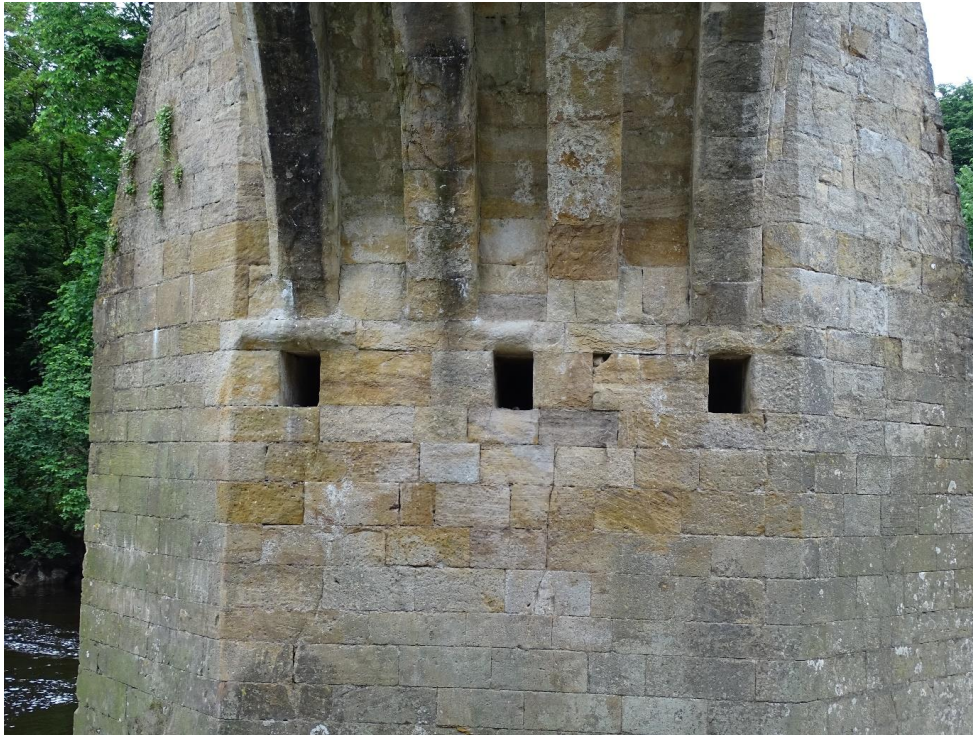
This picture gives the lie to one idea about ribbed arches. Four ribs and three sockets for centring so the ribs weren't built consecutively on the same centre.

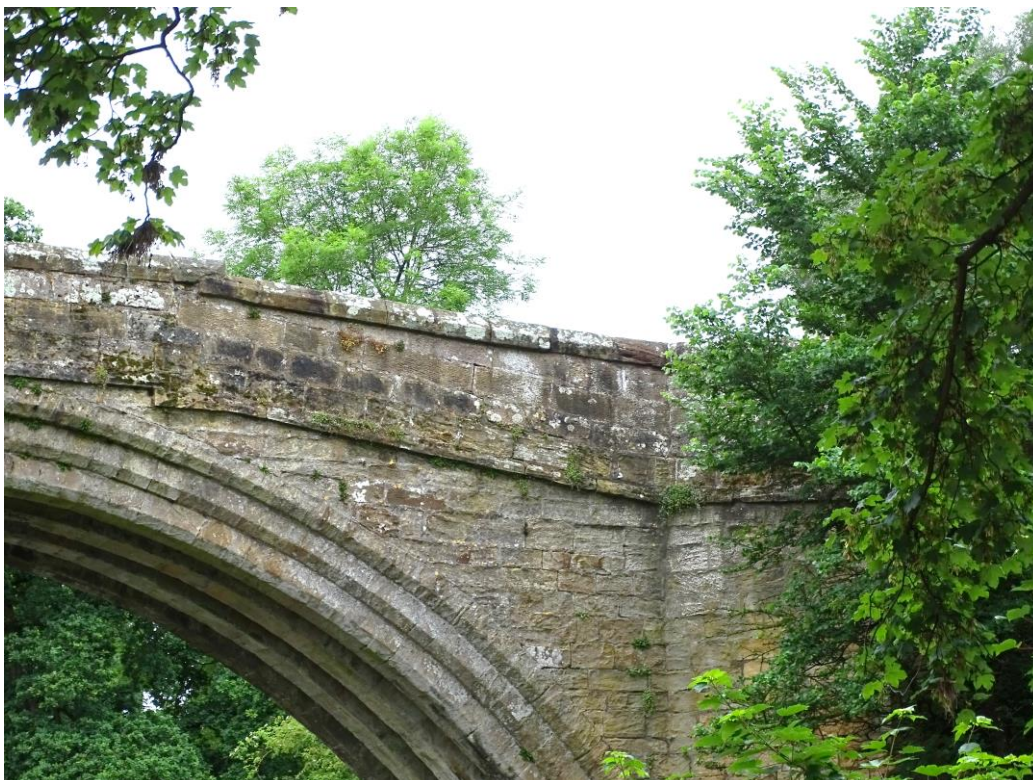
Looking even closer at the parapet disjoint, we see two elements of change. To the right, the parapet cope has been flattened considerably. The string course still follows the original slope of the approach. The left hand part is absolutely horizontal. It seems likely that the parapet originally rose on a continuous slope to some form of feature high above the river.

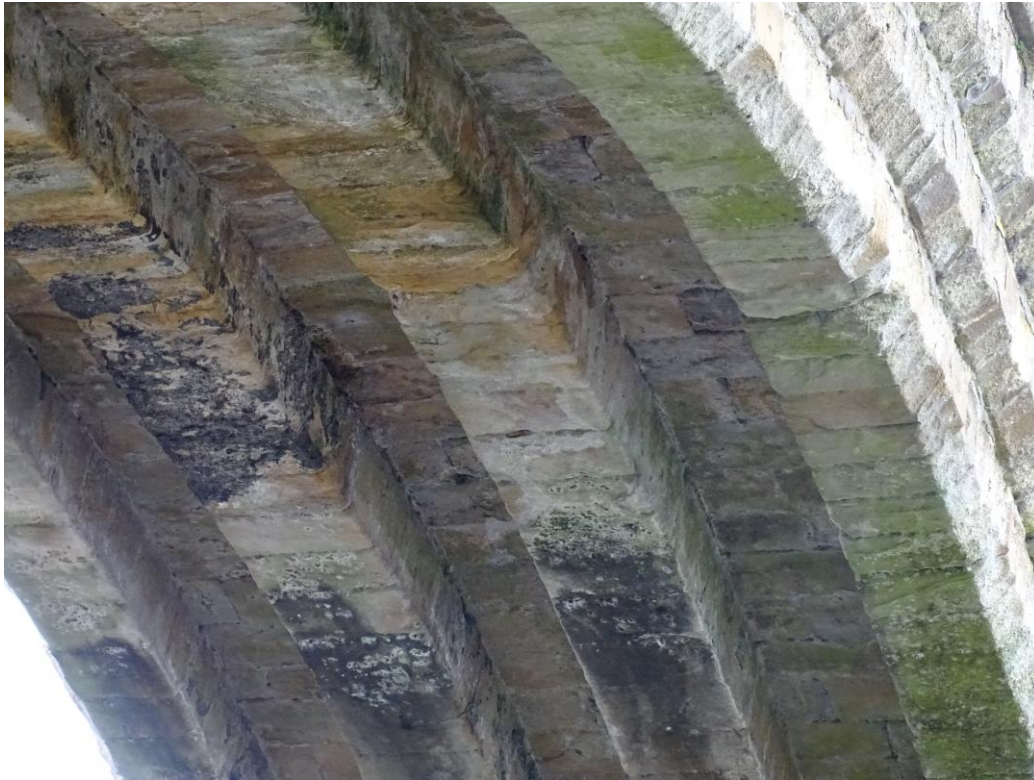
Looking up, under the arch, we can see that the arch is as well built as the ribs below. Looking at the coursing suggests that the barrel is continuous and the ribs do not have shoulders to support the stone above.

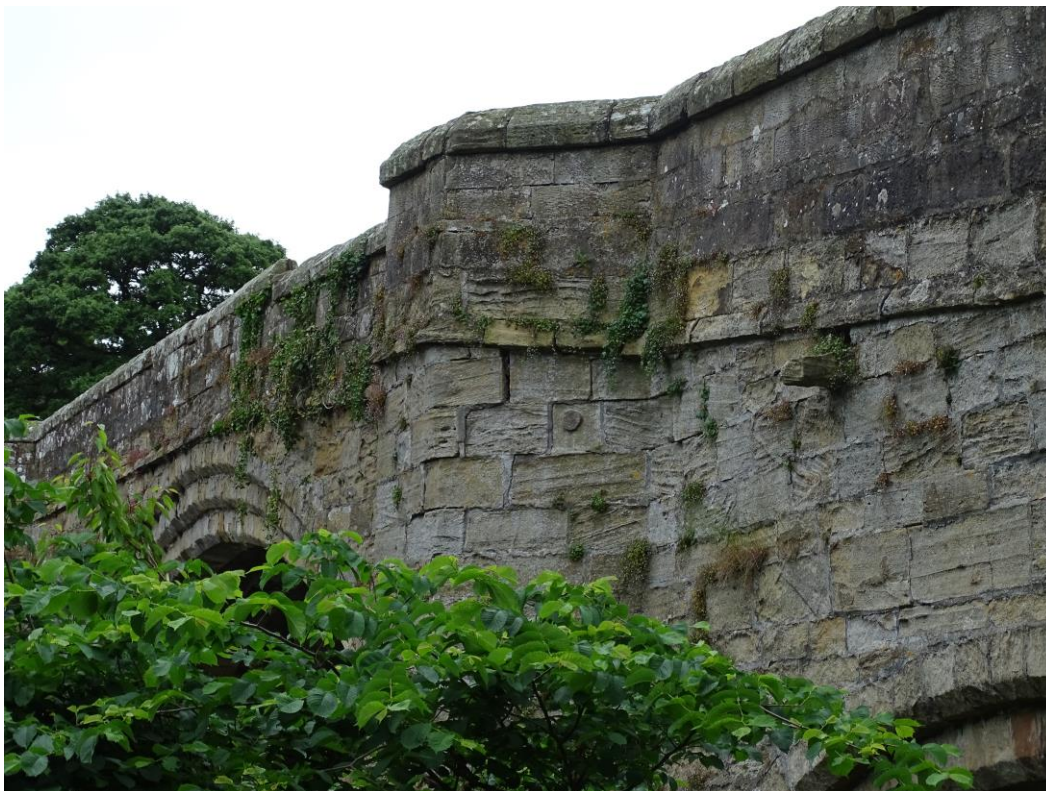
The damage visible here is presumably a hangover from the days when this was the main road, which means before 1932 when the bypass was opened. But what is that circular patch.

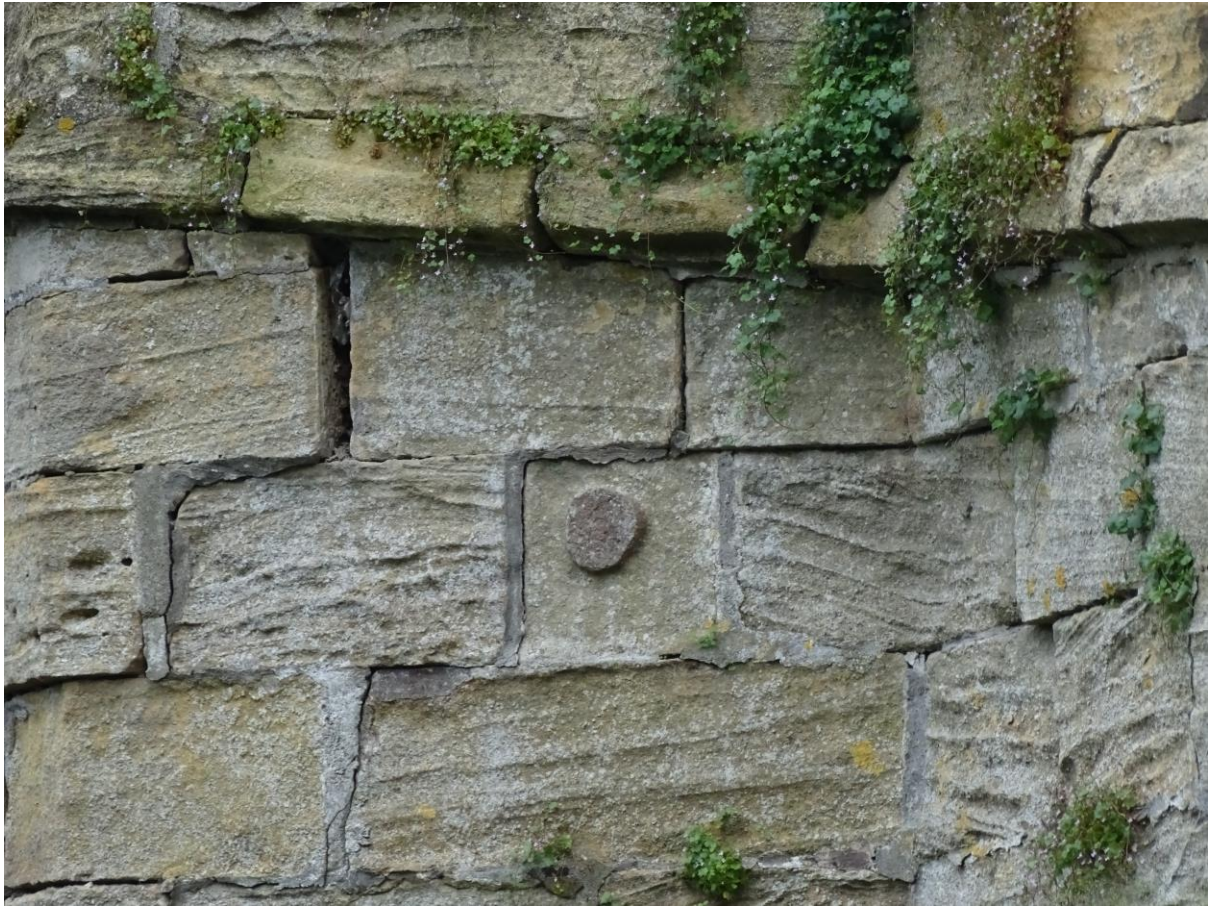
A closer look suggests it is something in the stone. The extent of the jostling and repointing here is considerable.
