The [Old Bridge at Stirling](#) is a wonderful thing. Only well through the 19thC was there a bridge over the Forth downstream of here. Indeed, the first of those, by Robert Stevenson, is visible in the photo. It too is a magnificent structure. For English readers, let me emphasise that I didn't spell that name wrongly. Robert Stevenson 1772-1850, was an outstanding engineer. Keeper of the Northern lights and founder of a dynasty of great engineers. His Grandson Robert Louis didn't join the business but showed his enormous respect in his "[Records of a family of Engineers](#)", which is an enjoyable and enlightening read.

Anyway, the old bridge. I had a collection of photos taken some years ago but they were slides and lost in a "library" of same. So the opportunity to visit in July was very welcome. It is variously dated to 15thC or 16thC, though there were a number of timber predecessors including the one where Wm Wallace beat Edward 1st in 1297. One span was demolished during the 45 to impede the progress of Bonnie Prince Charlie. I must look more closely to decide which, though since that is the better part of 300years back into a total life of possibly "only" 500, that may no

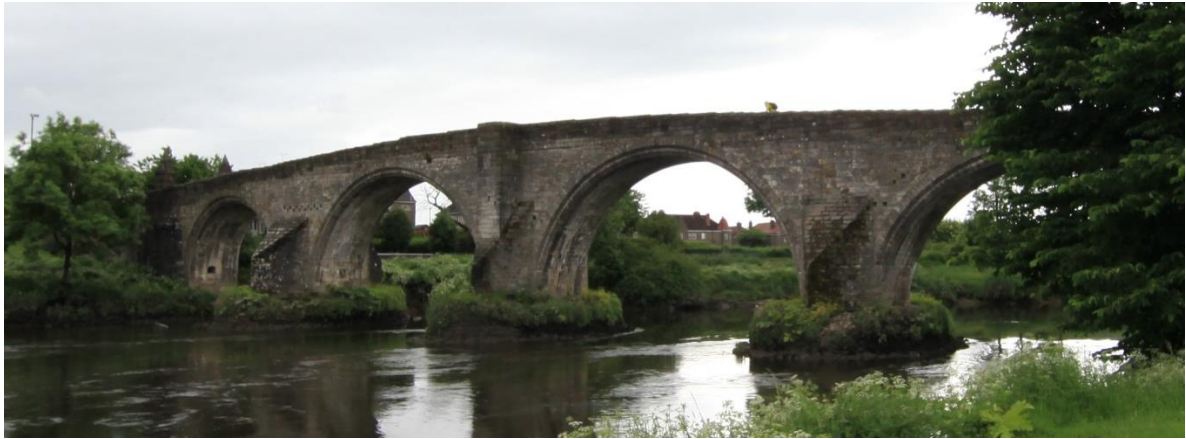
We know that one span was replaced in the 17th Century. I rather feel that the row of pigeon holes on the far pier here might be a sign of that later rebuild.

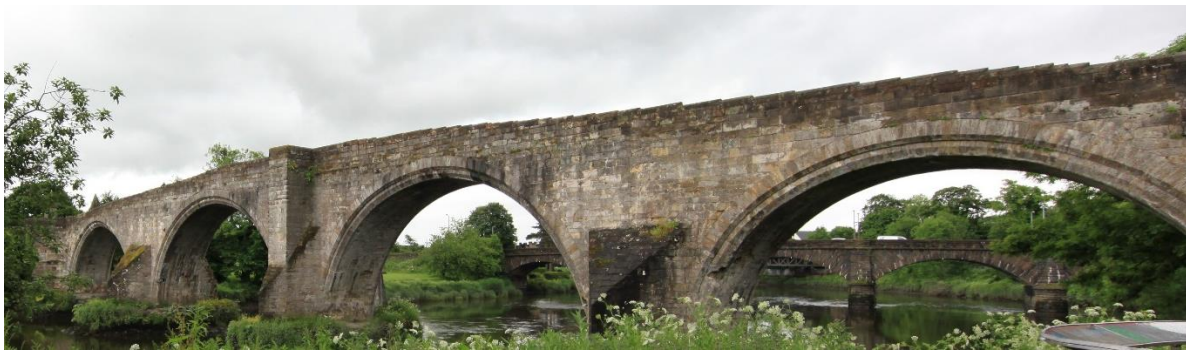
The distortion apparent in the nearer arch is simply stretch from the very wide angle lens.

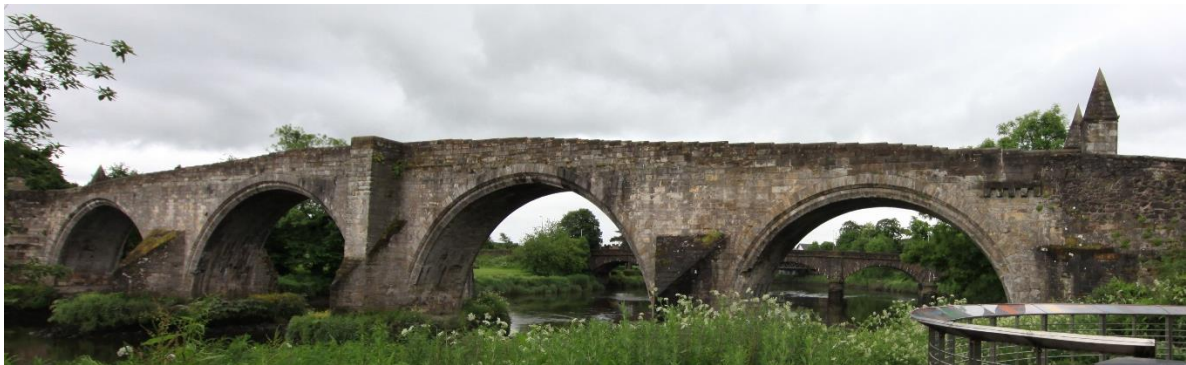
Once the arch is away from the edge the trueness of the shape is clear.

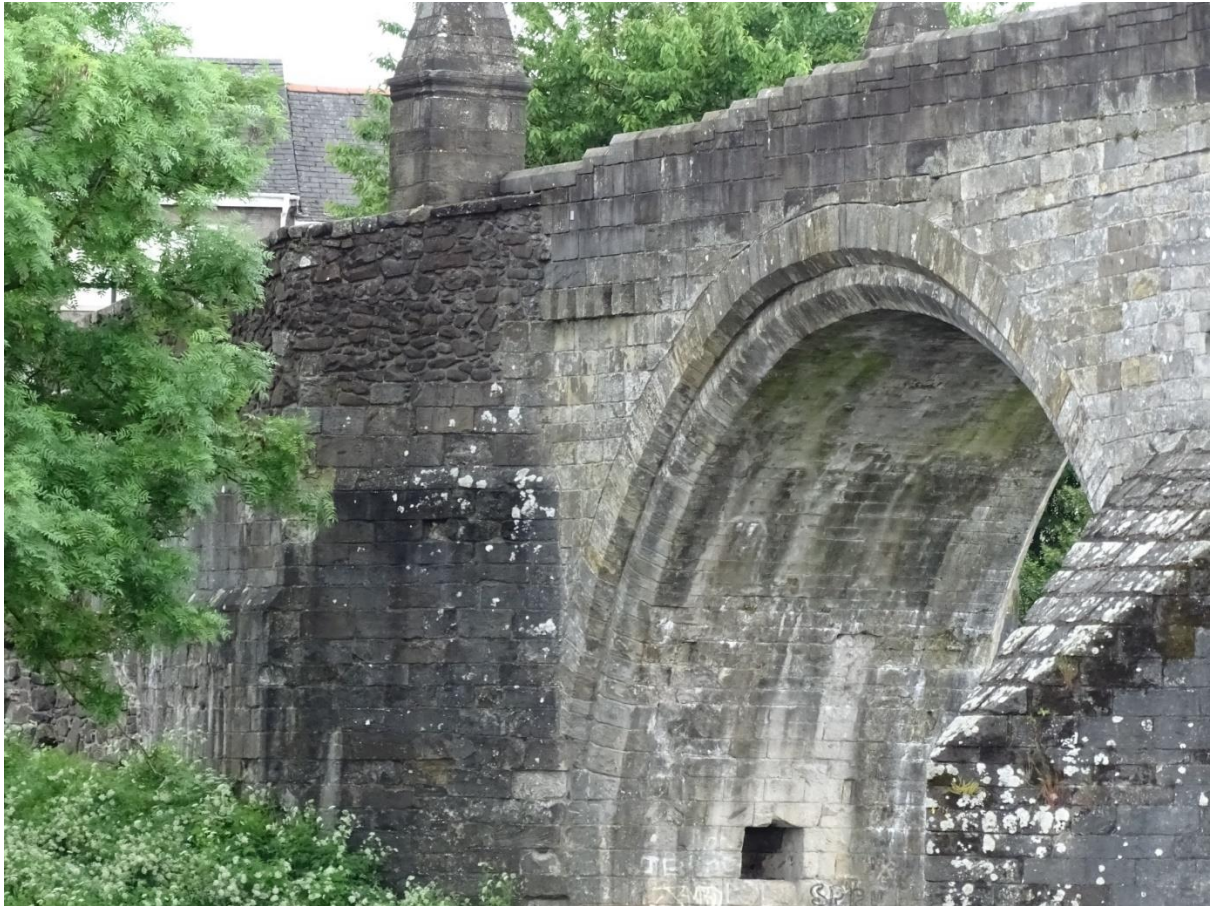
A similar set of corbels appears on the other side. It is understood there were once gates on the bridge. Perhaps these corbels mark the position. There are five different bands of condition in the visible half arch. Three are coloured in the view below but there is stone above and below too. The

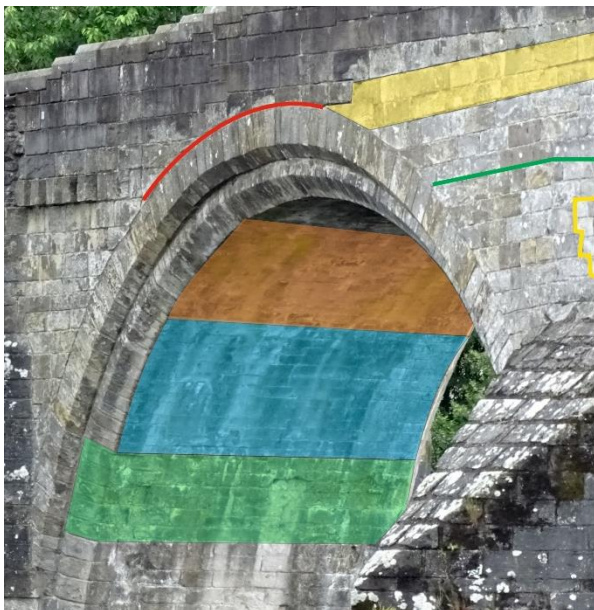
lowest of the coloured zones is very badly weathered. Above that is a band with dark water runs and above again, one with paler runs in distinct stripes. The lower band is very badly weathered, surely indicating considerable water penetration from behind.

Note the large opening into the abutment somewhat above springing levels. Any offers on the purpose of that would be welcome.

The lowest level of stones in the ring are bedded horizontally. A sewback is introduced one course above the opening. The chamfer begins within the skewback and the second layer appears immediately above it.

The Lines show marked open joints (red) and a substantial kink in construction (green). Look more closely at the coursing in the full frame and you will see that the yellow line marks a break in the coursing. All this together suggests that it was the Stirling side arch that was demolished.

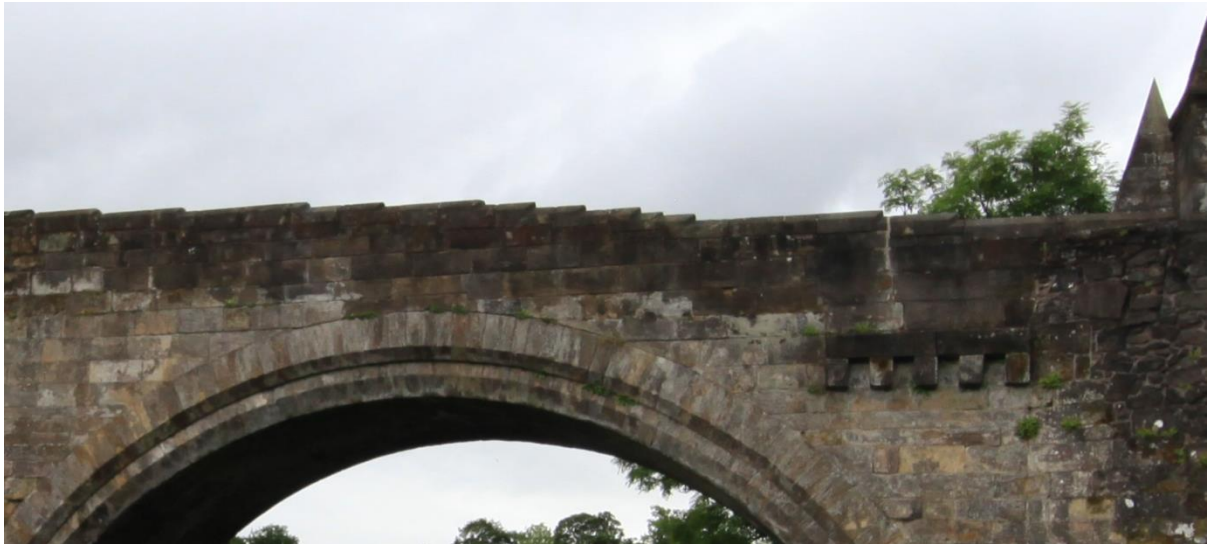
Looking more closely at the parapet and below on the upstream side there is a matching open joint round the top of the ring and extending along the bottom of the parapet. There is then a vertical crack in the parapet just above the corbels. There has been some form of settlement here, whether in the substructure or just the crown of the arch requires a closer investigation than I had time for.
