## Bridge of the Month No77, May 2017 Monitoring the Moco Bridge Lift

Bill Harvey Associates Ltd, 2017-02-21

This note describes the monitoring implemented during the ElevArch trial at Moco Farm in 2016. The monitoring had three components.

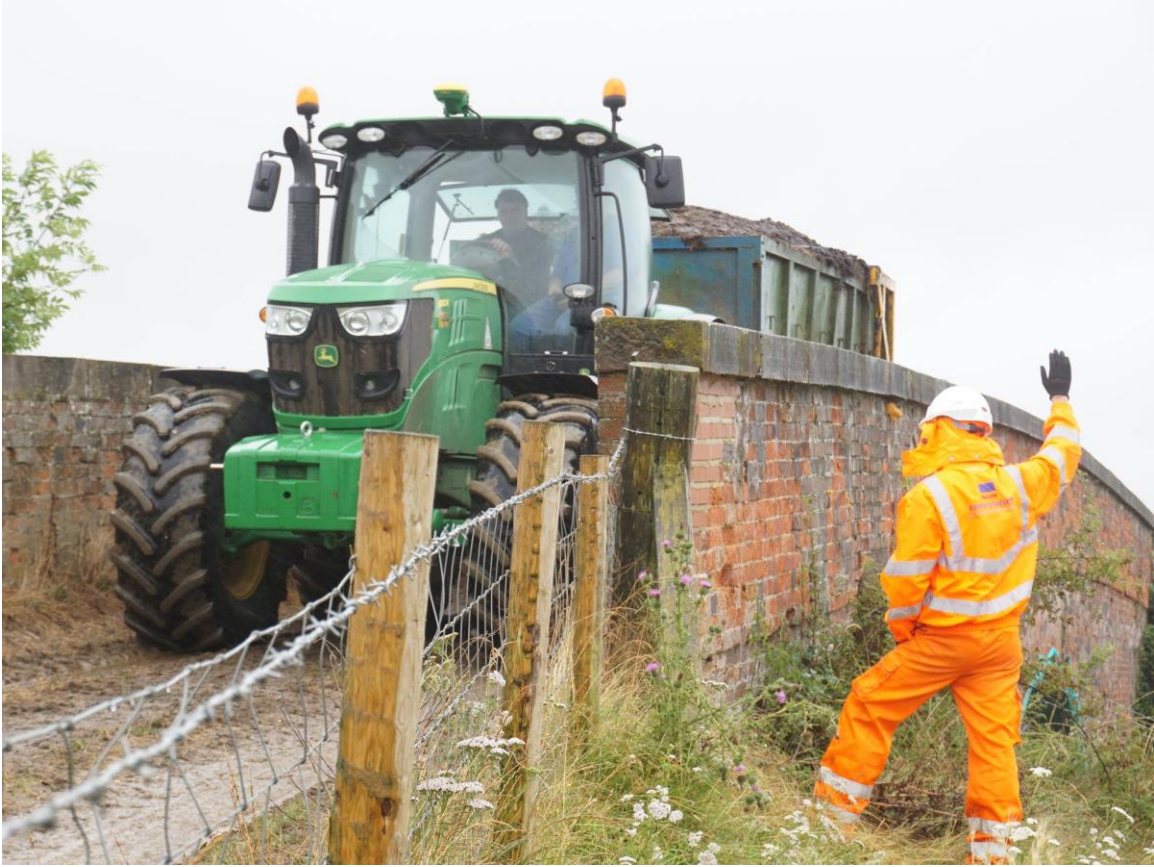
We needed a convenient load that could be applied twice, some weeks apart. Various options were considered, but in the end, the farmer offered a simple solution: a trailer load of manure.

He also suggested using the tractor's crawl mode. We could then post an observer at each end of the parapet to signal when the leading axle passed, and assume a constant speed between.

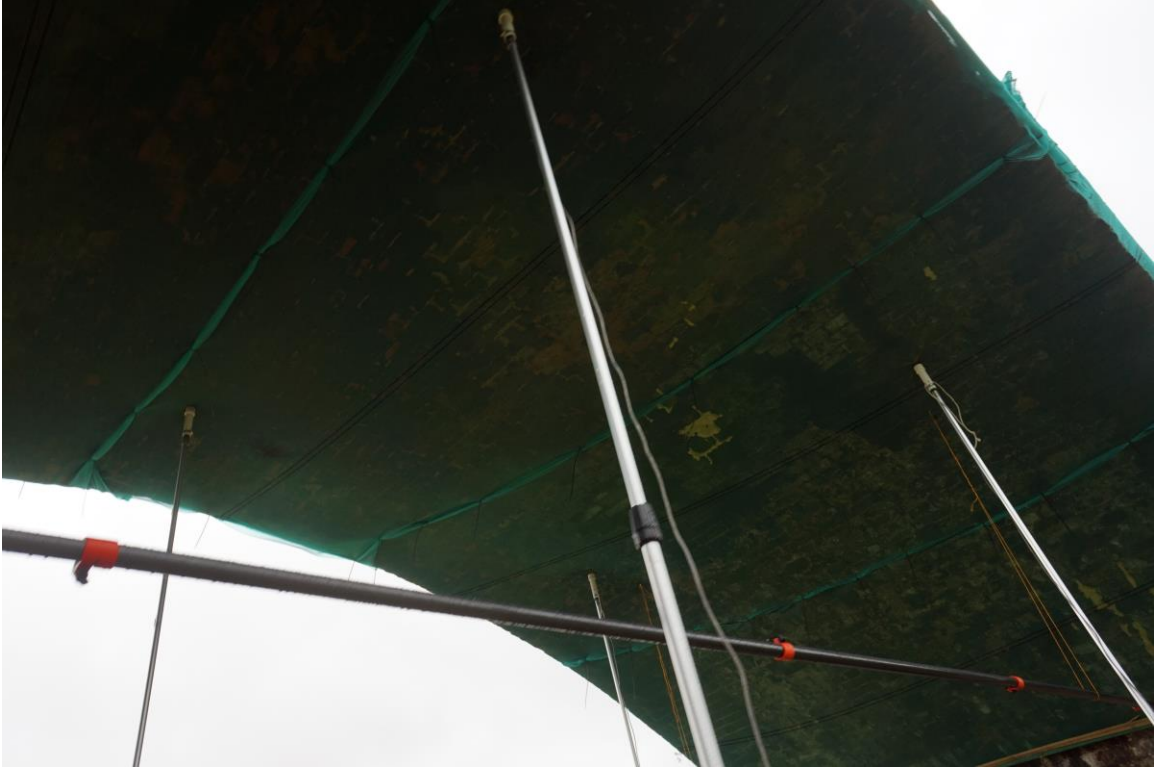
Vertical measurements were made using the BHA Ltd. light-weight deflection pole system. Gauges with 20mm range and a sprung rod are mounted on telescopic poles, and pushed against the soffit. The gauge spring holds the poles in position in the rough masonry surface. Six points were used, located in two rows, each one metre in from one edge, and at quarter span intervals.

The gauges are potentiometer type. The logger is portable, battery powered, and gives immediate feedback on an iPad, crucial when setting up in the field for a short test.

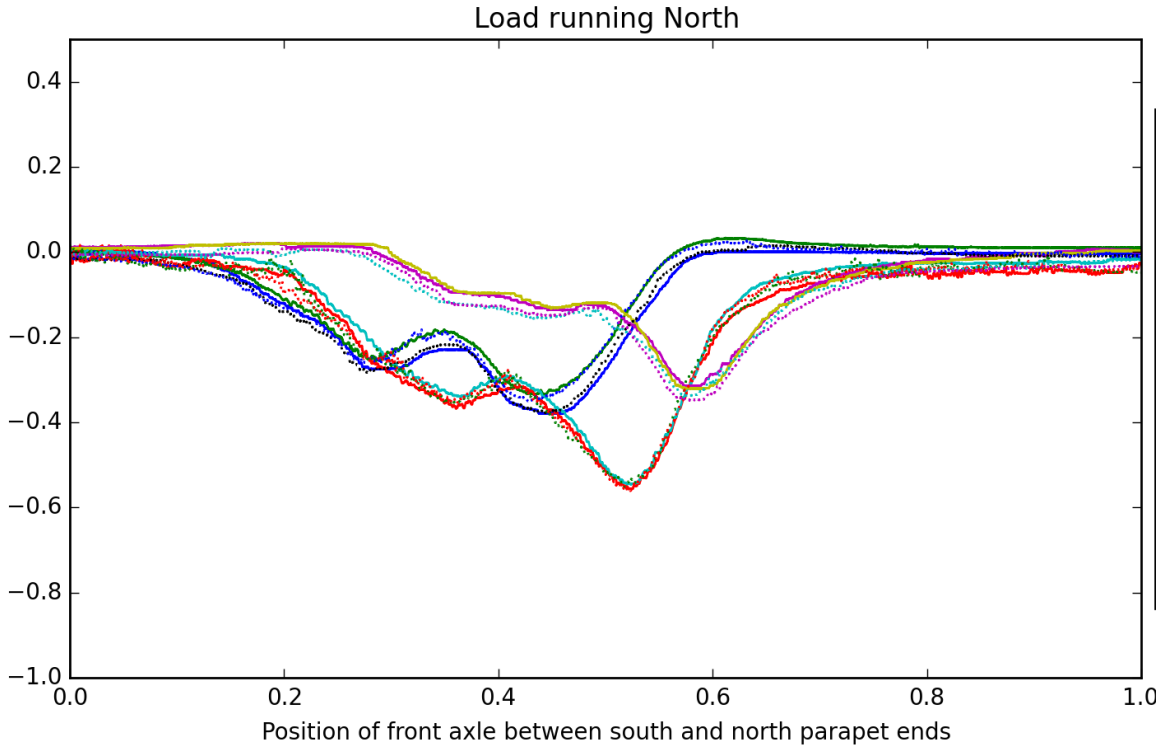
Plotting two runs from the before test together shows the repeatability of measurement, and a peak deflection of 0.6mm.

Before the lift, with the bridge unmodified, the peak deflection under a trailer load of manure was about 0.6mm. After completing the lift, making good the masonry, and replacing the fill, the peak deflection was 0.25mm. While the axle load of the trailer will not have been exactly equal on the two occasions, the same tractor was used, and the deflection under the tractor also showed a reduction.

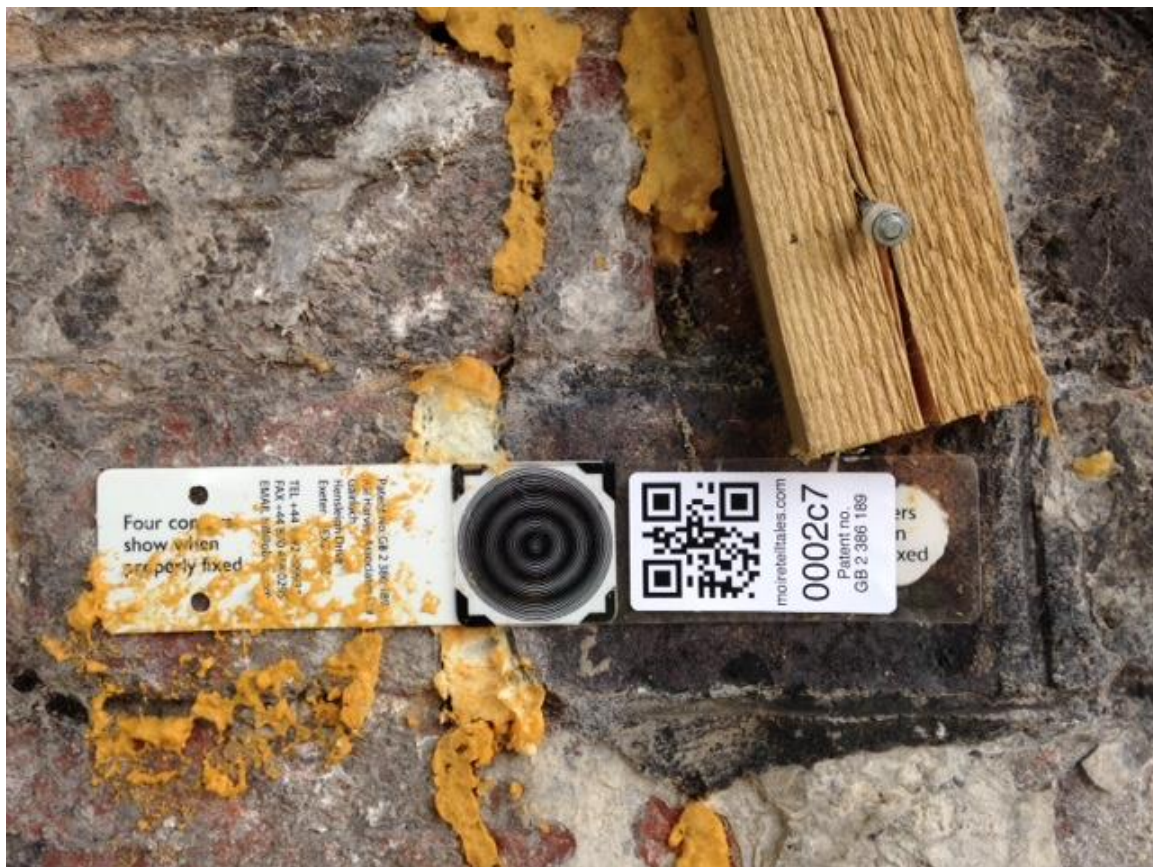
Moiré Tell-Tales were installed over all identified cracks well before the start of any other works. These two-part gauges are fixed one part each side of a crack. At installation, they show a set of three concentric rings. Should any movement occur, the pattern changes to indicate direction and magnitude of movement. The magnitude can be read to 0.1mm by comparing the pattern with a reference sheet. The Moiré Tell-Tales identified slight movement of the imperfectly attached brick "skin" of one abutment during grouting, and otherwise showed no movement, providing confidence in the integrity of the structure.

Cracks were monitored using the Moiré Tell-Tales already installed for longer term use. These could be checked very quickly on each jacking cycle for indication of movement.

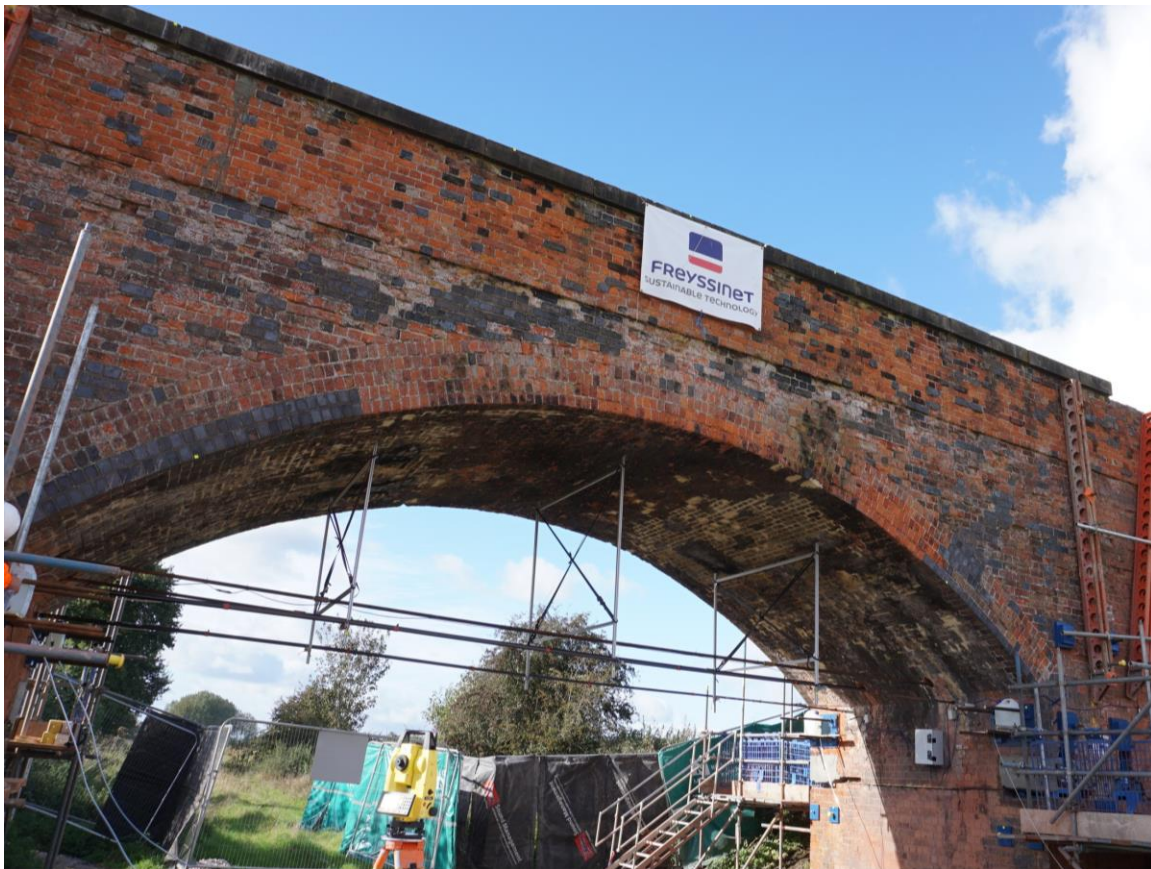
Span change was regarded as a key indicator of the behaviour of the structure during works. It is not a trivial thing to measure, however. This was achieved by mounting long deflection poles horizontally, suspended from frames attached to the soffit. The frames were fixed transversely (parallel with the abutment faces) and braced against in plane movement. The deflection poles themselves provided stiffness in the span direction. The foot ends of the poles were located on masonry screws to ensure positive location, and sprung back to the abutment with bungee cord to ensure all span change was carried to the other end. There, a simple cup mated with the deflection gauge mount and ensured that the gauge pin measured against the head of a masonry screw.

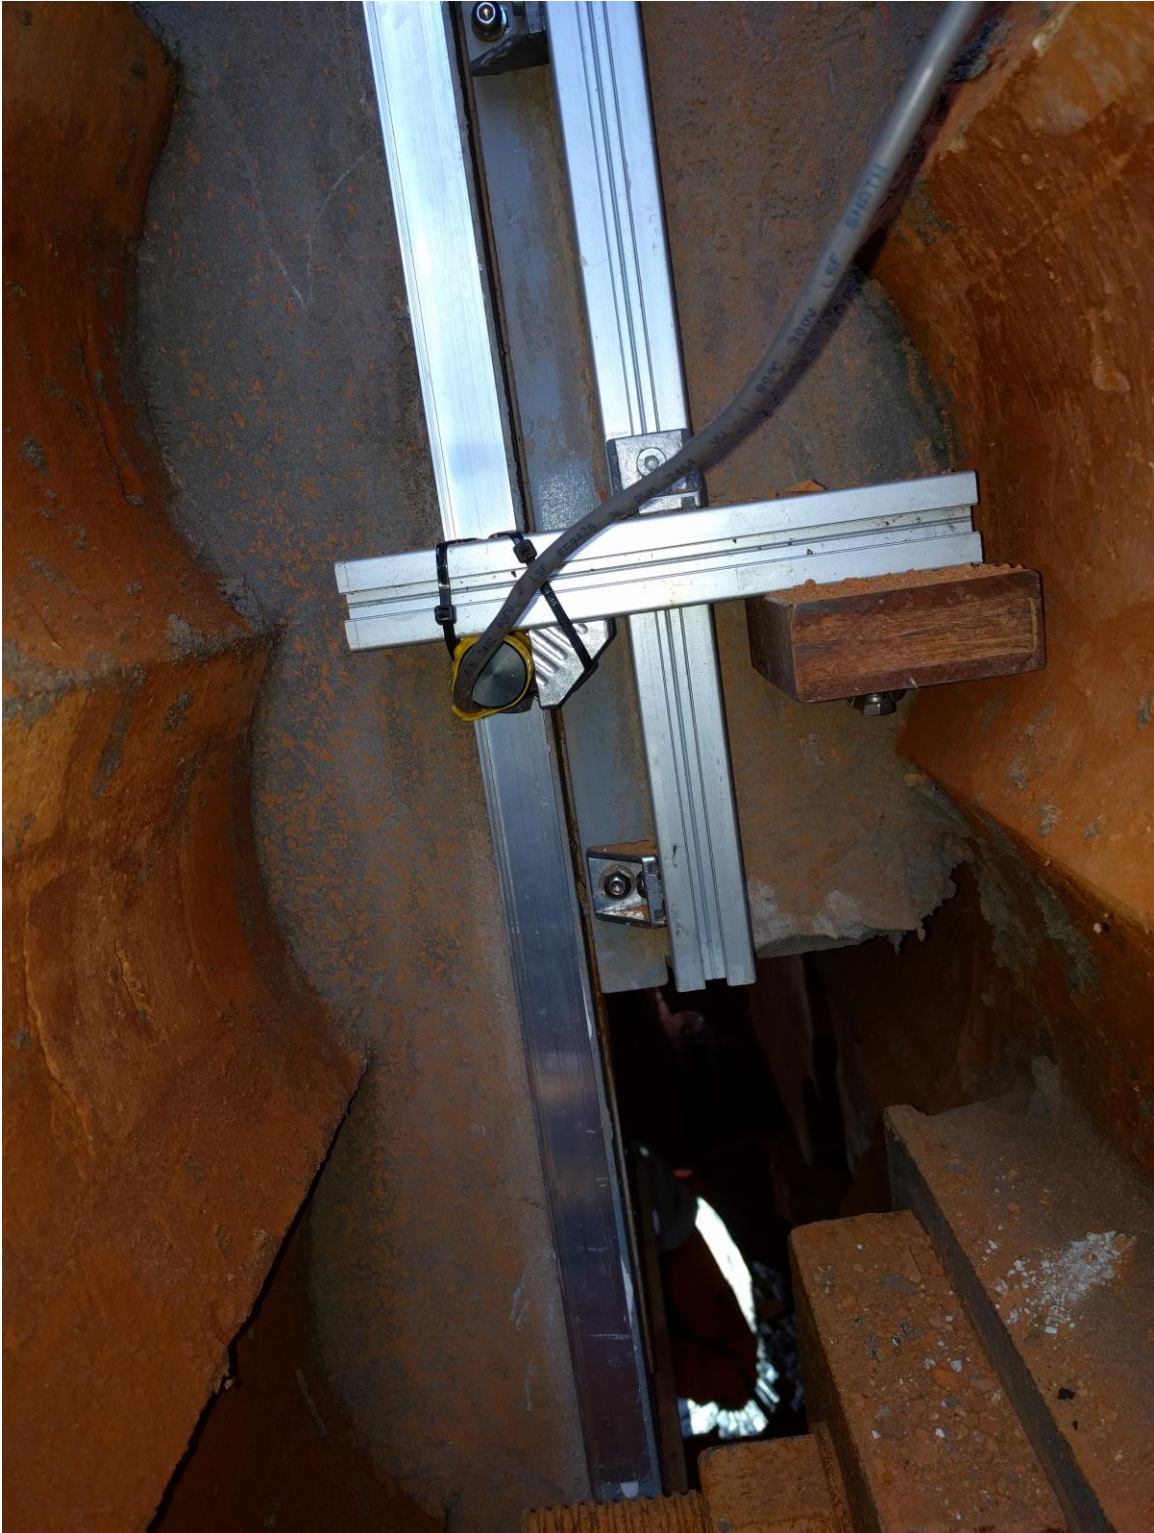
Transverse movement gauge mounted on sliding bearing.

Span change was measured using the same system as for longer term monitoring. Transverse movement was measured using sprung deflection gauges mounted on the sliding plate of the vertical bearings, and measuring against the edge of the fixed plate (with a smooth aluminium angle fixed to provide a running surface). A draw wire potentiometer provided a direct measurement of the lift height to provide context to the other measurements.

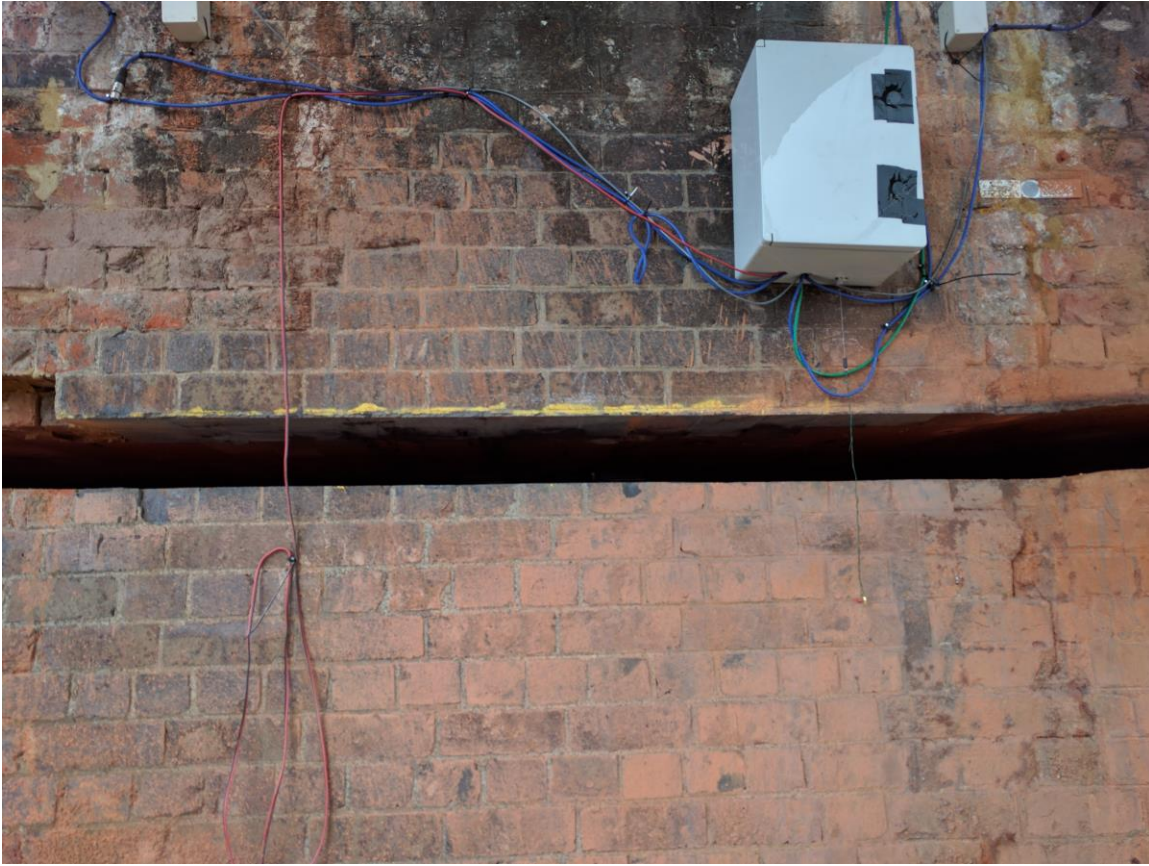
Vertical deflection gauge mounted in enclosure, with wire across gap.

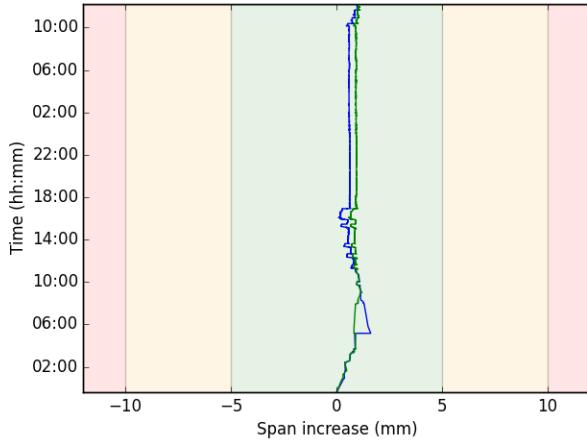
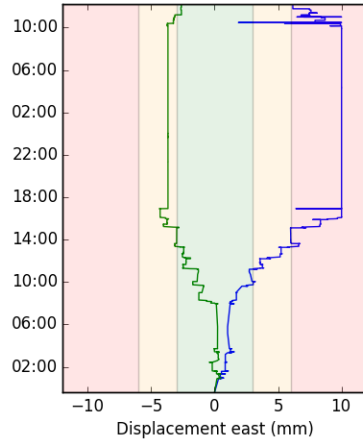
The output display of the main monitoring system at the end of the whole jacking process is shown in FIGURE. This display was updated in real time during the lift. The top row shows lift height, vs time to the left, and instantaneous to the right. The two columns below show to the left, span change, and to the right, transverse movement. There are two readings in each column, east and west measurement of span change, and south and north measurement of transverse movement.

In each column, instantaneous measurements were shown, followed by displacement vs. lift height, then displacement vs time. The dashboard was designed to aid interpretation of any movements, showing clearly whether these were progressive in time, or related to lift height. The jacking process involves jacking to leave space to place timbers and then de-jacking onto these, showing how measured quantities vary with de-jacking from early in the process.

The monitoring showed a slight transverse movement in opposite directions at each abutment. The plot vs. lift height showed clearly that this was linear in height, and reversed under de-jacking, with an apparent small non-reversible movement on each cycle at the north. Because the movement was rotational, the centre of mass of the structure, which was of primary concern, moved much less than either abutment.

The south abutment returned almost exactly along its outward trajectory. On de-jacking from 900mm, the north abutment transverse gauge mount was inclined to come free from the bearing plate. With re-mounting on each cycle, the fact that the north abutment was returning as well was confirmed. The degree of return is not known exactly, as it was impossible to replace the gauge in exactly the same position, but the final readings from total station measurement and the monitoring are consistent.

The span change during jacking was even smaller. After settling in on the first jacking cycle, the moving section of the structure showed a consistent, very slight shortening of span on each cycle, and an equal lengthening on de-jacking from 900mm to the final position at 435mm.
