Bridge of the Month No78, June 2017 Victoria Bridge, River Wear

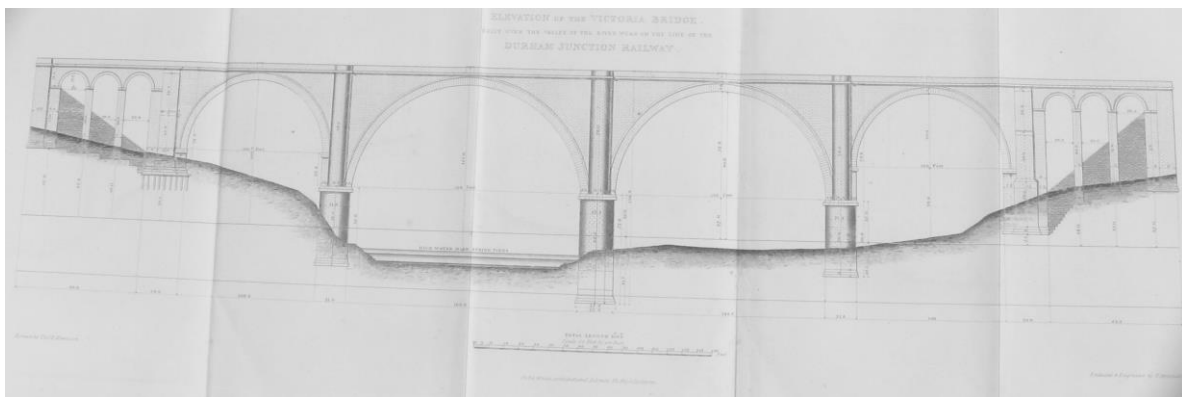
In a place like this, photography is really quite limited so here is a drawing to show the whole bridge. This, and many others, was published by John Weale. All four main spans are big. Note how the springing levels are adjusted so the crowns match.

This is a view from the East. The wide flood plain is on the northern (left) bank of the river. It looks as though the end three spans each side are only 20ft. All the piers seem to be founded on rock but the south main abutment is shown as piled. I have been told, though I couldn't find them in my brief visit, that the inclined planes which preceded the bridge are still visible alongside.

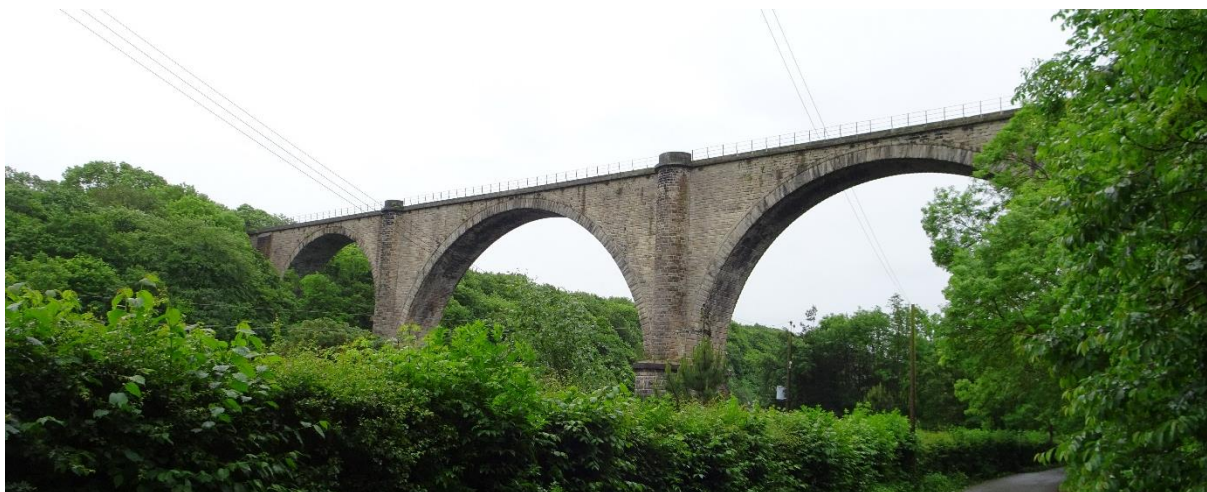
Lots of vegetation this late spring day means that views are severely restricted. I had to cycle right past and look back to get a decent view. The angle of view disguises the fact that the middle of these three spans is the big one.

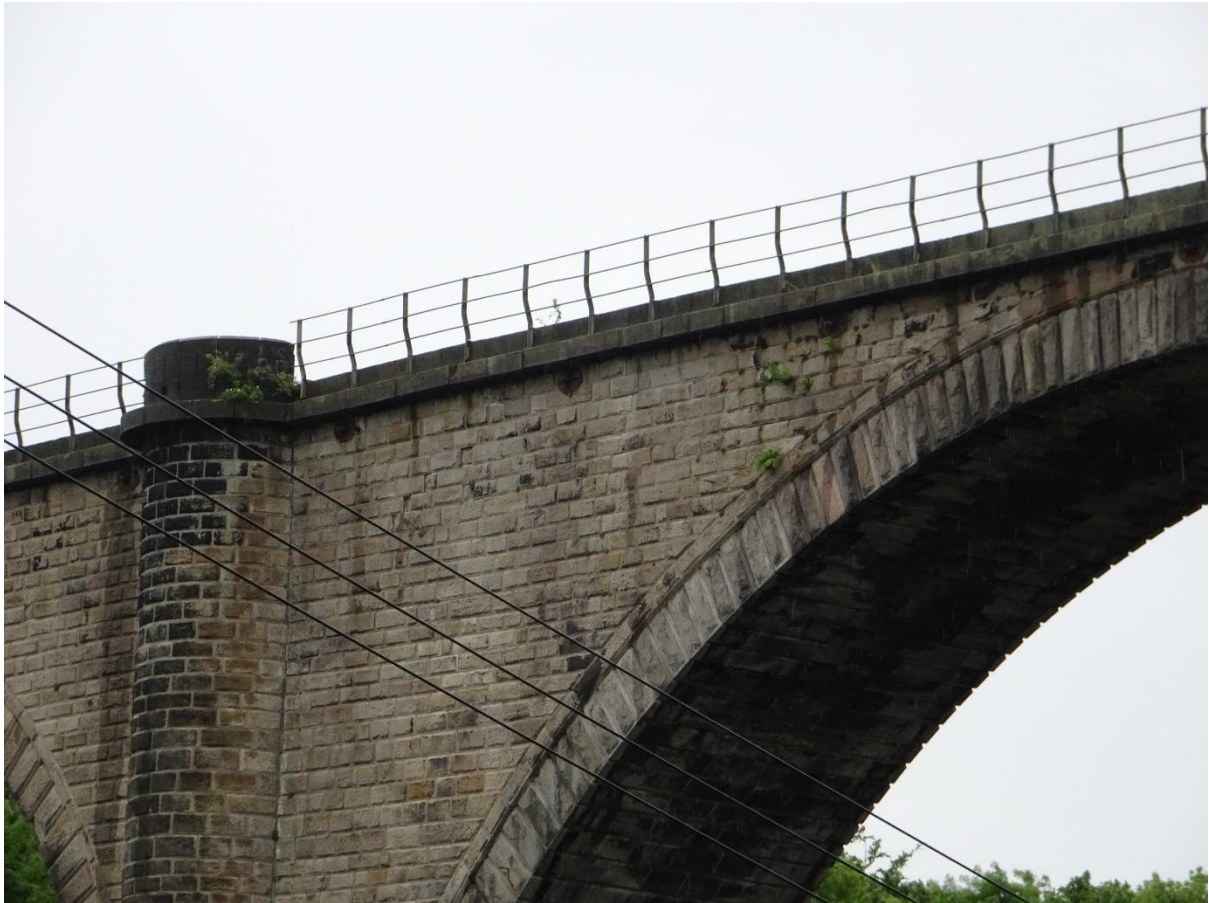
Looking a little closer shows the generality of construction. Large voussoirs the full depth of the ring, an expressed ridge above, the rusticated stonework dressed in more or less (but definitely not quite) equal courses. Interesting that the black soot covering that must have been overall a mere 40 years ago is now reduced to those semi-circular pier extensions up to the refuges above.

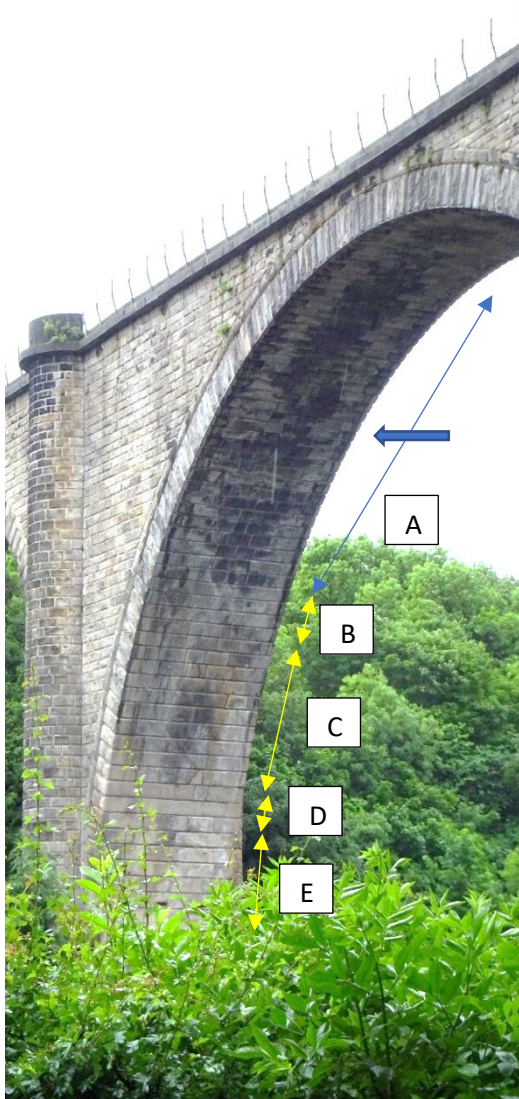
This view, though confused by the size of the span, shows how narrow the arch is. Note the differential water staining which surely provides some indication of the internal construction.

Bands B and D are relatively narrow. There may even be another similar one picked out by an arrow in band A. I suspect that these might be cross walls surmounted by a mini viaduct inside the spandrel walls. Looking back to the first picture there is definitely differential staining of the spandrel walls.

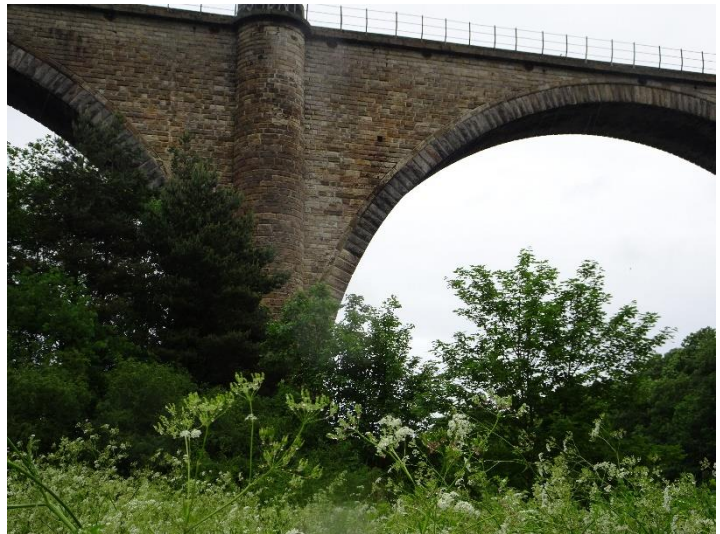
What I think I see is highlighted below

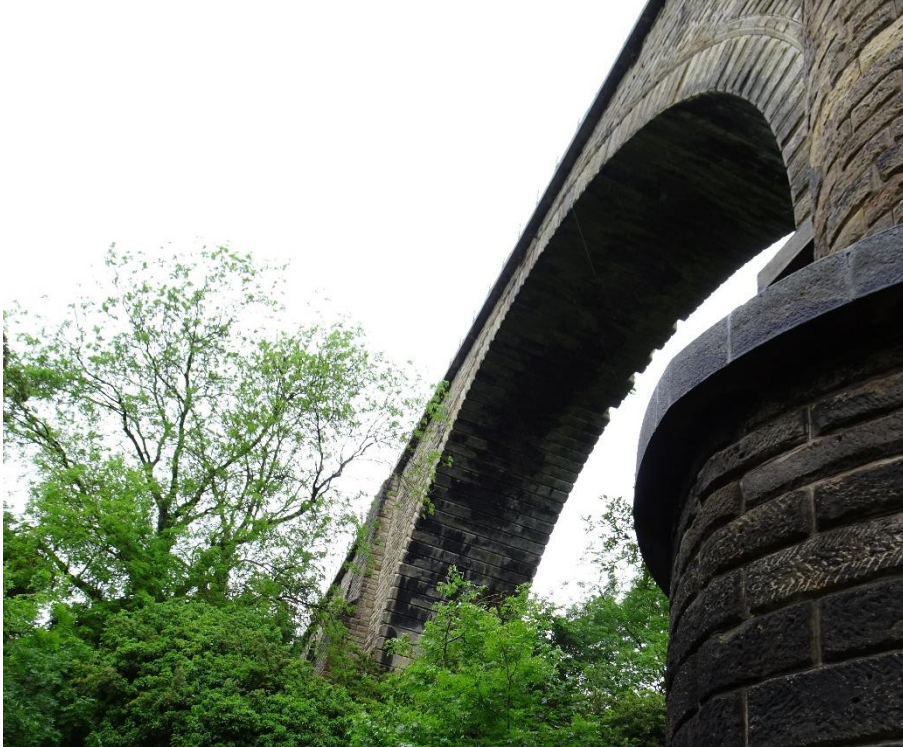
But what is going on here. It really doesn't look at all good.

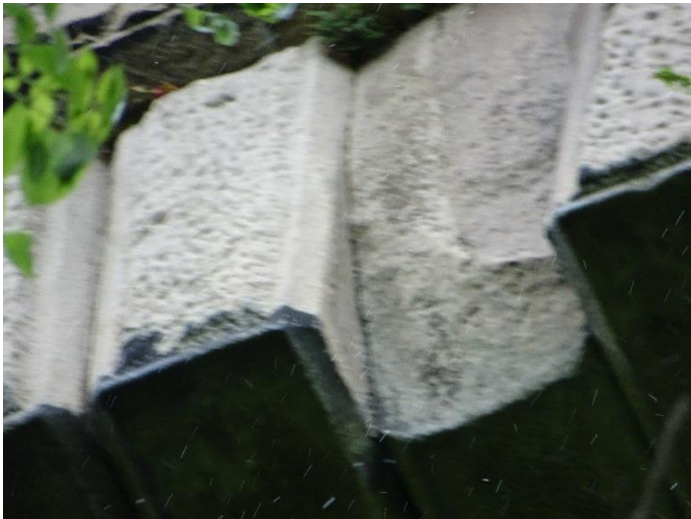
I have deliberately shrunk this to disguise the poor focus but it is good enough to see that it is almost certainly a fault in the stone. It just happens to occur in four voussoirs closely spaced.

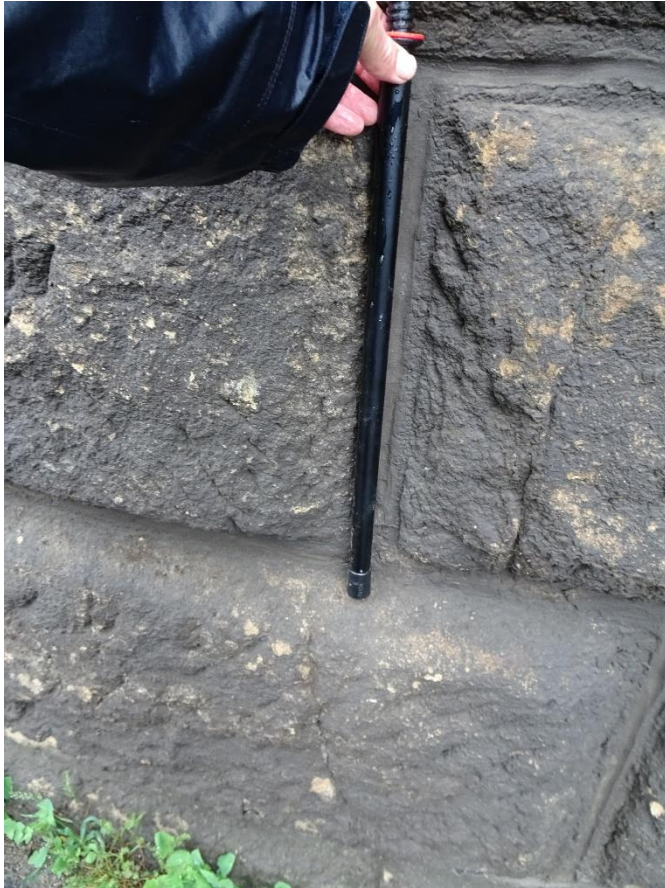
This half meter extension poles gives an idea of the scale of the stones in the pier and the voussoirs are similar.

This crack leaves little doubt that the sudden change in section at the top of the pier/ bottom of the arch is not a good thing.

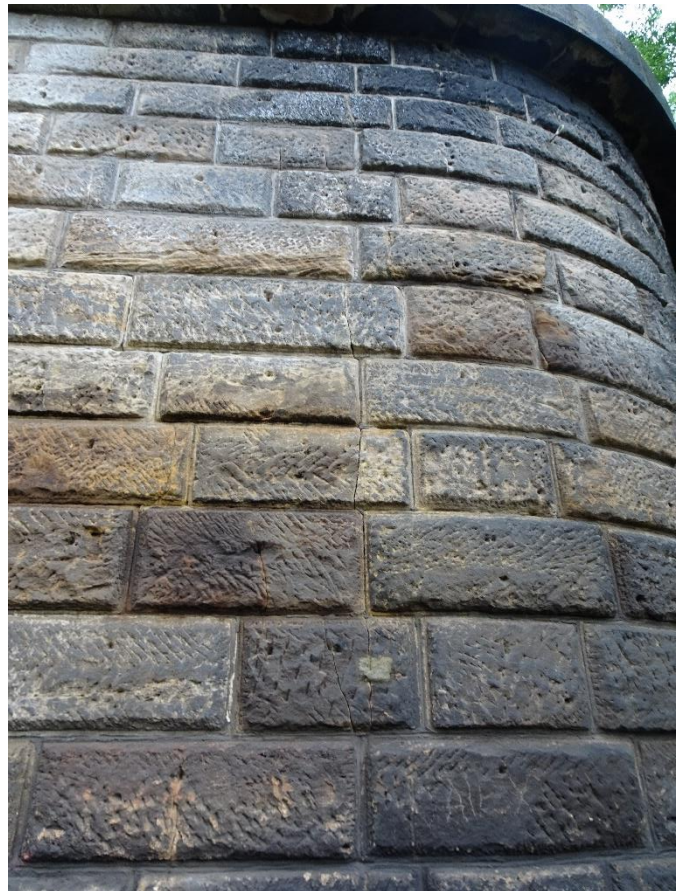
And finally, what are those brackets about?
