Bridge of the Month No87, March 2018 The Skew Bridge, Harpenden

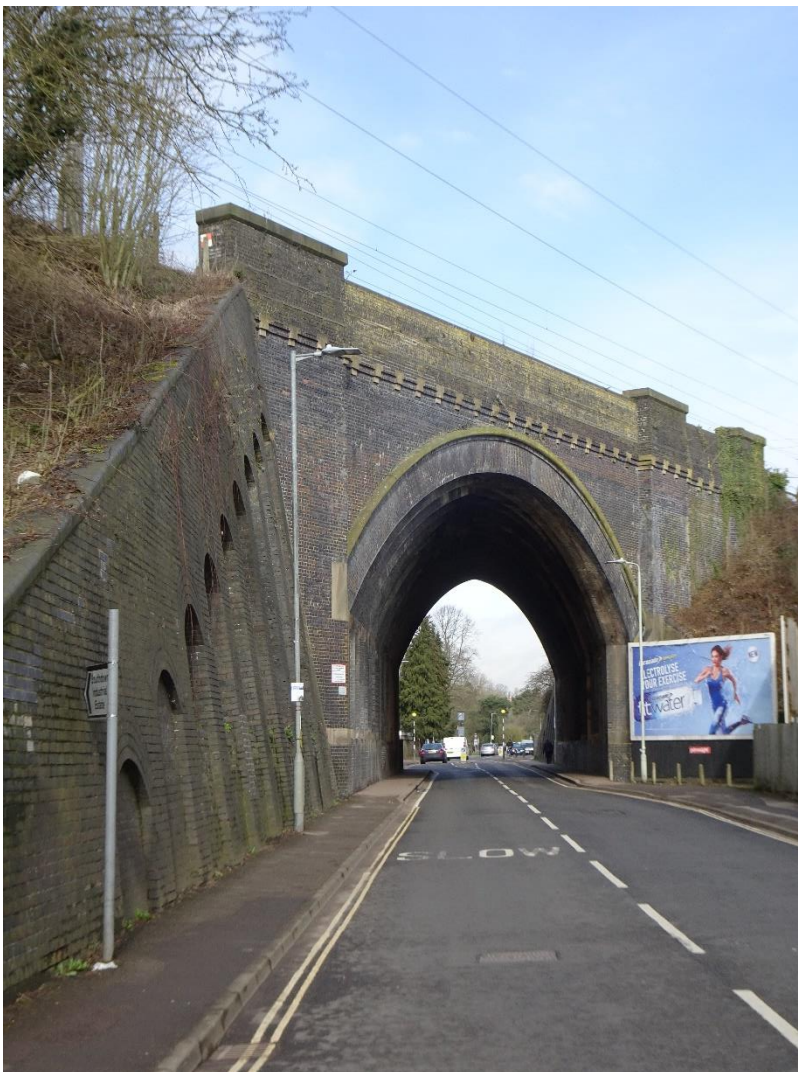
Because it is so skew, it demonstrates clearly the difference between the square and skew span shapes.

Here we see the ellipse on the square span, though it is clearest on the near side where it isn't complicated by the different edges of a rib showing in profile

Looking at photo 1, it was almost certainly possible to just build the new abutment into the old wall. Exactly how the stone base of the first new rib was cut in is an interesting question.

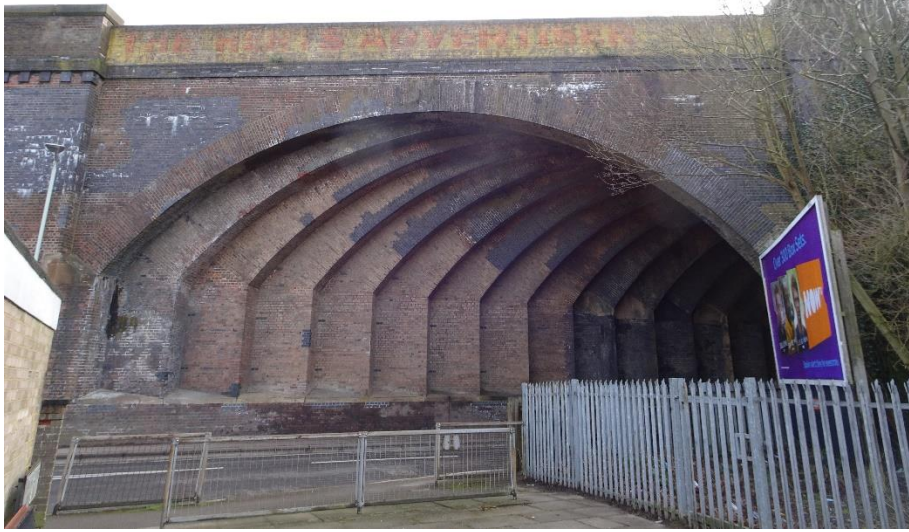
This alleyway provides a square view. Though I still had to tilt the camera upwards, it is still clear that the curve is a circular arc in this direction.

Note that the first picture shows a decorated elevation with stone finishings. This is the Southdown side. To the North, the bridge was widened rather later and is all in stone, even the skewbacks. This picture also shows a vast amount of patching in both the arch rib and the spandrels. The parapet is a completely different colour. Are those the original bricks which proved inadequate for the arches?

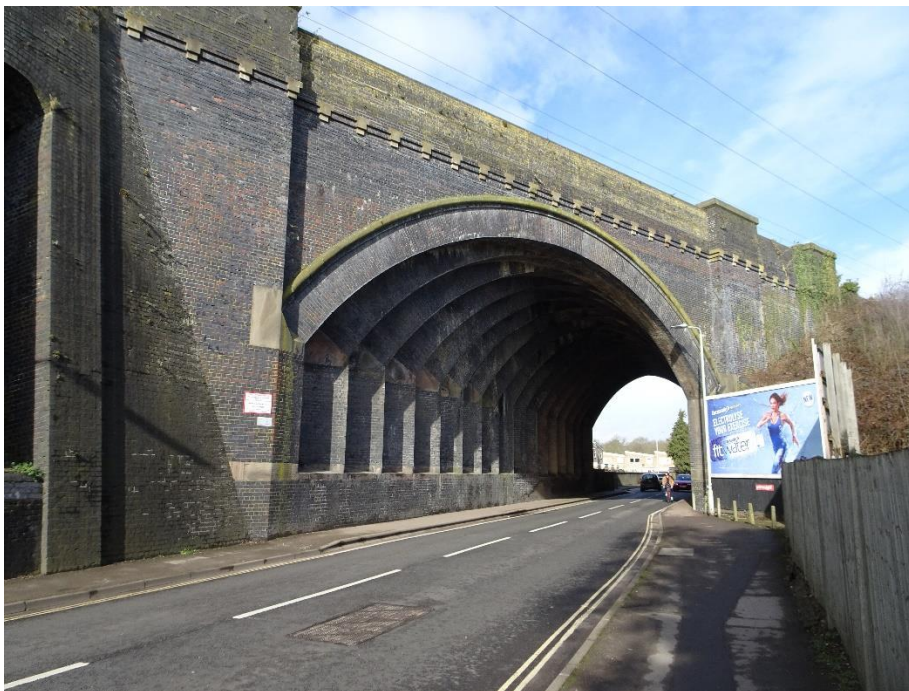
In this broader elevation, there is a very clear change in the mortar condition, roughly level with the crown of the arch. That, almost certainly, marks the level of backing behind the spandrel. The enlarged view below shows the change more clearly

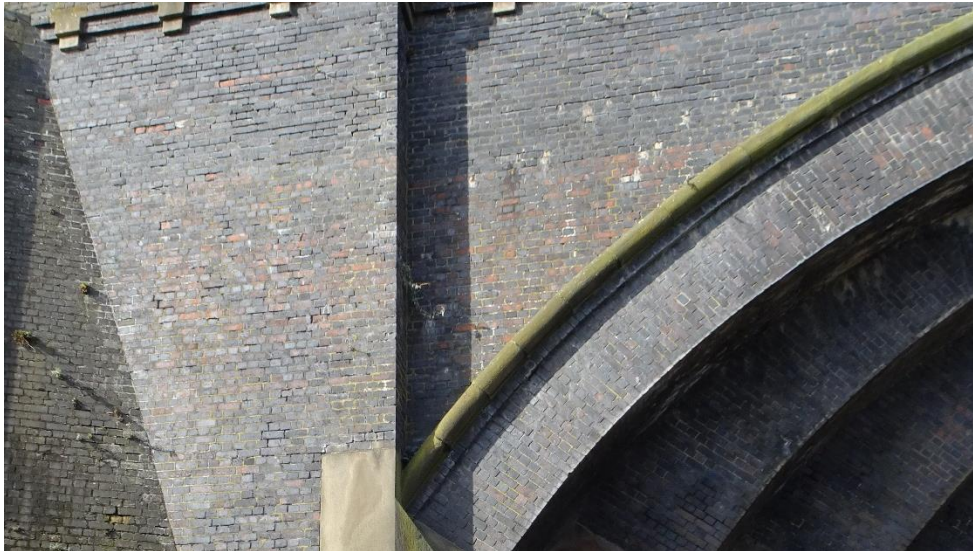
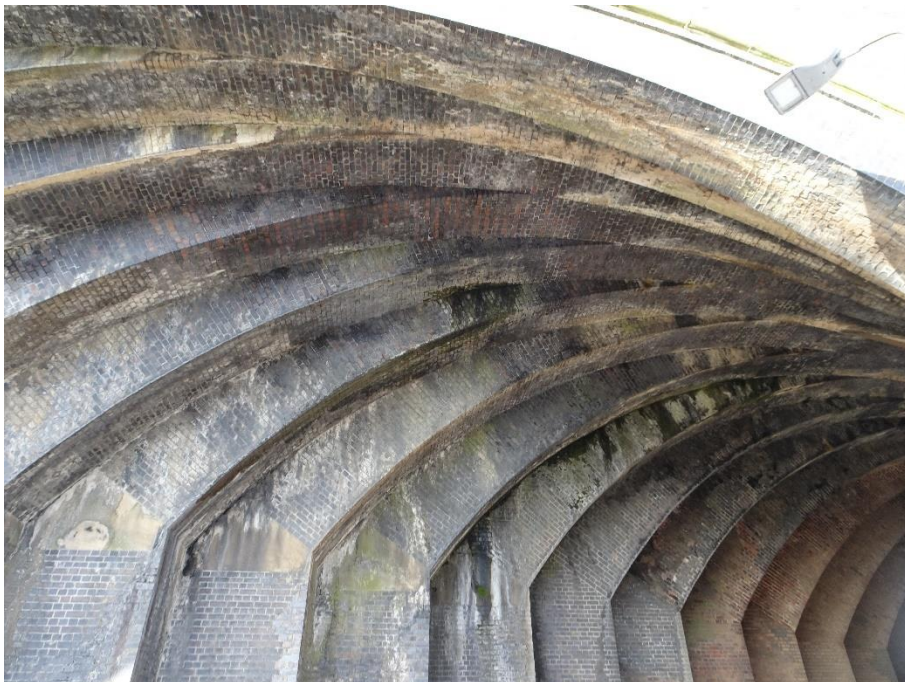
Lots to see in this picture.

First, note that the skewbacks and arches are made thick enough that the arches overlap even at the springing.

Then note the zigzag crown with no continuous horizontal line through. This is what creates the apparent cusp in the first photo.

Notice, too, the water leaks which are surely sufficient evidence that these arch ribs are completely independent, at least down to the level where the backing links them together.

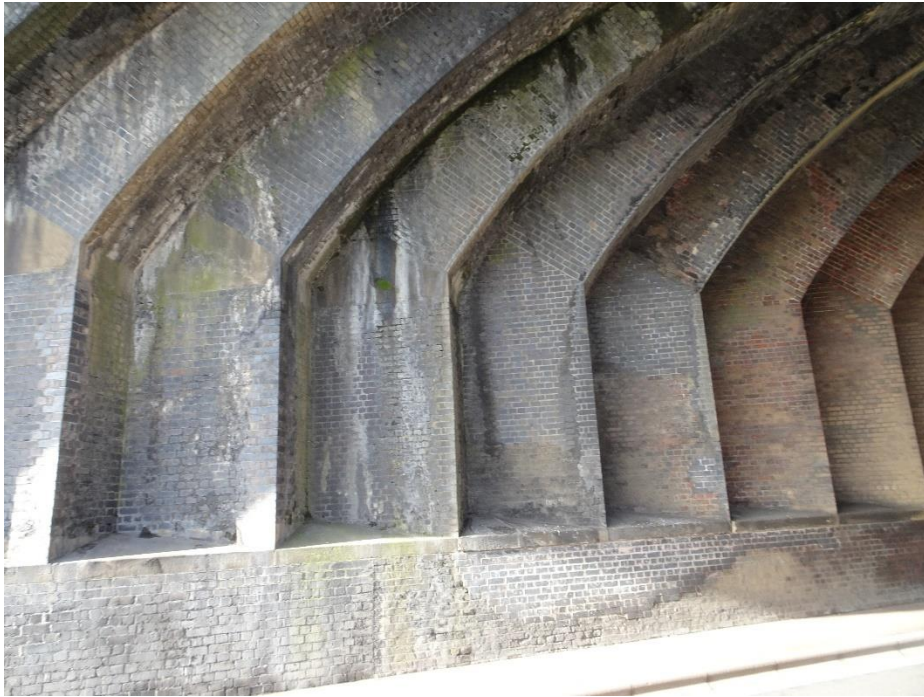
In this closer shot, the water running down the skewback has obviously tracked down from higher. The run naturally hugs the intersection.

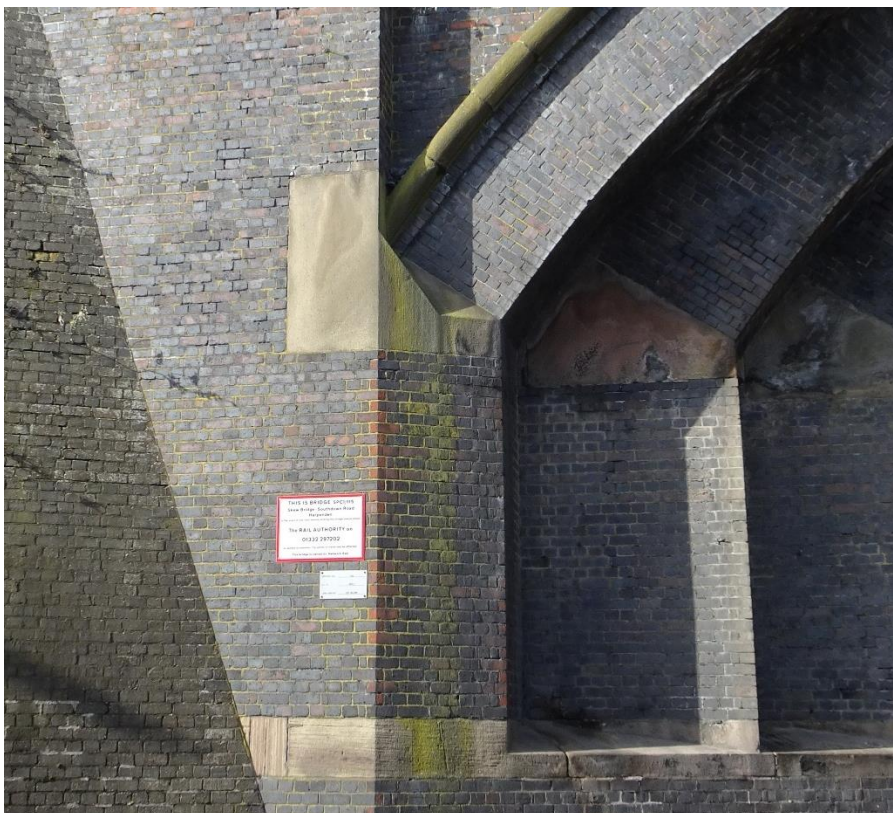
The end skewback is a magnificent piece of masonry work. The original piece of stone must have been a metre high and wide and nearly 2m long.

A bridge of this skew and height demands a big retaining wall on one side of each approach. The ones here are colossal. Notice how the counterforts get closer together as they get higher.

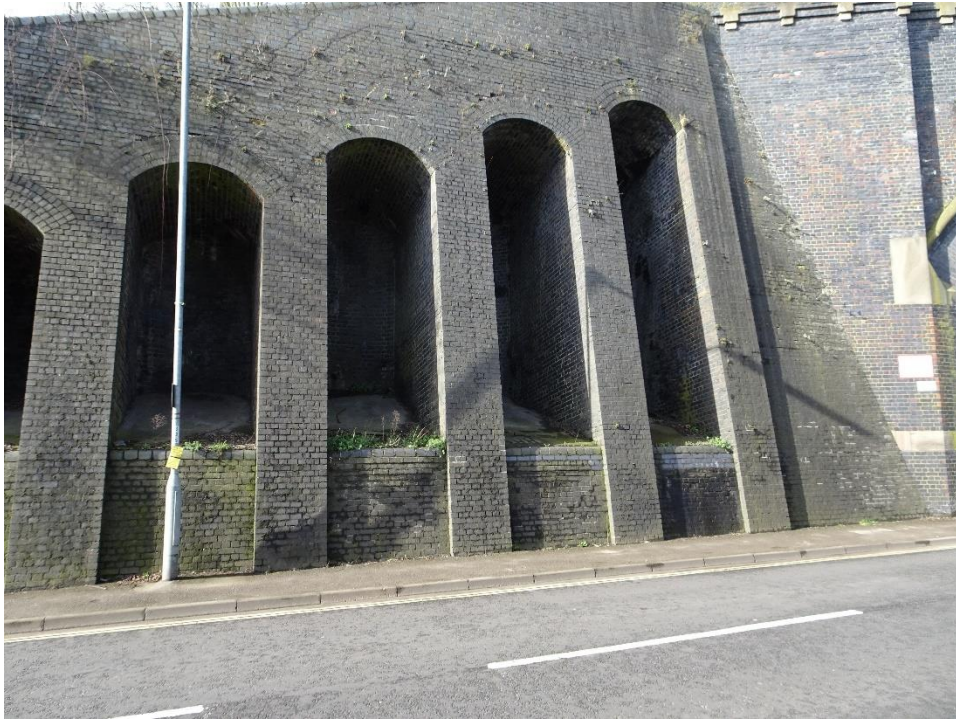
What isn't quite so clear is that the voids also get deeper.

Dealing with that wall when the bridge was widened must have been quite a business, as the railway would have had to be kept open.

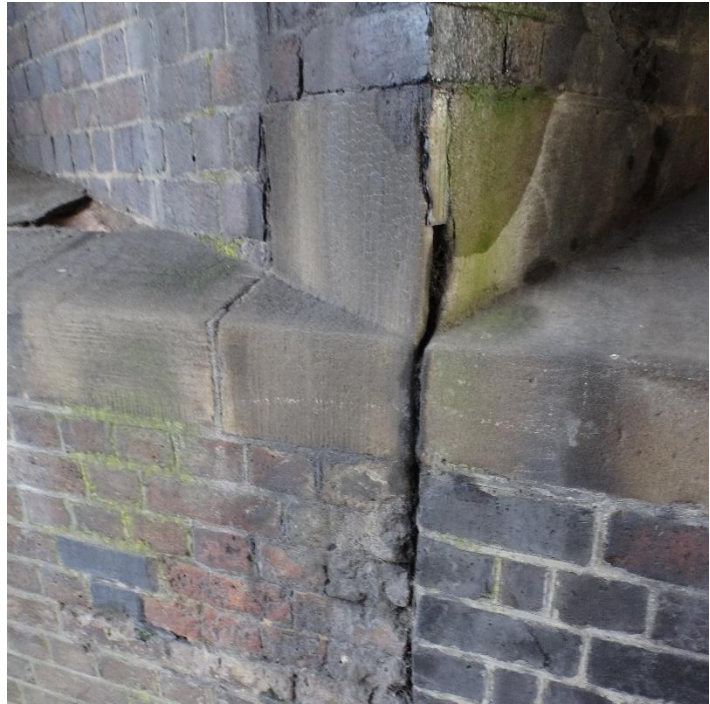
The obtuse corner of the newer work is very different. The upright section is built in solid to the second rib, presumably to provide a degree of stability.

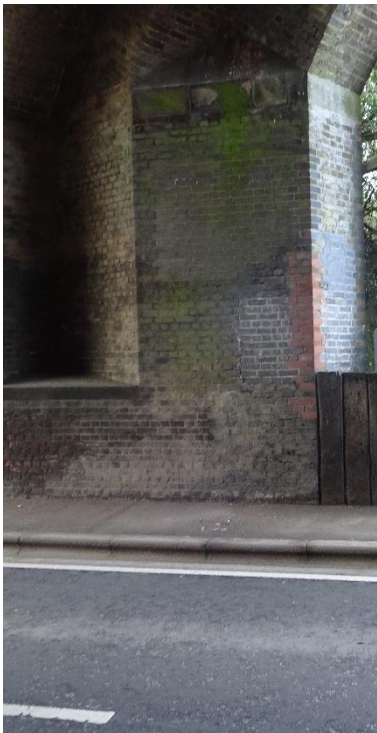
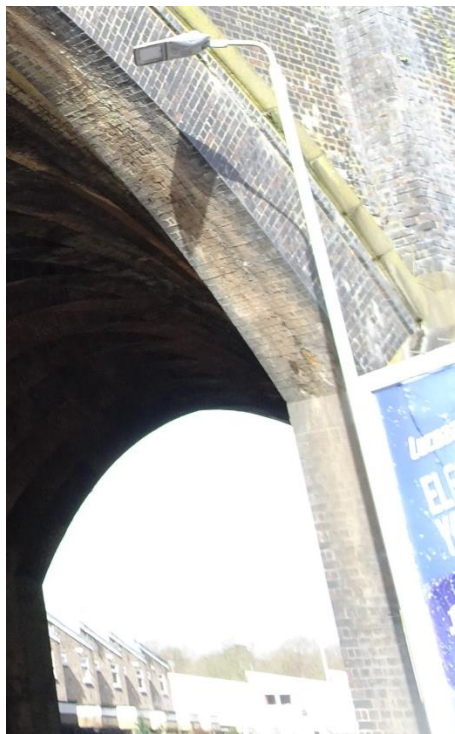
The older corner is concealed but the skewback is just visible, blending into the buttress behind. There is no infilled V, though I don't have a photo to prove it.

Looking up to the crown, it is interesting to note that some of the joints between ribs are tight and some not.
