Bridge of the Month No92, August 2018 Bridge 74A Leeds and Liverpool Canal

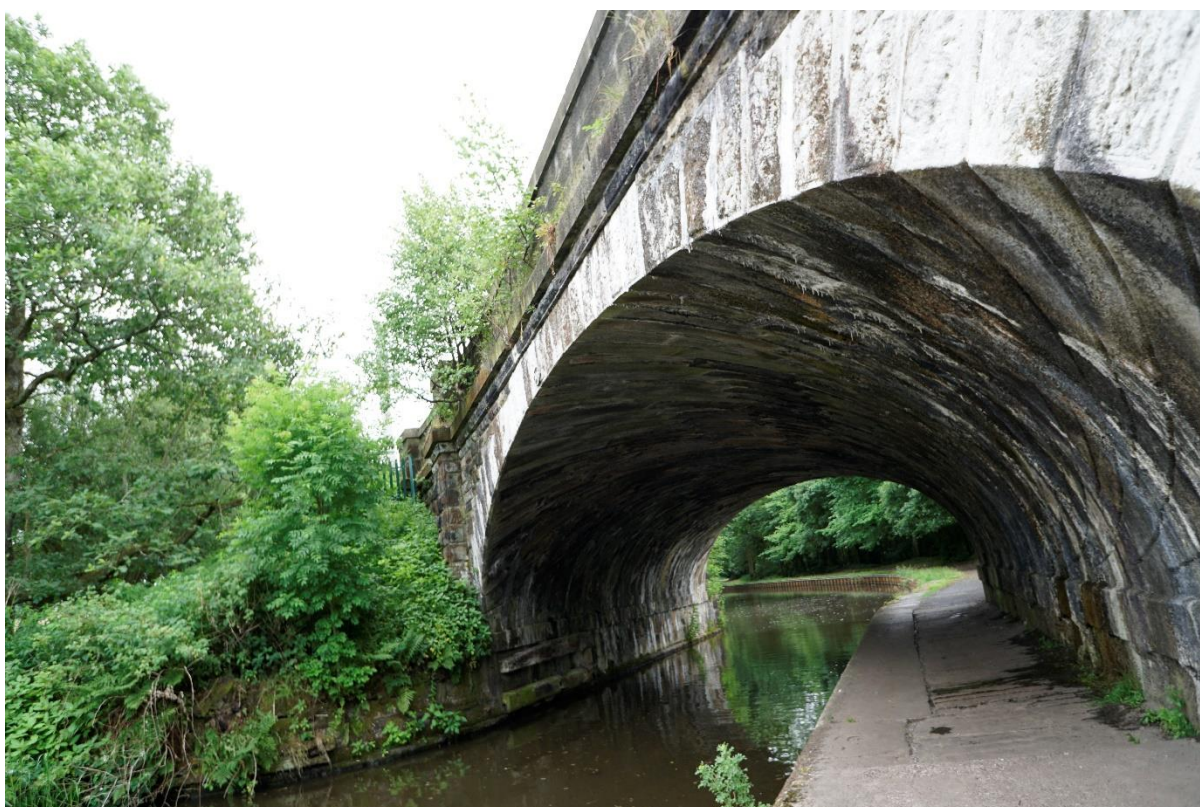
What we can see here is that the arch is highly skewed and that the basic shape is perhaps elliptical or three centred on the square. Three centred is more common over canals because it gives better headroom for a horse and leader on the towpath. Because it is so skew, and because it was built to carry the railway over the canal and is therefore a one-off, it is most likely that the centres were set on the skew. As we will see, the complexities of that geometry are trivial compared with other aspects of this bridge.

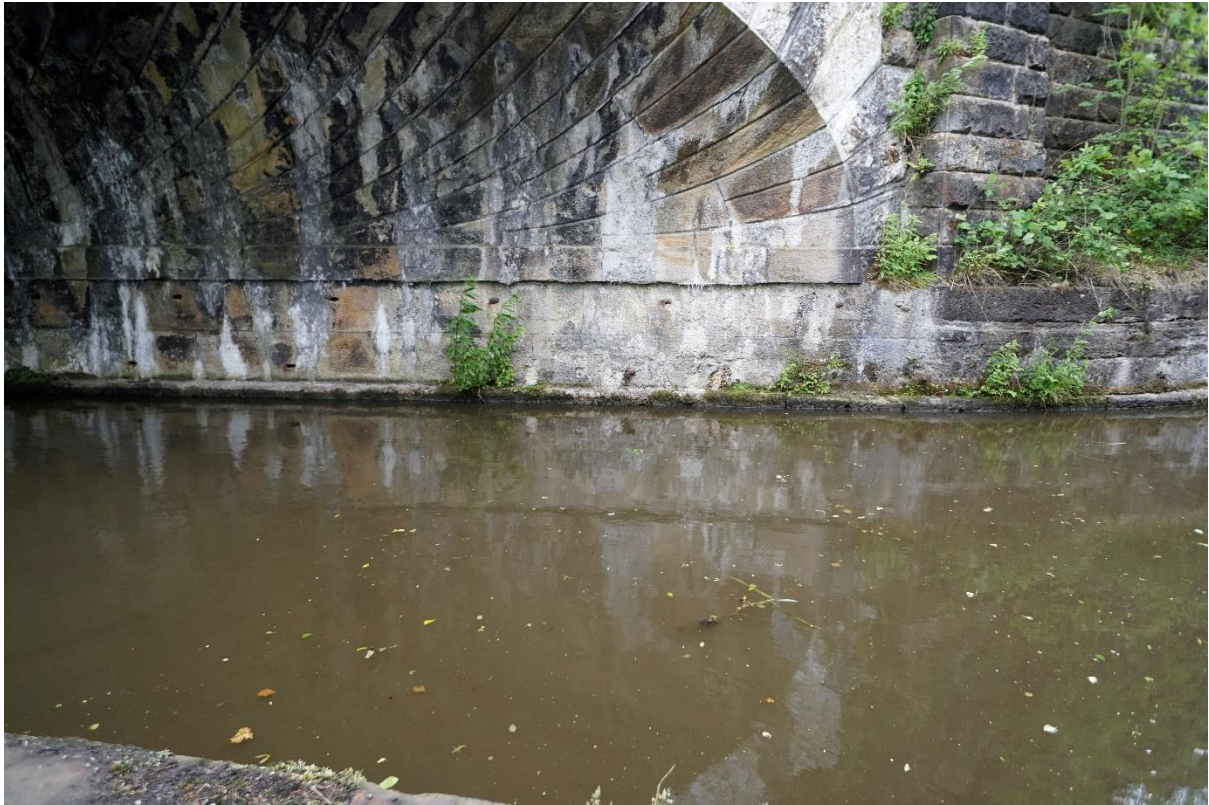
This view of the acute corner shows well what I mean about complexity. A little bit of careful observation shows that the beds all meet the edge at right angles.

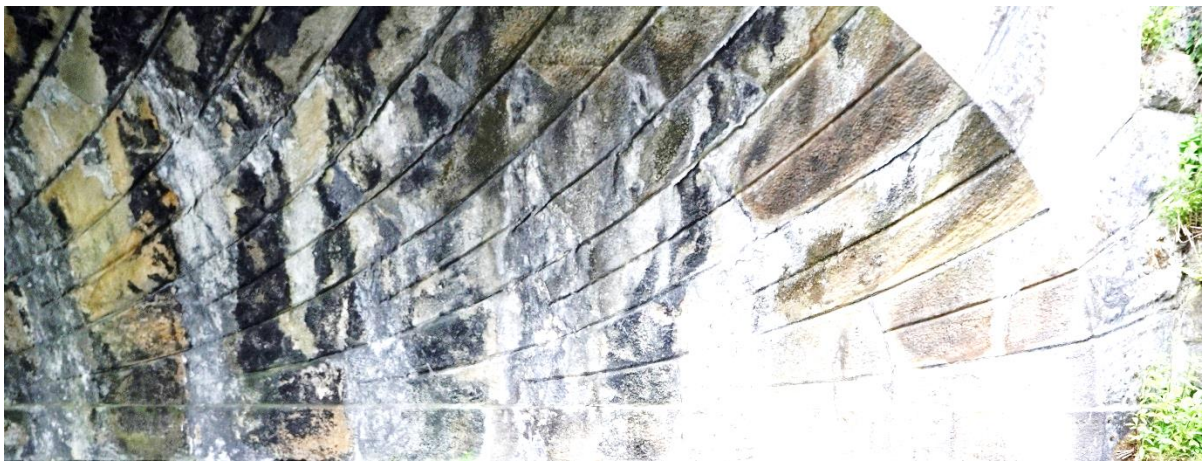
If you look closely you will see how the stones repeat. And they also mirror, of course. So there are actually a lot of identical stones to cut. On the other hand, this would be very difficult in really hard stone and I suspect the masons would have worked the stone green for this job. Sandstone newly exposed is very much softer to work than when left to dry so it needs to be worked as quickly as possible. If the quarry wasn't local, these stones would have been shaped before transport. Perhaps a quick highlight will help.

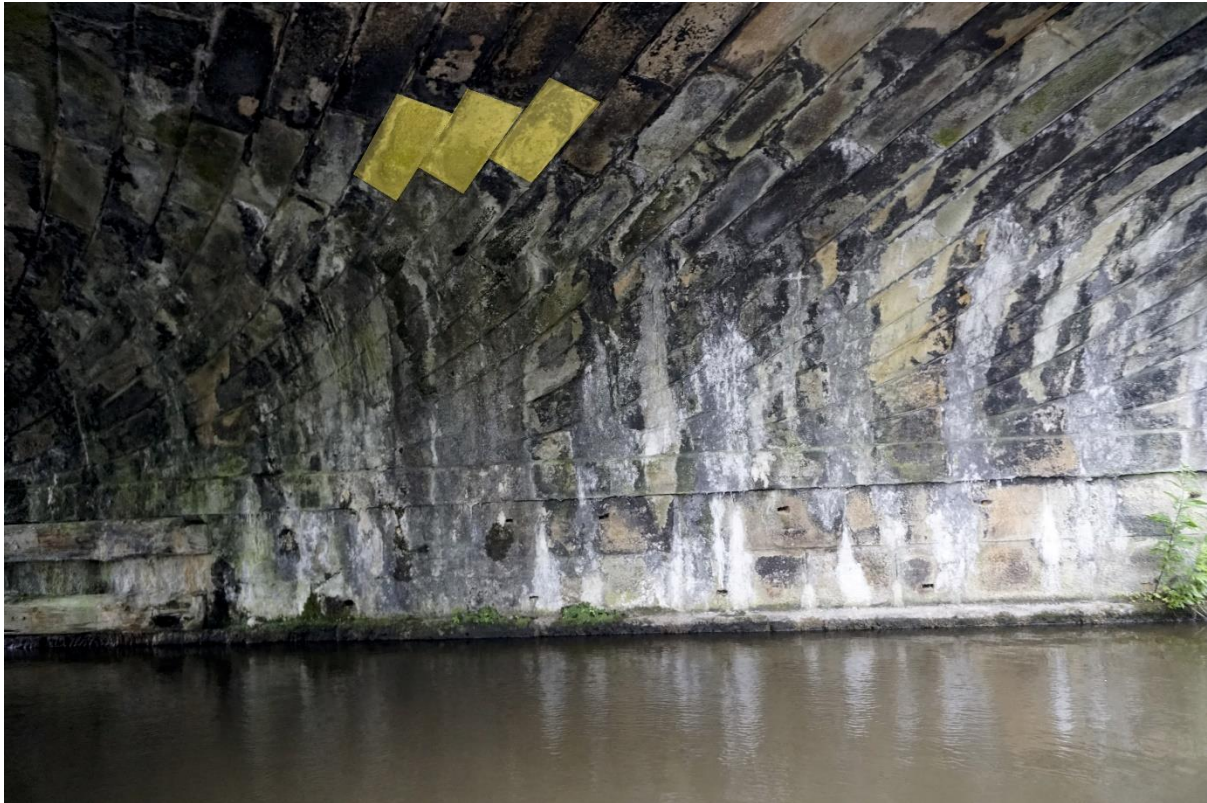
What I find most interesting about this is the apparent belief that:

- 1) The force flow was definitely on the skew
- 2) It was important that the beds crossed the flow of force at right angles.

The first of these may be broadly true (certainly closer than the equally firmly held modern belief that the arch spans square except at the edge) but if we consider half the arch as a free body, there must be considerable shear at the crown to direct the thrust on the skew and that shear must react somewhere. If at the skewback, the straight horizontal line becomes an obvious place for failure.

But back to the details of construction The tinted picture above shows the degree of repetition possible. Not as much, though, as in a helical bridge where if they are all the same length, any stone can go anywhere. To make these complex stones, the engineers had to design templates to help the mason's cutting. I have detailed instructions for such templates for a helical bridge.

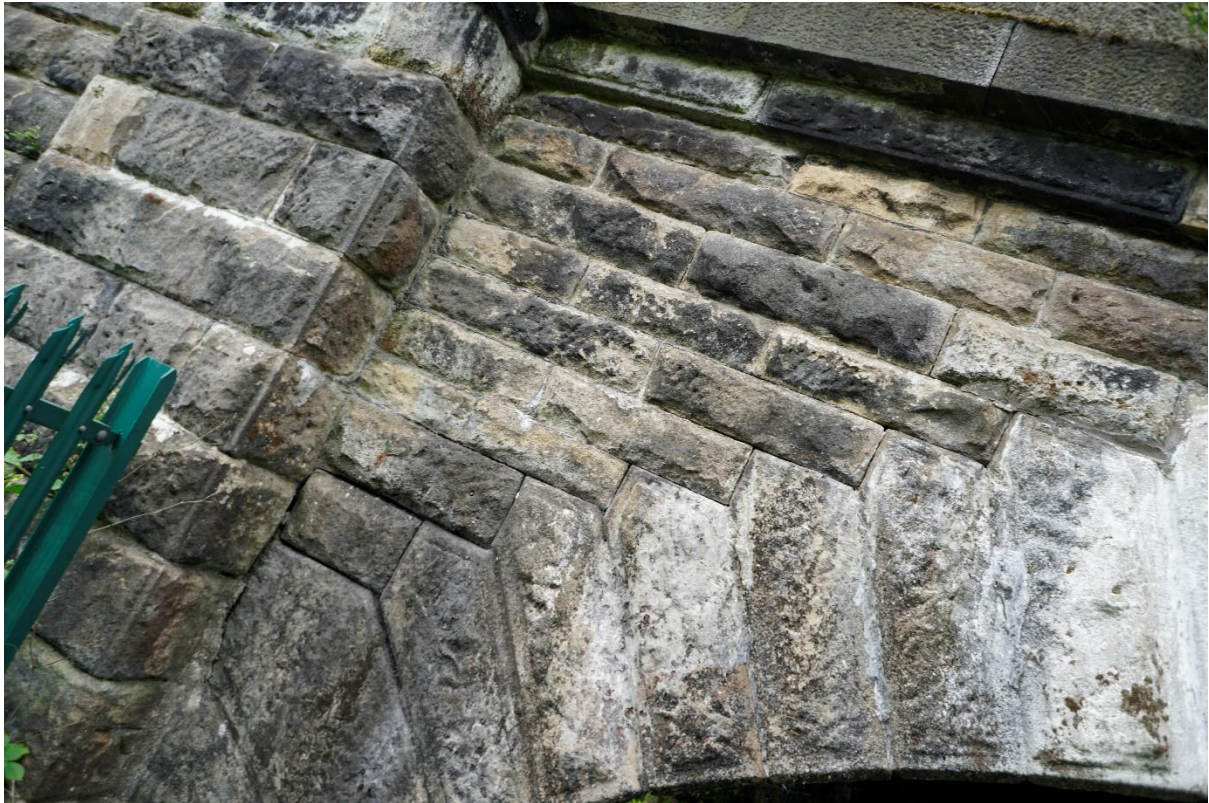
This is the obtuse corner of the arch above the towpath. The picture is squint to get in the maximum amount of detail for modelling. Notice how the smallest stone in the spandrel is completely free. There is no sign of mortar anywhere round it. The open joint seems to continue down but not up the pilaster though there is some later filling of that joint further down. The joint between wall and ring is open as far as this photo reaches, though once again there has been cement mortar patching near the top. And several other spandrel stones are clearly working loose.

All this is telling us something important about the way skew arches behave. Next problem is to work out just exactly what it is telling us!

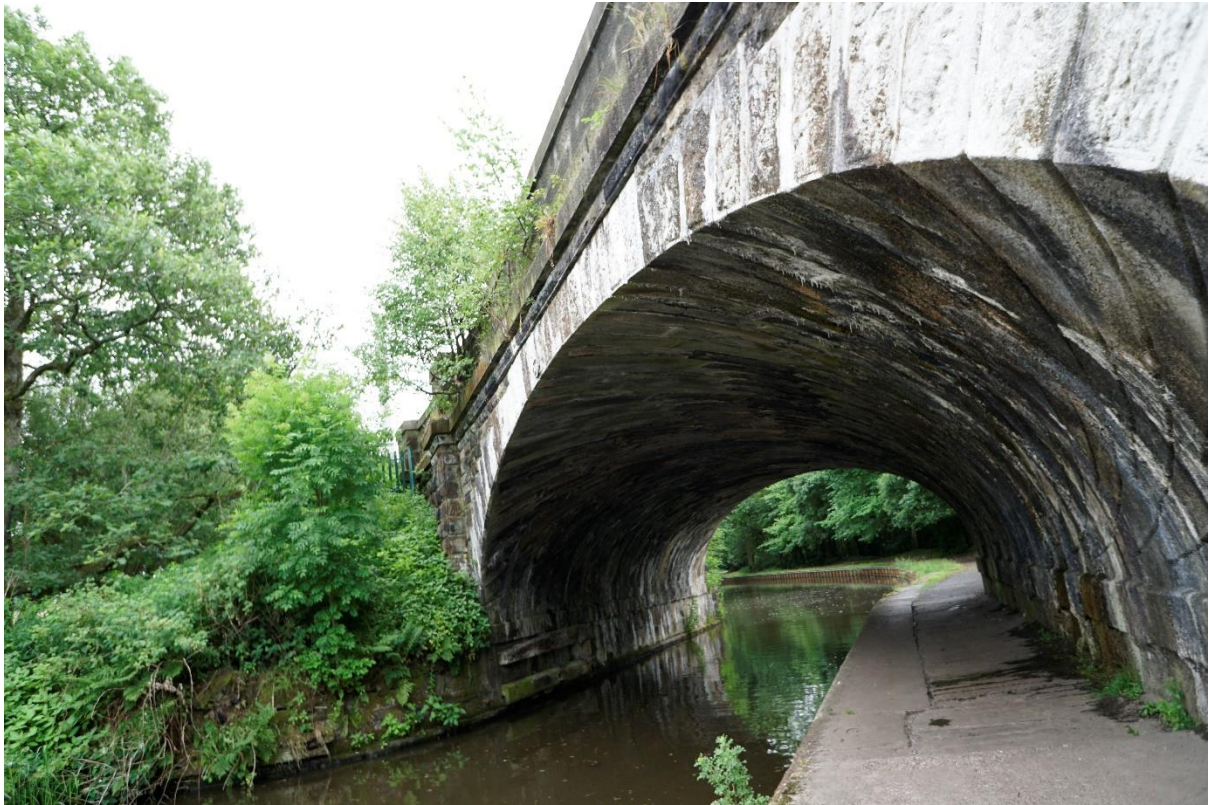
The 3D model makes it possible (in our own viewer) to get an ortho-photo of the spandrel which reveals some interesting things. If you wish to explore the model in lower resolution it is [here](#). Note first how different the stepping on the Voussoir tops is left to right. Unfortunately, the skew meant that the photos ran out on the other edge so I can't make a direct comparison but certainly the right hand end repeats. This narrow shot is the best I have and explains why the model falls apart in this area. If I get there again I will leave time to cross the canal and fill in the details.

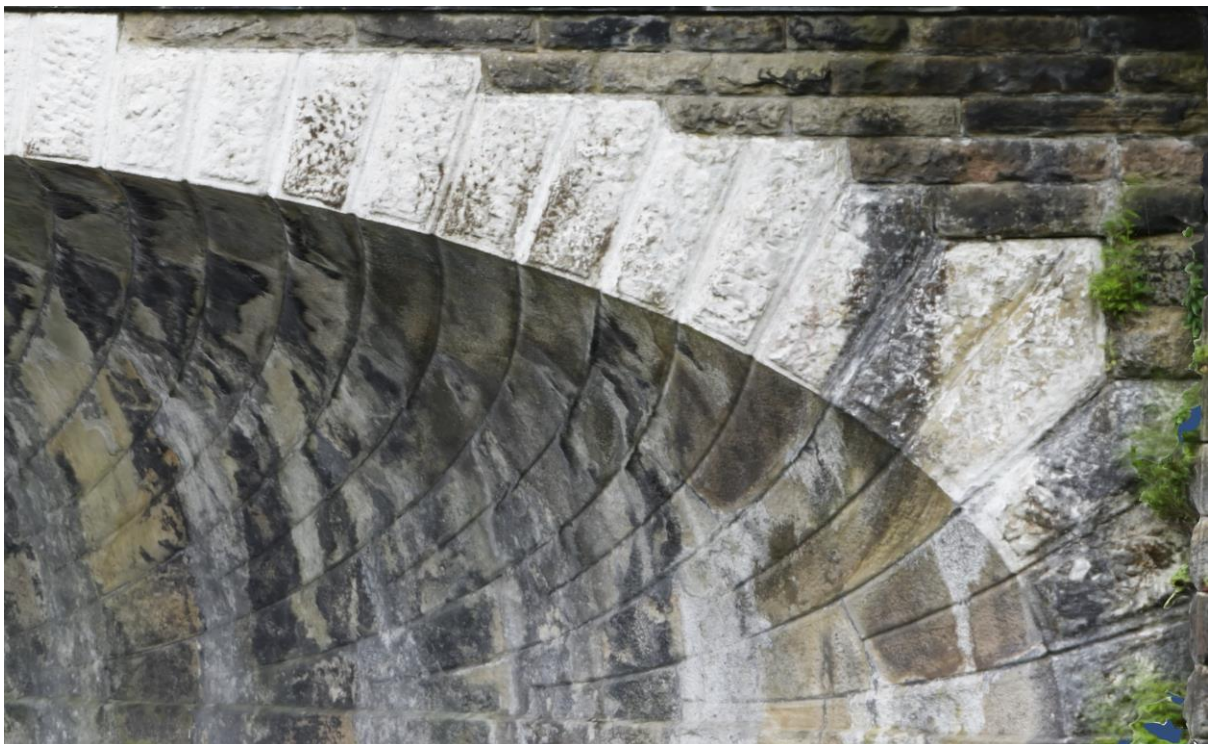
This closer view suggests that the joints are intended to be square to the intrados but lean a little around the quarter span.
