Bridge of the Month 154, November 2023

Pont Julien, Roussillon

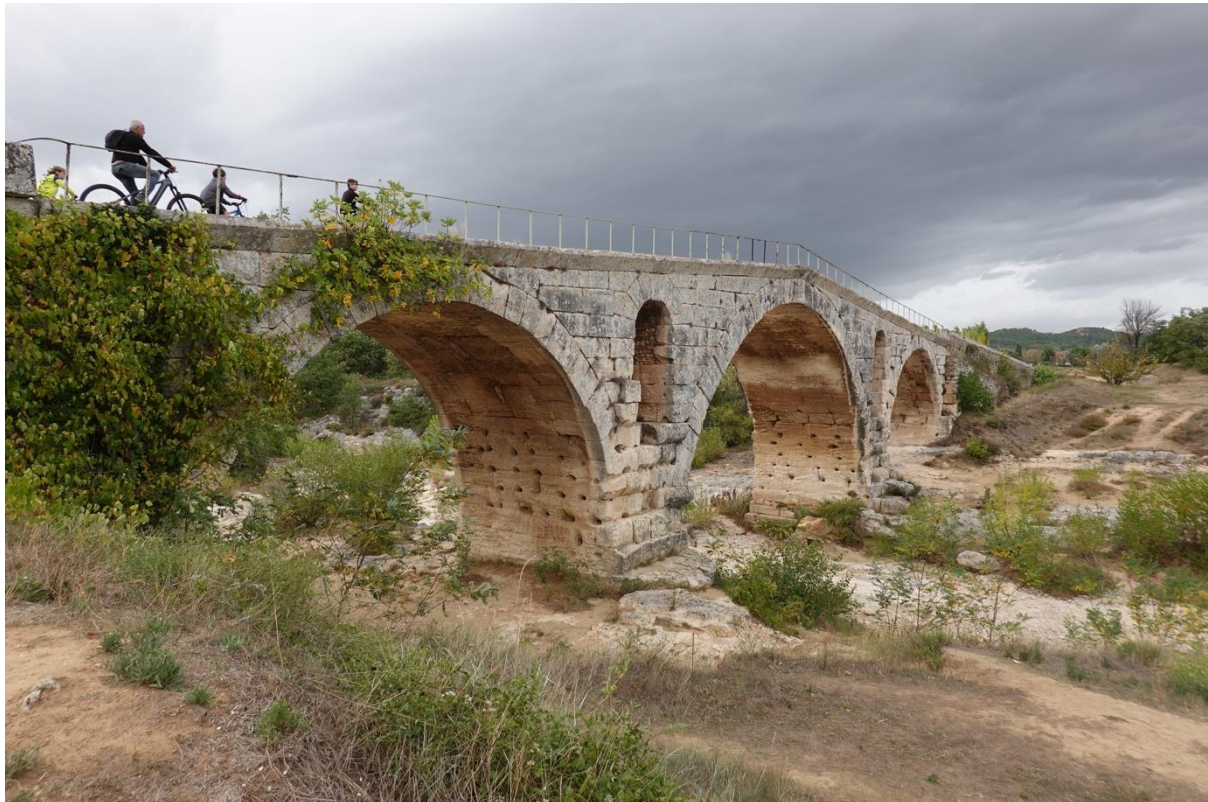
... and [Pont Julien](#), a well preserved Roman bridge dated [rather precisely](#) to 3 BCE.

The bridge rises to a point over the crown of the larger central span. A smaller span each side defines the slope. A bypass was built in 2005 to take vehicular traffic off the bridge, which is still used by cyclists and pedestrians. Cycle routes in the area around Avignon are notably well used.

The openings over the piers are reasonably interpreted as providing for increased flood conveyance, though the effect is surely limited. This is clearly a valley that carries large flows at times, though it was completely dry for our visit despite recent heavy rain in the area.

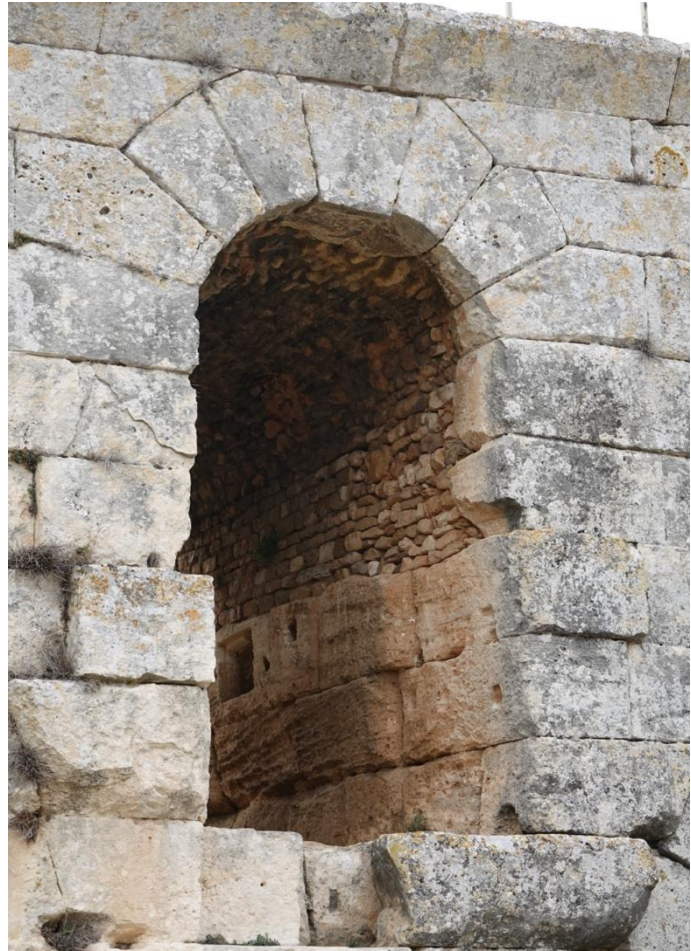
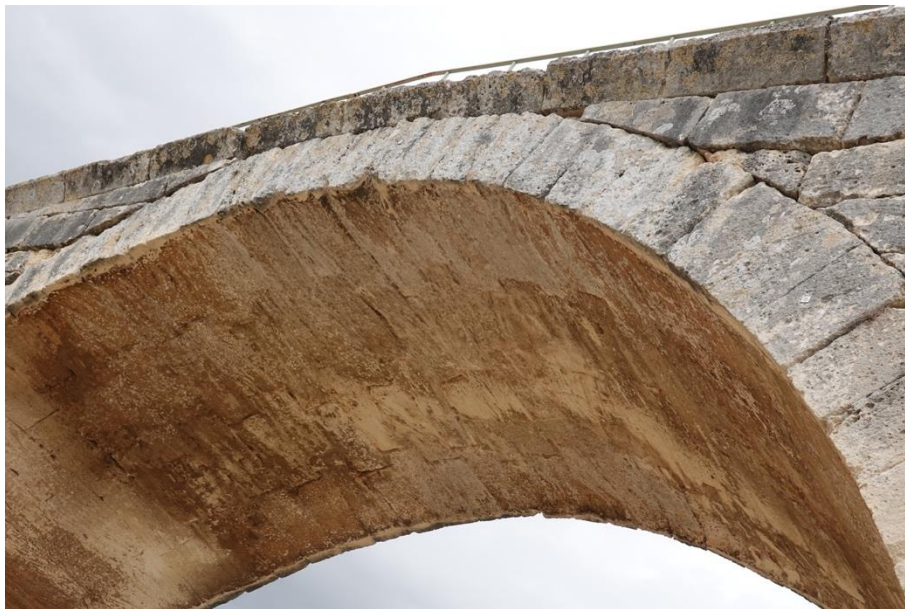
The ring of the main span is entirely of large blocks. Unlike Pont du Gard and the two medieval bridges we visited, these are bonded in the width, if only slightly, suggesting that a full width centre was used for construction.

The piers are fairly stocky – though not as wide relative to the span as many

medieval bridges in the UK – and it might have been possible to build a single span and strike the centre, but the distinct radii of the side and centre arch means at least two centres would have been needed here in any case.

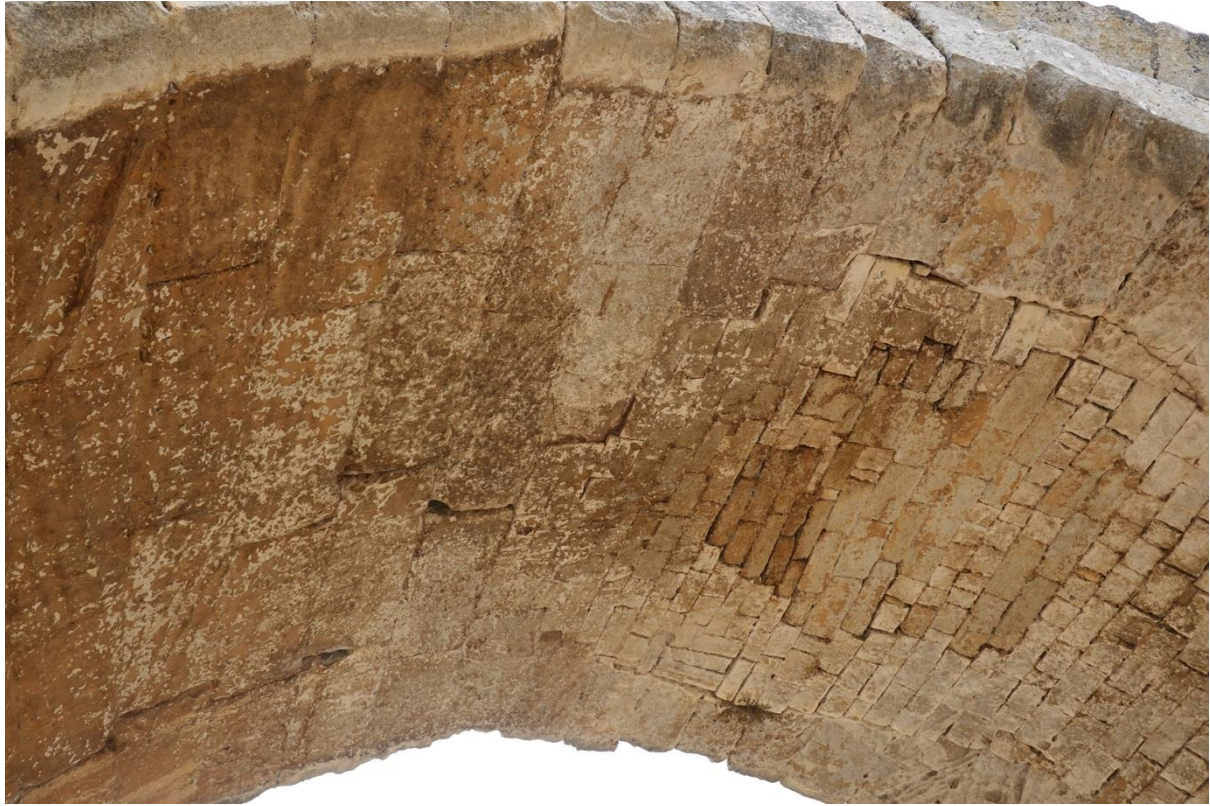
The side spans have areas of small blocks over the crown. These are irregular, and not symmetrical around the crown, and are surely repairs. Within the small block masonry sections have been replaced again. Notice the stones placed longitudinally at the far side.

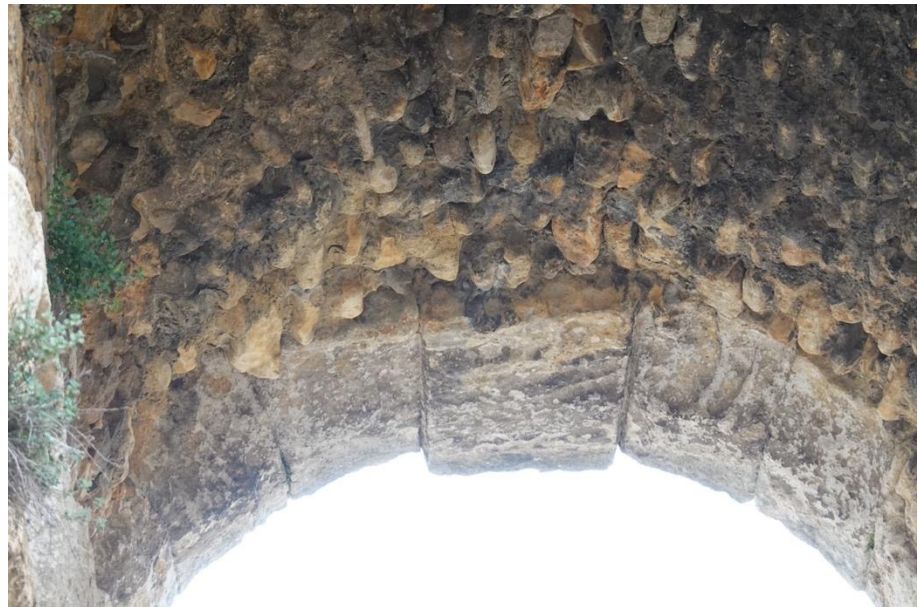
The flood arches are of undressed pebbles with dressed voussoirs only. Rubble concrete fill was used at an aqueduct structure near the Pont du Gard, this (through a long telephoto lens) looks rather similar. The crown voussoir is displaced.

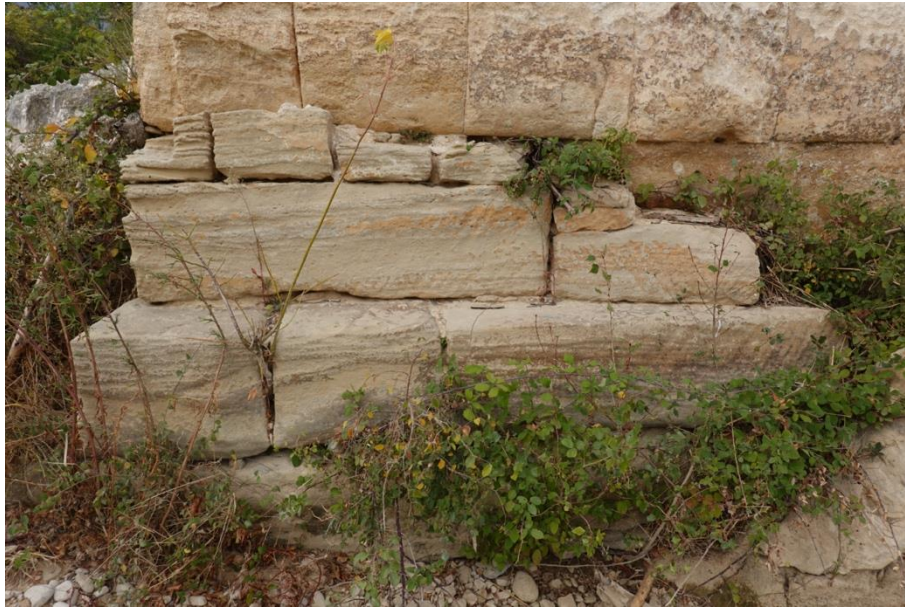
The corner of one pier is of quite different stone, a greensand. The information board states that the piers were built over remains of an earlier bridge. Preserving just these stones would be a strange thing to do, aesthetically (which clearly mattered to the builders) and structurally.

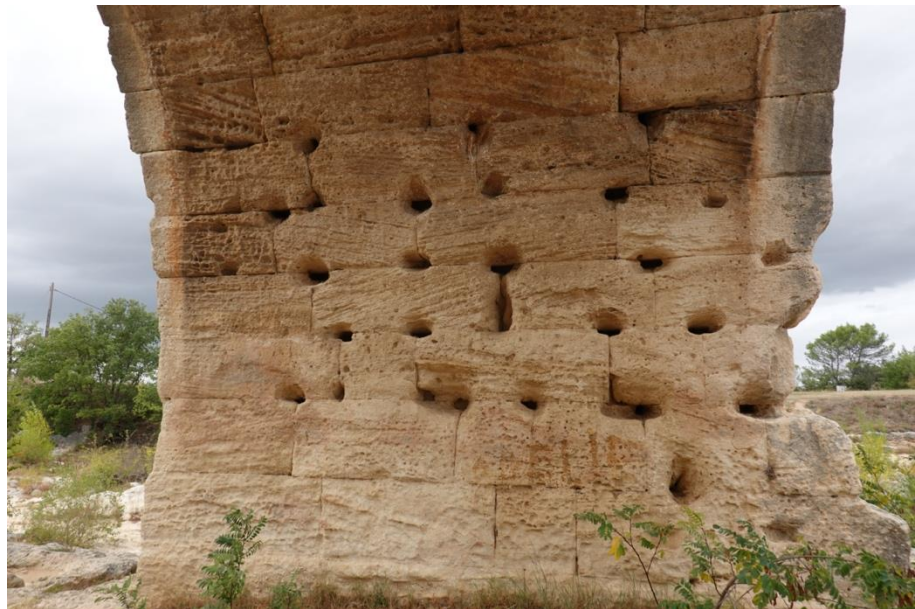
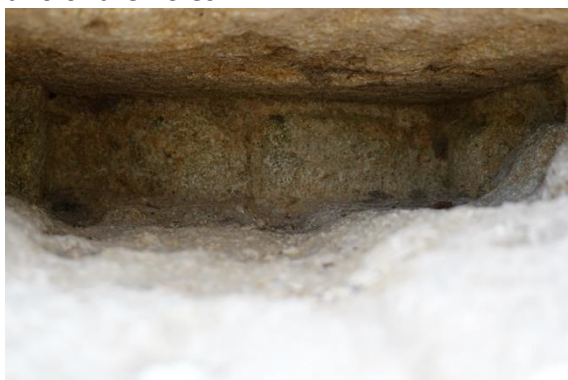
There are many holes in the stonework. These all lie in the lower parts of the bridge. From the number and pattern they are not putlog holes to support centring and scaffold. The holes coincide systematically with the intersection of bed and perpendicular joints. In odd places, two of the holes

extend along one or other joint and connect. I suppose these are erosion from flood flows. The bite from the right hand edge is where a cutwater has been lost.

Dressed masonry is visible behind. This contrasts with typical masonry construction over the last few hundred years at least, when in internal construction would be of undressed rubble. Rubble concrete is used internally at small structures near Pont du Gard and in the

flood relief arches here, so it is interesting that the lower part of the pier is dressed stone within.

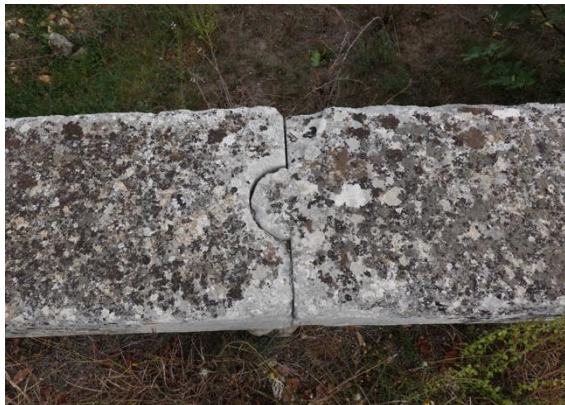
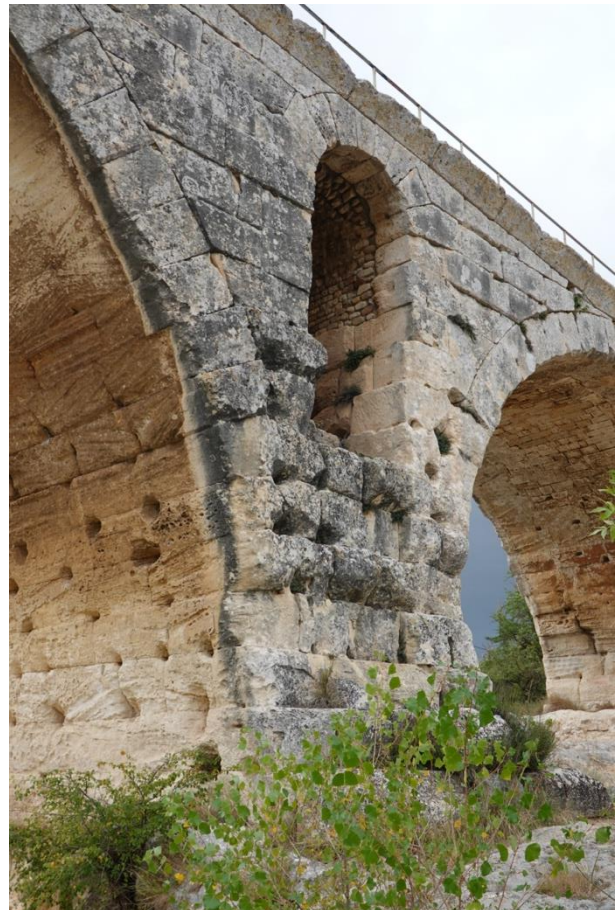
The upriver pier faces show clear evidence that these were once cutwaters of dressed, bonded masonry. Were they slowly eroded by flows, or quarried for the stone? Either way, the current bridge feels more exposed to damage from high flow than it should be.

The step in the water run is because a corner has been lost. Flow from above drips off, but water running down the face tracks in again.

The parapet stones are more recent. The interlock is delightful. The same feature appears on the 18th C “pont moderne” at Pont du Gard.

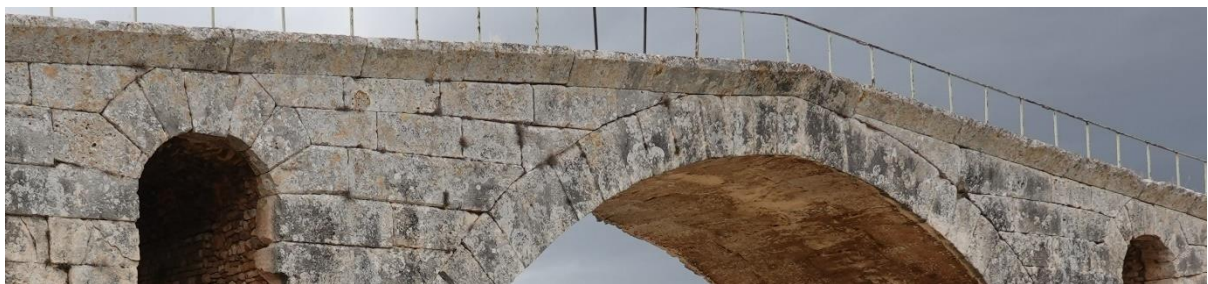
The parapet stones cut into the crown of the flood arches and even slightly into the main span. That surely isn't original – perhaps the road was reprofiled to reduce the gradients.

The parapet stones are largely above road height, vehicle loads would have been applied directly to the arch rings at the crown. The main arch ring is either undamaged despite this, or was repaired in matching large blocks.

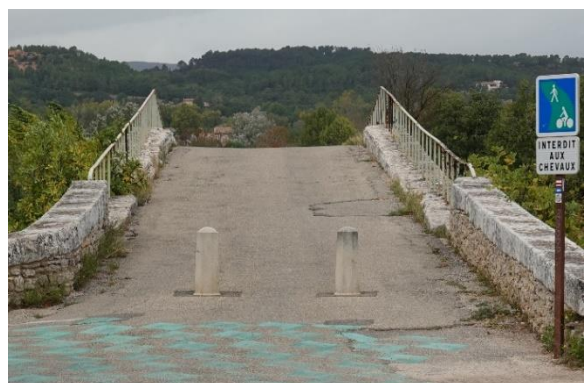
In the side spans, I think the small block repairs are asymmetrical, in both cases to the outer side. At the south side the offset is small, at the north, much greater. Cover is lower downhill from the crown, though only slightly, and that probably isn't enough to explain the north side.

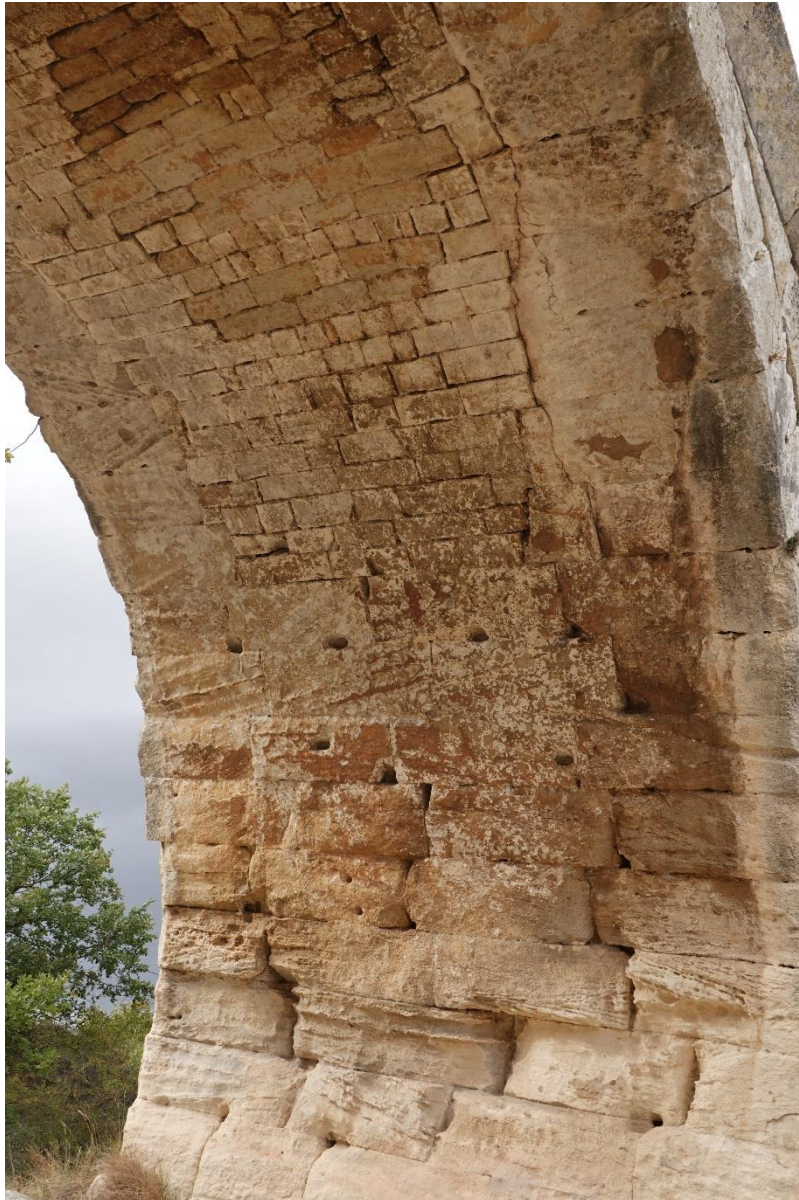
This is the north side of the north span. Notice the crack through the inner edge of the near voussoirs top right.

Masonry is very stiff, but *differences* in stiffness dominate much real behaviour. *Force follows stiffness* should be front of mind when interpreting masonry behaviour and damage.

We would normally expect (though this is not allowed in assessment models) concentrated loads applied to the ring to distribute in the masonry toward the springing, just as concentrated loads on a wall spread. Here the reverse is happening; the stresses are gathering to the stiff point. The stone, after all, doesn't know which way is up.

The load perhaps built up gradually as mortar washed out of the patch. With vehicular loading it would also have had a cyclic

component. The crack wanders through the stone. It also bifurcates, with a finer crack continuing parallel to the edge while the now larger crack heads out to the left. Both of these features suggest that the crack started small and was propagated by cyclic loading.

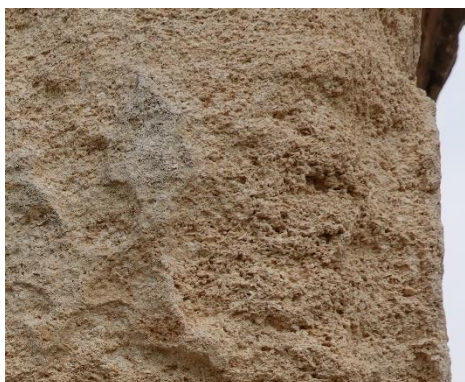
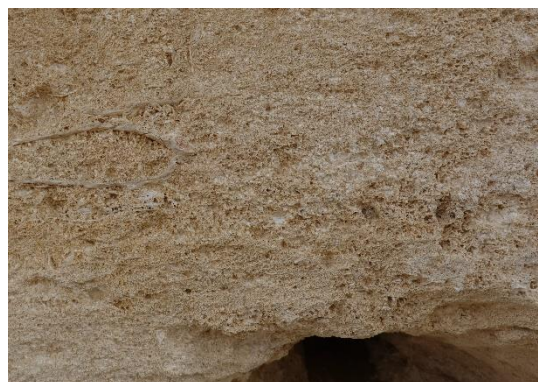
And finally ... Surface erosion reveals the structure of the rather beautiful shelly limestone.
