We turn now to Pont d'Avignon, properly known as Pont Saint-Bénézet, the primary interest of the IBG trip. Those who learned French at school will likely be aware of this bridge from the song – German was my language of choice, and I was quite ignorant of both.

Its most striking feature now is its length, or lack of it. Only three river spans remain of around 20.

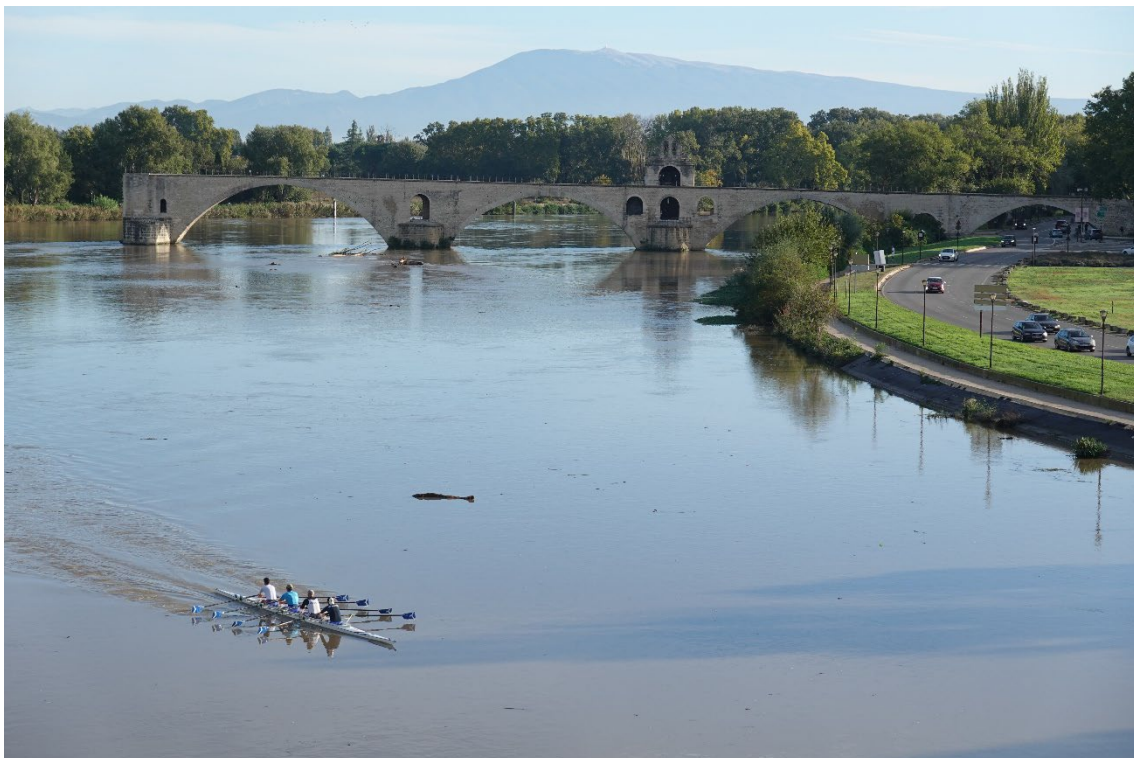
The end span stands happily, indicating that the piers, though very much narrower as a proportion of span than those of many medieval bridges, are wide enough to act as full abutments. Each span is an independent bridge.

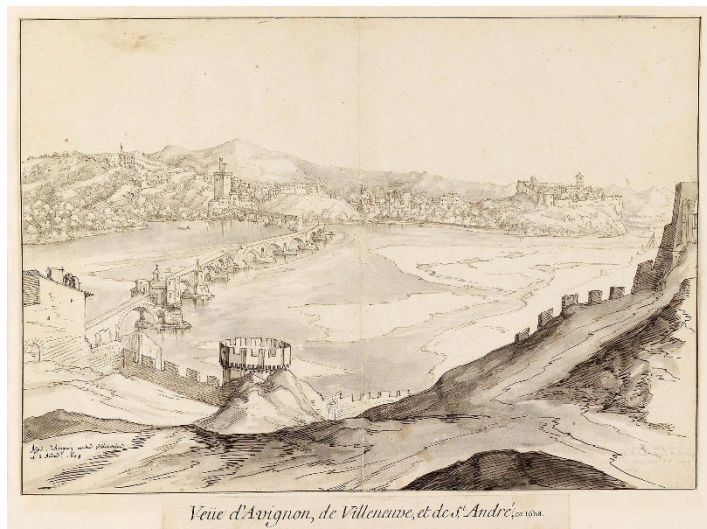
The 1608 drawing by Étienne Martellange, right, shows the indirect course of the bridge, which originally linked shallows or islands. It also shows several spans missing.

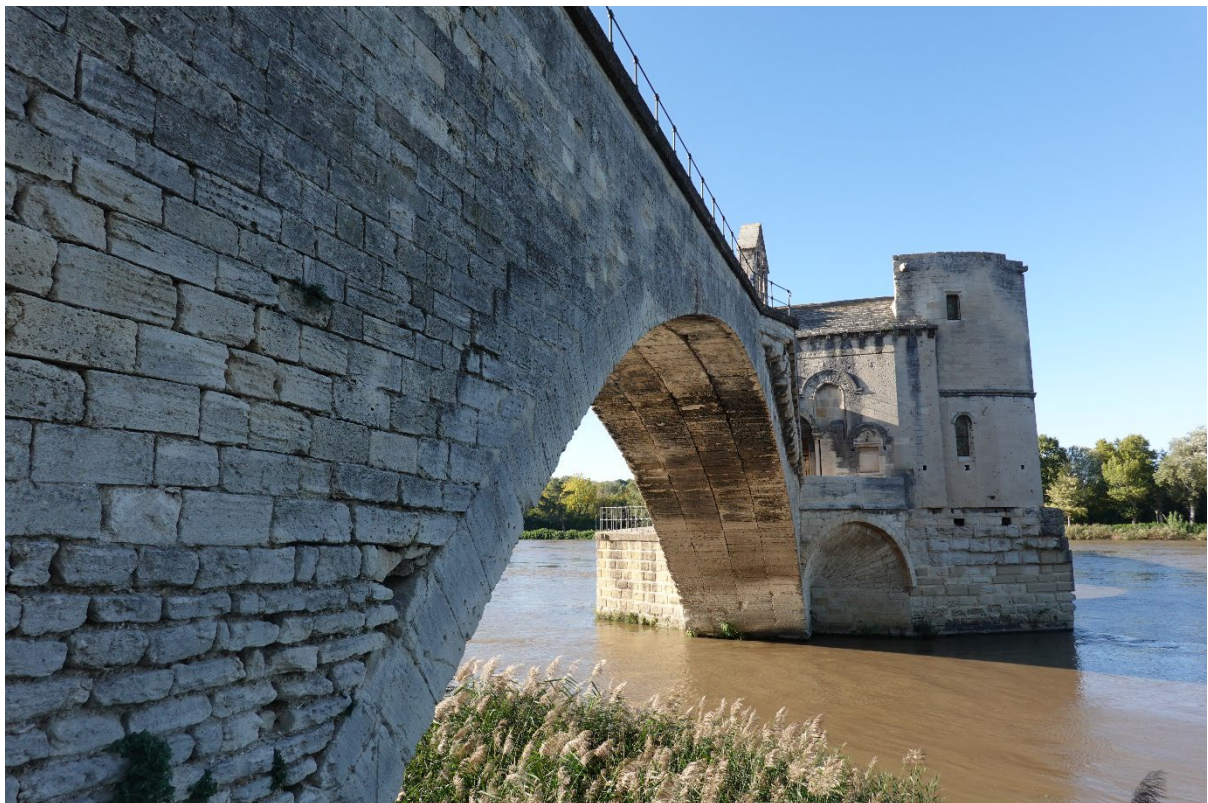
The first river pier supports a chapel, seen below from the river bank. Bénézet's remains were buried here until 1669. The chapel now is rather

muddled, having clearly been modified several times.

Notice that the arch itself is of independent rings with no bond. This style of construction matches that of the Pont du Gard – but Pont Julien, featured last month, had a bonded ring.

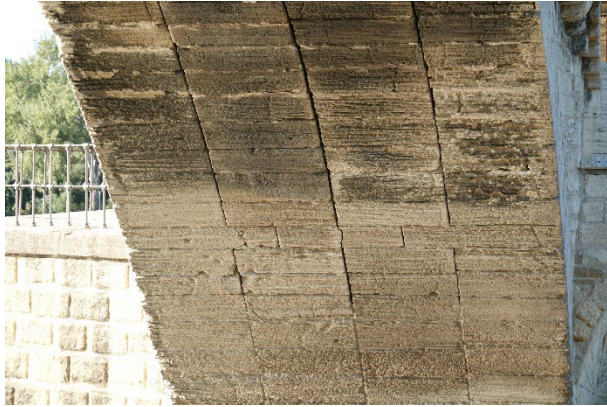
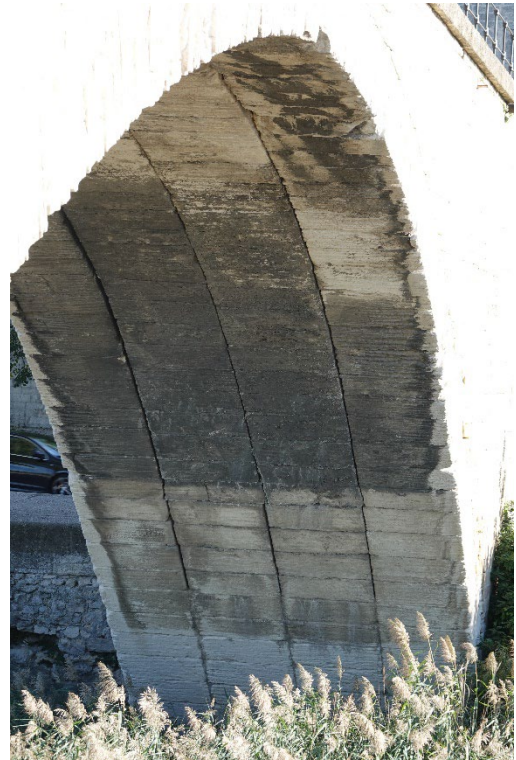
Close inspection reveals that a single course of three longer stones provided some bond at low level. At the river bank (right, viewed from the chapel pier) these have fractured at the main joints. At the chapel end of the same span (below) the damage is less complete and the distinct course more obvious.

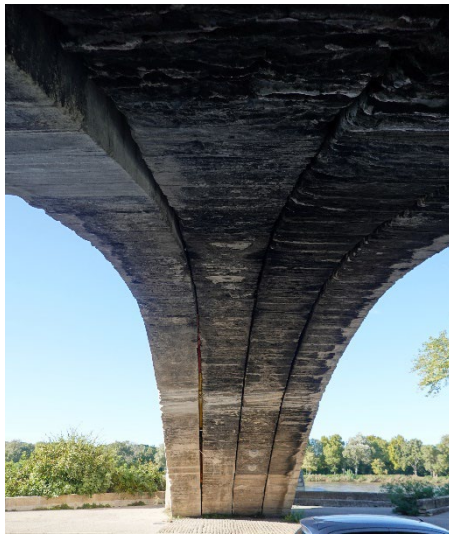
There is a definite tendency for the separate rings to separate at the crown. That this separation is so slight may be a result of the lack of freeze thaw and the fact that the bridge has never experience significant live loads.

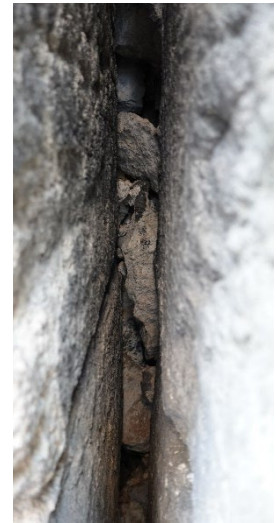
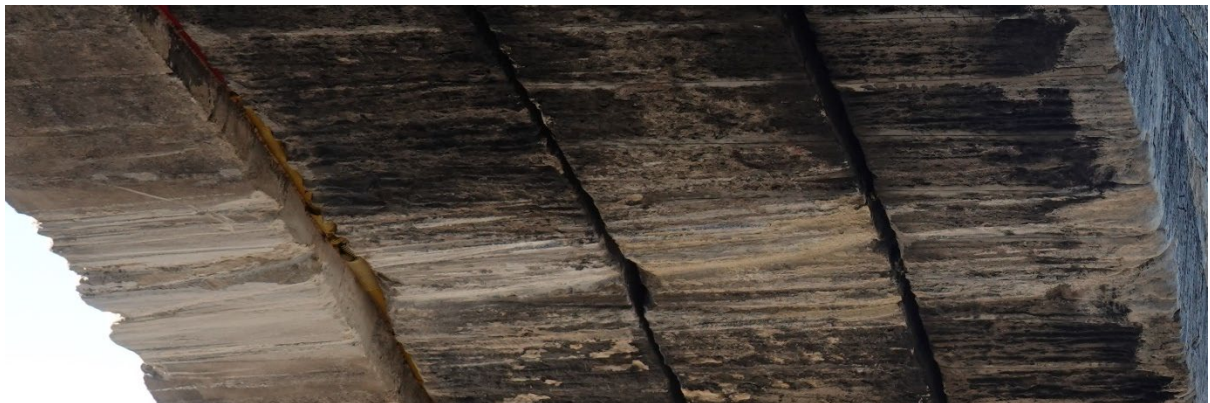
The end span (left) looks rather less happy, having suffered repeated attack by motor vehicles. I suppose it gave as good as it got, but has this been enough to drag the leftmost ring away from the rest? The wide joint (enlarged below) is stuffed with corrugated pipe and expanding foam. An unsympathetic treatment perhaps intended to stop fill material (right) dropping through.

Where that fill is visible from the footpath, as above, it seems to be in the form of quite small shards of stone with no mortar, so the fear of pieces dropping out is not unfounded.

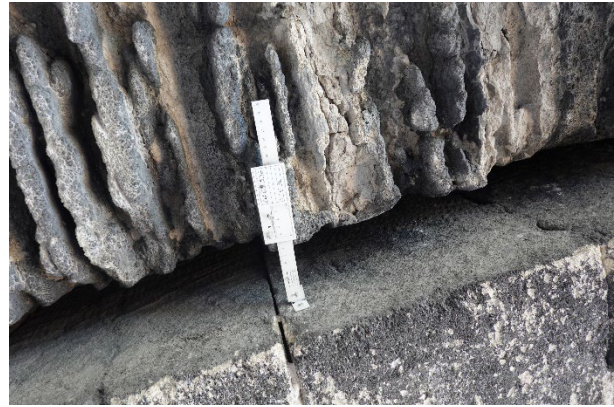
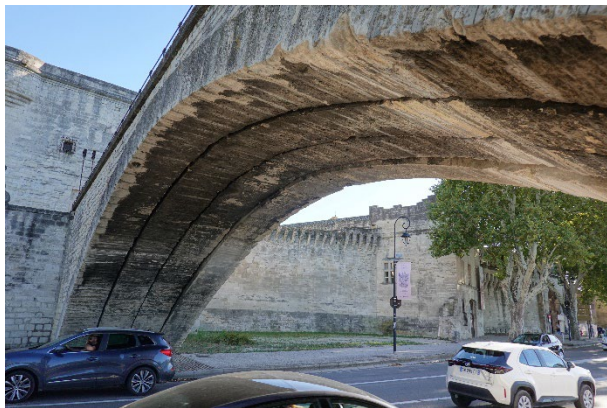
Several tell-tales have been installed, of a “flexible tape and Vernier scale” type. Interesting that the initial reading recorded is given to one decimal place, rather than the two allowed by the Vernier. I didn’t

take the liberty of tensioning the tape to check the current reading, so it might not be indicating a 0.5mm movement in two years as it appears.

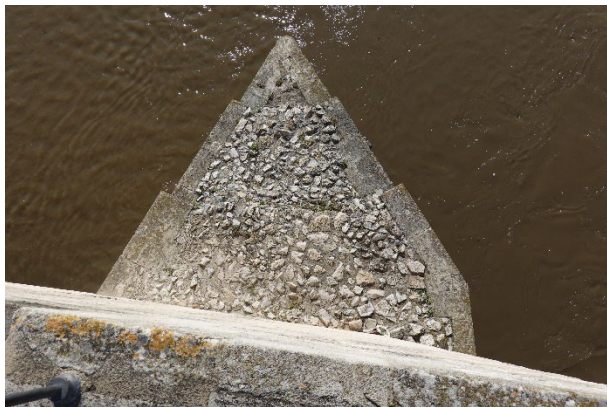
Back out over the water, the starlings are skew to the bridge. Built, I suppose, to match the flow direction, which has since changed.

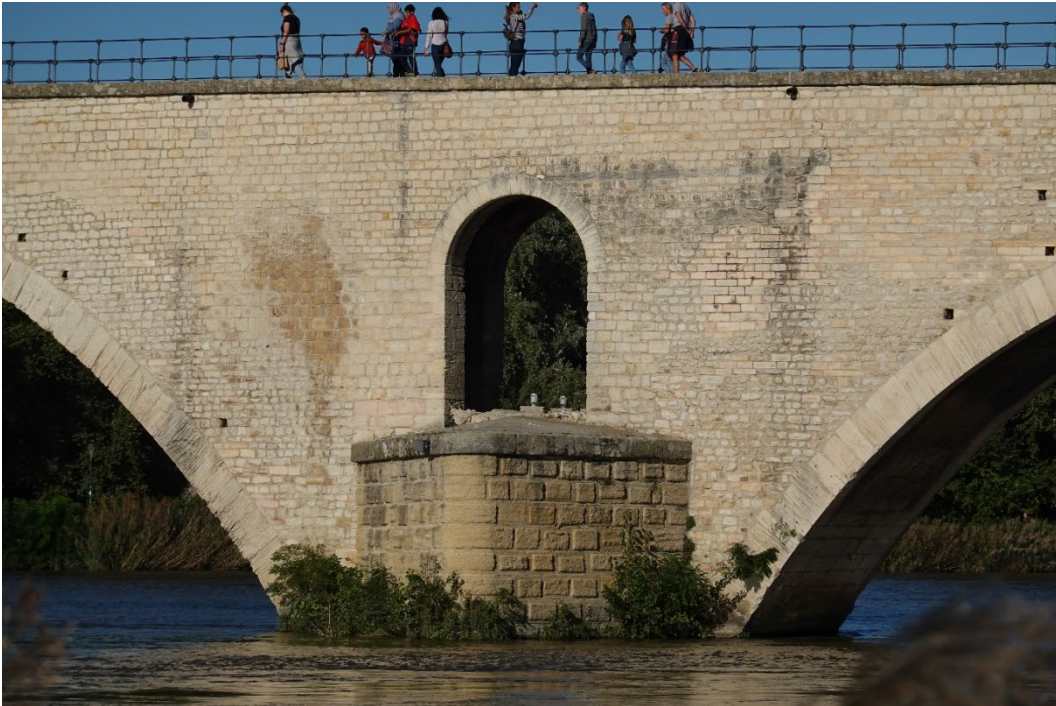
The spandrel walls of the river spans are a patchwork of repairs as we would expect. The starlings are faced in very different material, a repair from a less sympathetic era.

The arch over the pier saves a bit of material in construction, and allows a little flow in space (the Rhone is heavily managed now, and the climate is different, so floods much less severe). Do we suppose the spandrels are filled, or are there hidden voids? It would be odd to include transverse voids but close them to flow.

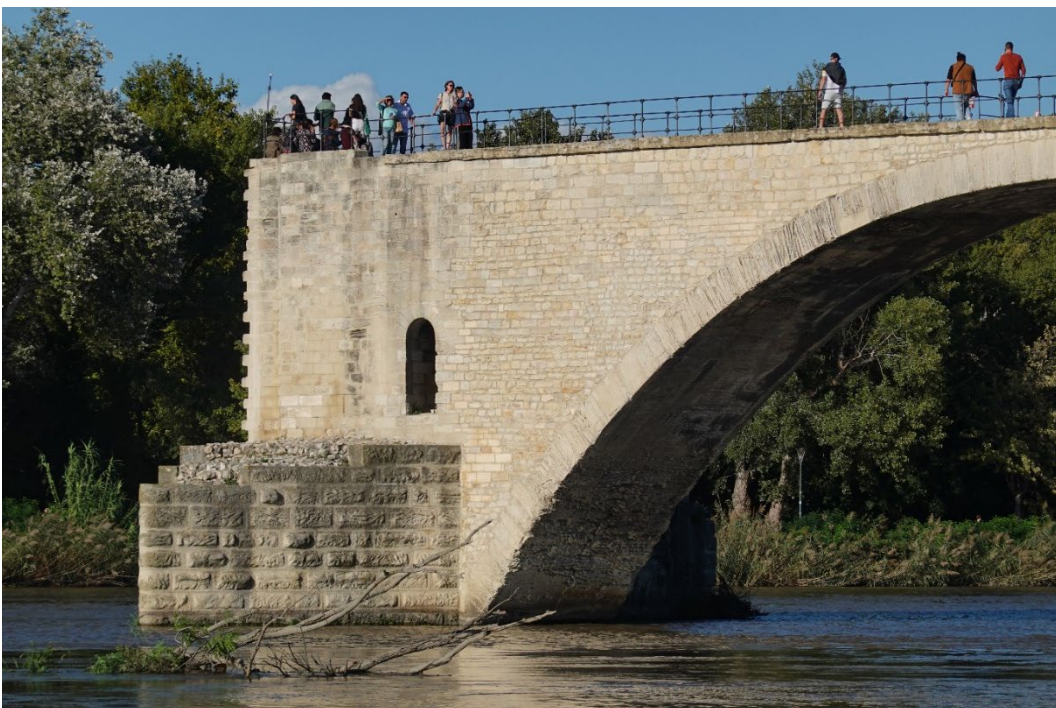
The masonry over the final pier is quite different. There is also no flood arch here. Is this older, or has it been rebuilt to better protect the remains of the bridge?

Those photos give a good impression of scale. Wikipedia has the longest extant span at 36m. The audacity of this, given the time and the setting, is quite something.

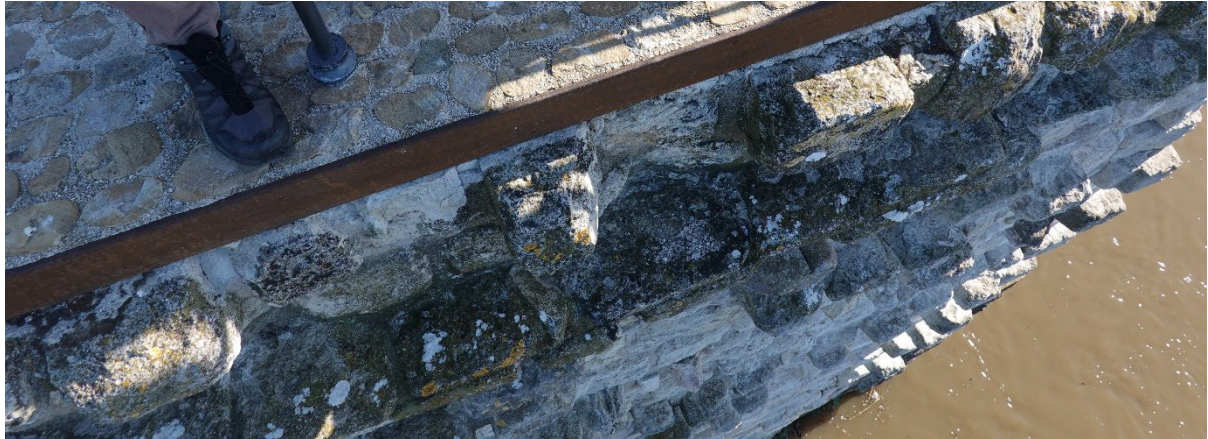
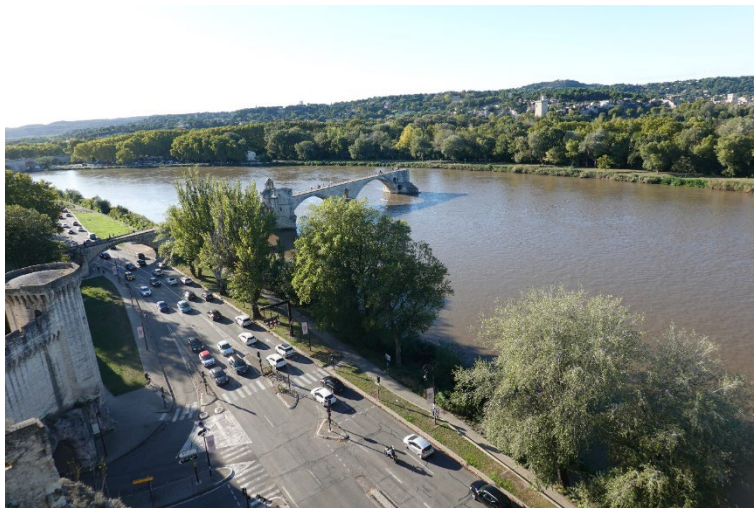
A limited view down the end face shows solid bonded masonry on a perfect vertical break. Not necessarily what we would expect to find.
