# Bridge of the Month 159, November 2024

## Pontrhydyfen Aqueduct, Neath Port Talbot

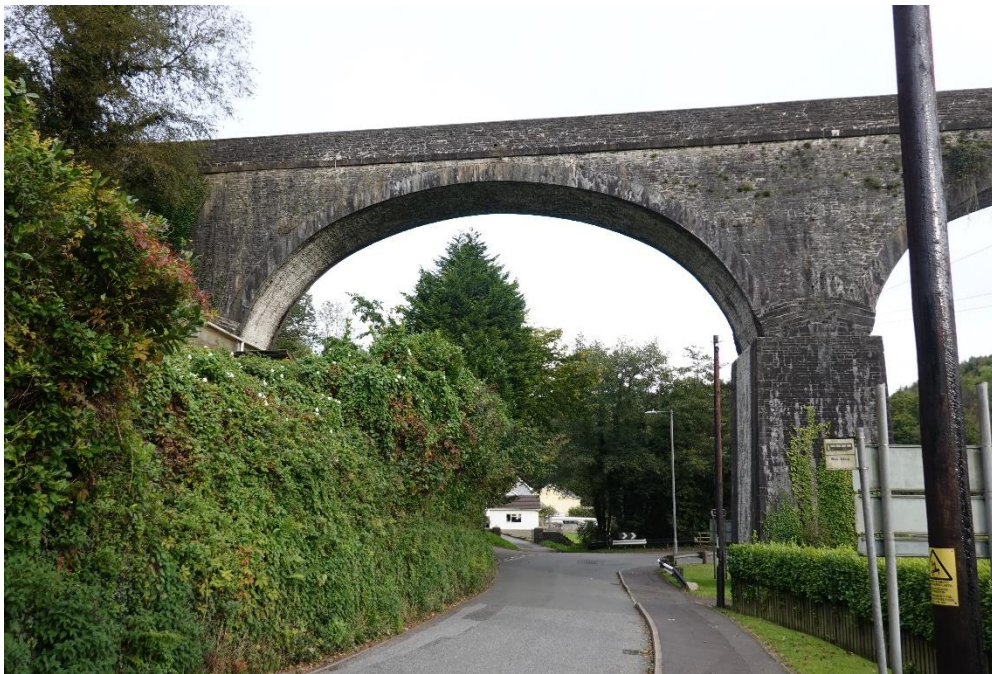
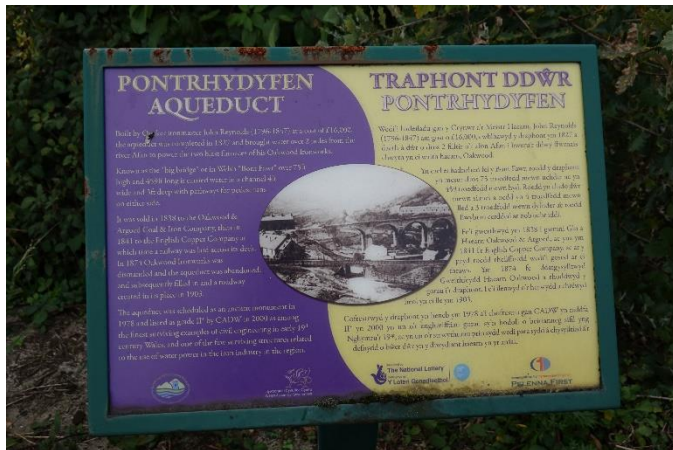
The aqueduct inspired an unplanned, albeit brief, stop. It strides across the valley with four unusually long spans, much longer than typical for railway viaducts, and the shape is intriguing. Here is the view as we came down the hill.

Looking around the quarter points in the first view above, my first guess was that the curve is three-centred (see right). Unusually though for either multi-centred or elliptical geometry, it doesn't seem to come to vertical at the springings. That is common in large span Norwegian masonry bridges, springing from rock, but I haven't come across it before in the UK (examples please if you have!). The possibility that the piers were originally more slender and later enlarged burying the true springings, was discounted because the decorative corbel is clearly original. Perhaps the impression is an artefact of the corbel. Can we confirm that?

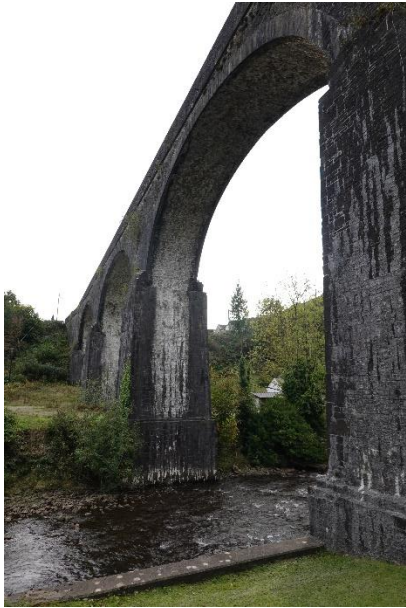
The views from below are dramatic. The view left shows how slender the superstructure is in plan. Notice the lime staining from the rubble ring continuing down the pier, where the dressed edge voussoirs are clean.

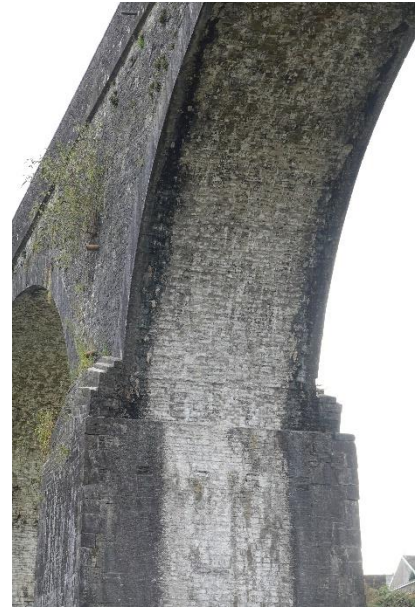
Zooming in on the area around the springing (right) we can see that the ring and spandrel wall corbel out in steps, but the soffit comes to an abrupt ledge.

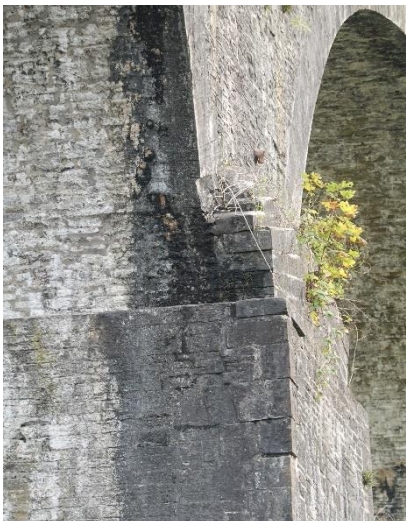
Zooming in a bit closer still (left - the Sony RX100 I inherited from Bill is a phenomenal tool), it looks distinctly as if the rubble of the ring extends out further as the outer voussoirs step out. The face of at least one lower voussoir has spalled off, perhaps as the less rubble masonry has compressed slightly relative to the stiffer ashlar. The corner of the pier seems to be having some trouble too, what is driving that?

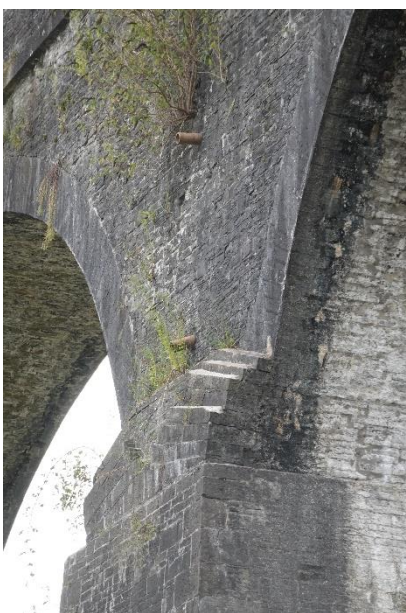
There is a big volume of spandrel here. Two clay drain pipes emerge (right), but I suspect these are retrofitted. Comparing piers this is confirmed by the vertical position varying.

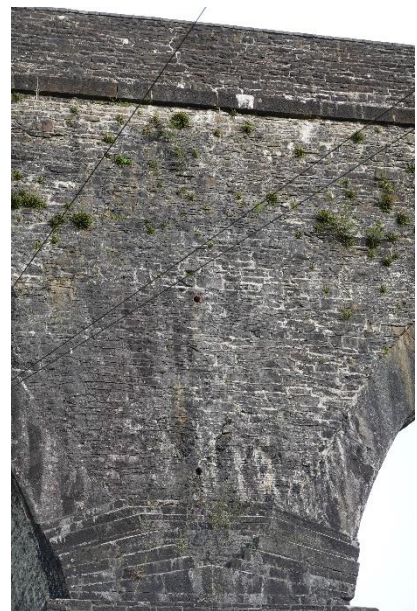
Left, the clay pipes haven't broken off, and we get a better view of the corbel on the elevation and the makeup of the ring. The fight between ashlar and squared rubble is visible again.

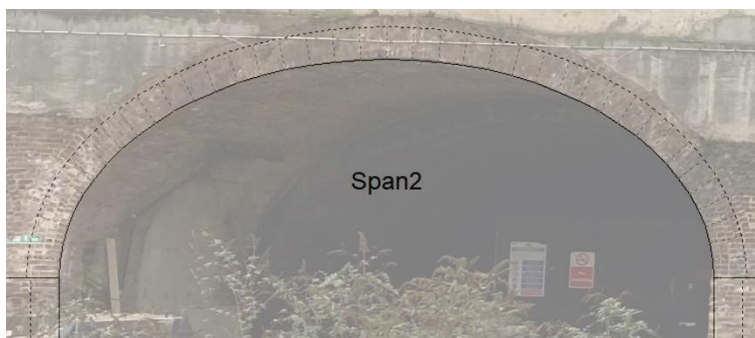
The common case in assessment is that we have a measured span and rise and we can see the springing points. In this case, if we have a photo from close to mid span and now too far below the level of the arch, it is very quick to check whether the shape is elliptical

or not, or at least whether the difference is enough to matter. Here's an example. The ring thickness in this was set to 4 bricks rather than the 5 visible in this wire-saw-cut elevation, but the shape is a good fit.

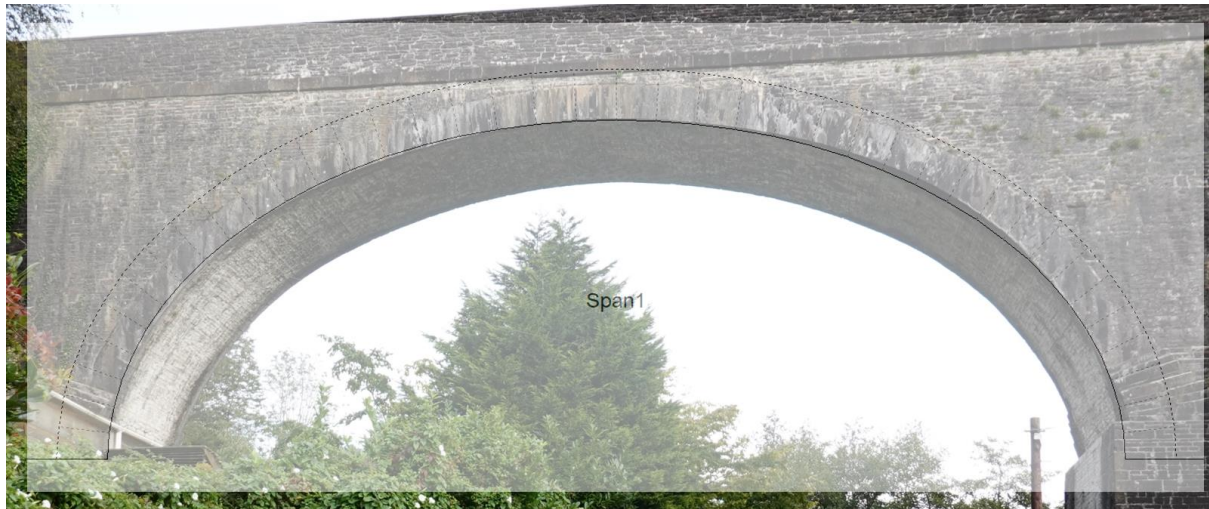
That's an interesting result. The Archie-M curve drops below the real intrados to the right, but it's much closer at the left. I guess that is a result of perspective distortion in the image. Compare the ring thickness drawn by Archie-M with actual ring in the photo. The Archie-M ring thickness is too large everywhere, but it is better at the right than at the left. Again, the difference is perspective.

We don't have a span, so let's use 10000mm (the actual span may be closer to 20m, but the ratios are easier if we use 10m). The span to rise ratio is clearly less than 2 (that would be a semicircle in any geometry) and more than 4, so let's try 3, so rise 3333mm. We test an

elliptical curve first, as the quarter point rise is fixed by the span and rise, so there are fewer variables.

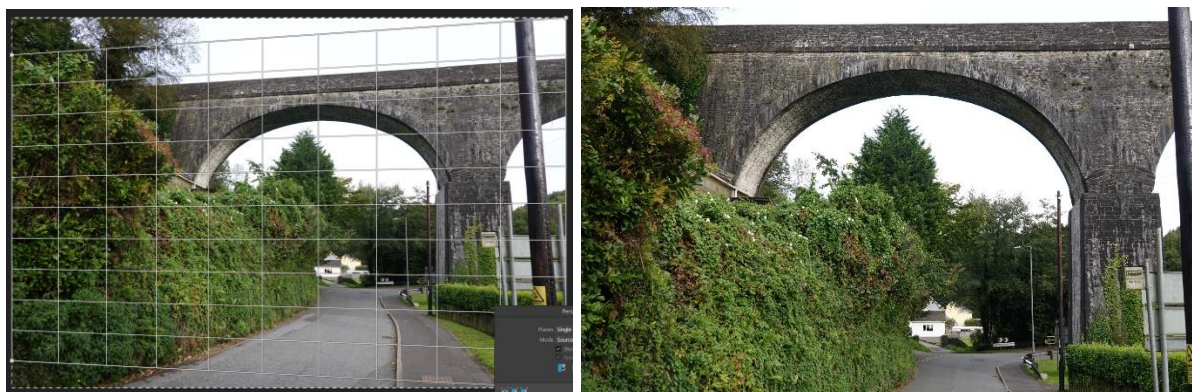
Left is a rather hasty tweak, with the grid lines aligned with the top of parapet and top of corbels (everything below that being hidden by vegetation to the left). Right, the result. The string course still isn't dead level, but it's closer.

It looks as if we aren't going to get very far without correcting perspective a bit. Affinity Photo has a tool to do that. All of the distortion we're interested in is in one plane, so single point perspective should do it. We're a bit limited in control points, but the string course above and the top corners of the corbels below we might assume are both level. No doubt there is a foreshortening vertically as well as the camera is well below springing level, but we don't have any vertical lines to work with.

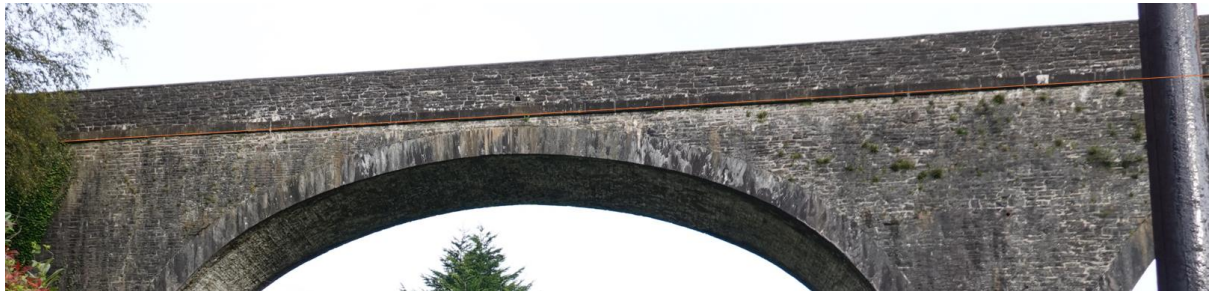
While we're looking at that string course, my eye sees a dip to mid span. Is that real? Overlaying a straight edge says it is, but in relative terms it is slight. On this large span it might not be trivial.

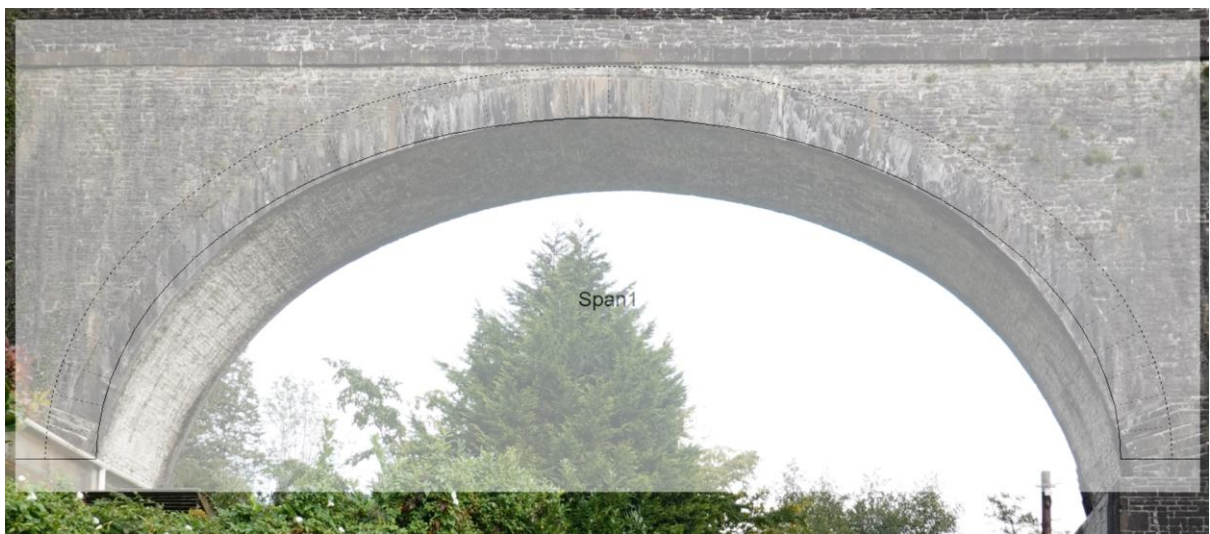
Trying our overlay again with the corrected image, we find that the aspect ratio doesn't fit any more. The springings in the screenshot are clearly too high.

Thinking about it, my perspective correction will have stretched the image vertically everywhere except the very right hand edge, with no corresponding stretch in the width. That is unavoidable I think, which makes extracting a span:rise ratio impossible.

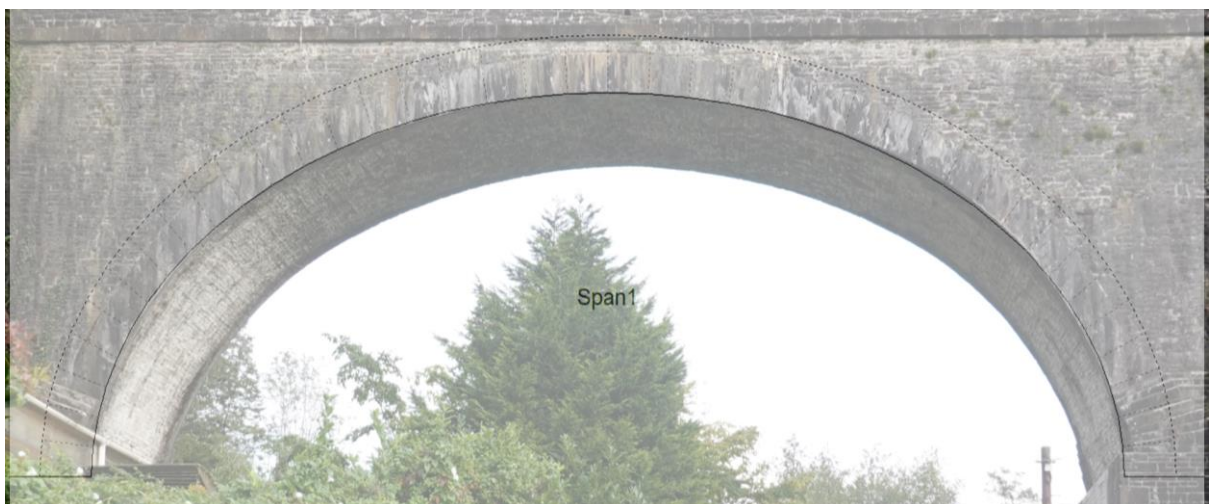
Accepting the vertical stretching, we can stretch the Archie-M image too. We finish up with a close but not perfect fit around the intrados curve, and springings not far from top of pier ledge.

From which, we have a revised though partial view on the geometry. The span:rise ratio might well be 3:1, but we can't be sure without measurements or a square on photo.

I'm still unsure about the shape – from this, elliptical is possible. The deviations we see in that last overlay might be saying that it is three-centred, but we've finished up with too many variables to be sure.

One thing seems clear though. The true springing is probably at the pier top ledge – the feeling that it is lower must be an optical illusion, probably created by the corbels.

Even in that last image, the real ring is smaller than that in the Archie-M model, where I have a 400mm ring on a 10000mm span. If we suppose a real span of around 20m, that means a ring of perhaps 700mm. Rankine's rule of thumb ( $\sqrt{0.12 \cdot \text{span in ft}}$ ) would ask for at least 850mm, so the feeling that the expressed ring is slender is fair. Whether the squared rubble between is thicker or thinner we don't know.

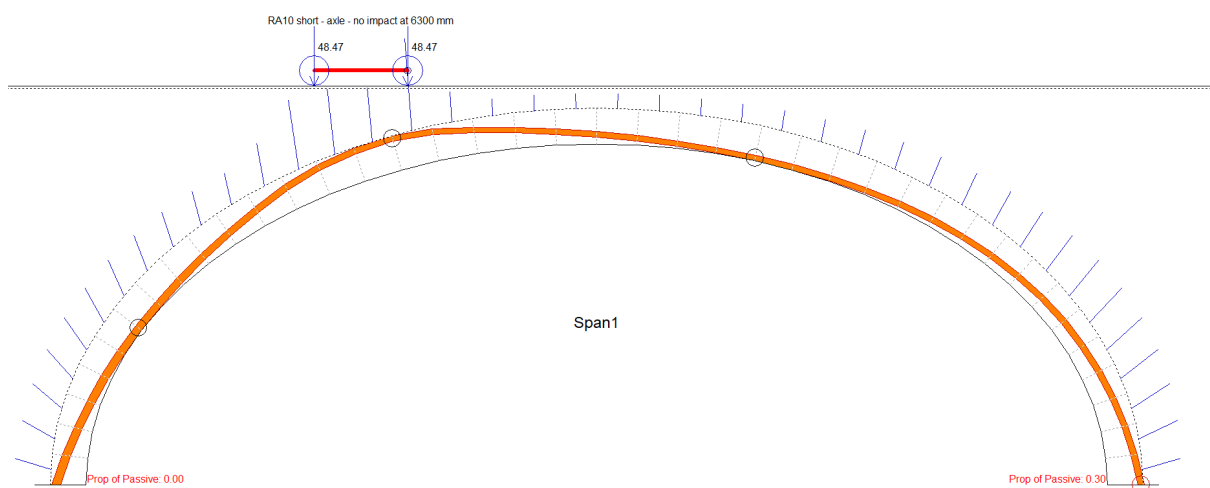
The conversion to rail is interesting. An aqueduct will never experience any concentrated load. You would want to show at least a little backing (stiff masonry over the pier between the arches) to pass this for any interesting rail loads to modern practice. Passive pressure can get us to RA10 *without* impact, but only RA3 with impact.
