Bridge of the Month 164, August 2025

Fatherford Viaduct, Oakhampton

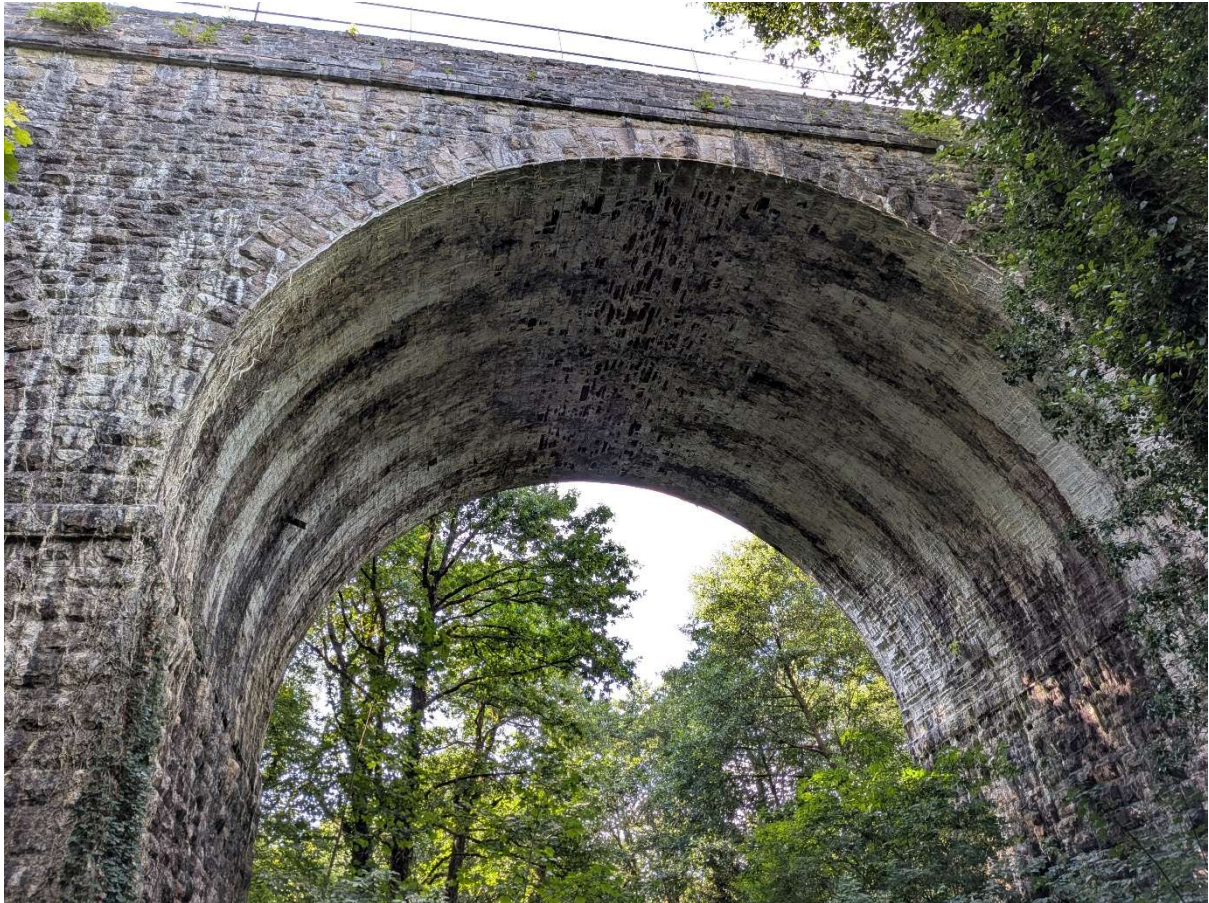
The construction looks fairly standard. All stone, semicircular arches, large voussoirs at the edges of the arch barrel, alternating between single full depth stones and pairs, with the position of the joint varying. The stone between these edge voussoirs is smaller. Basically rubble, but of a naturally slabby stone. That may mean that the bed joints round the ring open to the extrados (top), where they would need to be wedged into position with smaller stones and the voids filled with mortar. The piers are thick enough that the expressed rings don't quite meet.

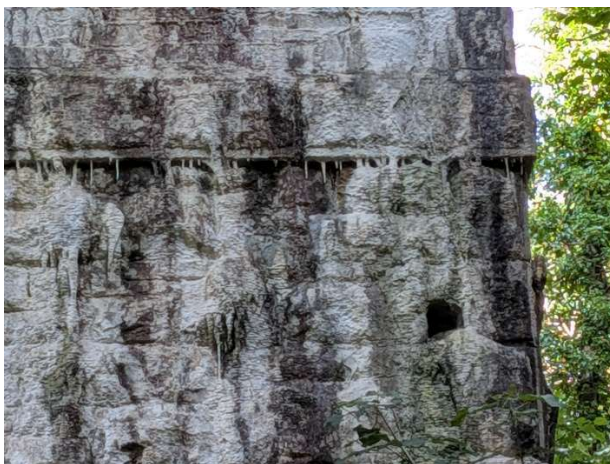
The most striking thing about this structure is how thickly encrusted with carbonate deposits it is. These have layered over and through ivy growth to remarkable effect (right).

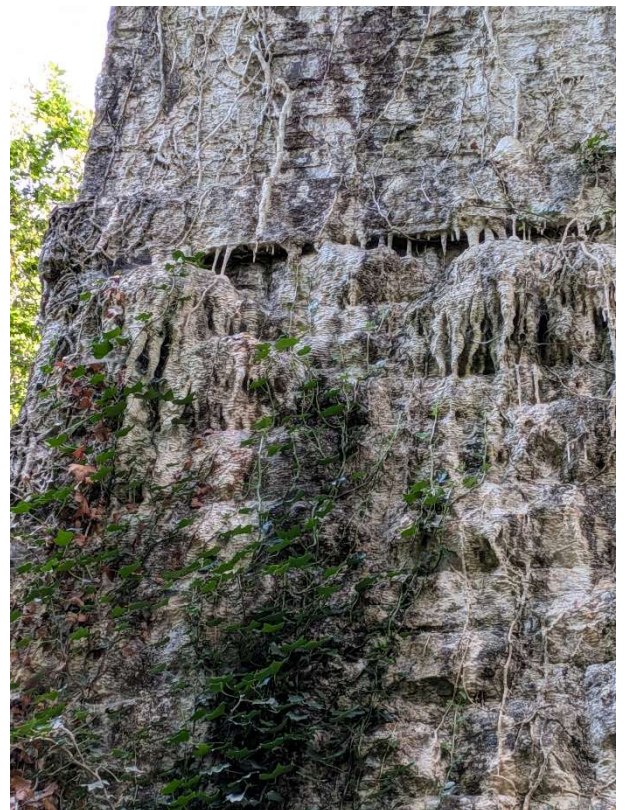
Here and there, where the coating is less total, we can see putlog holes where the centring was supported by “putting logs” through the pier to support centring each side (below).

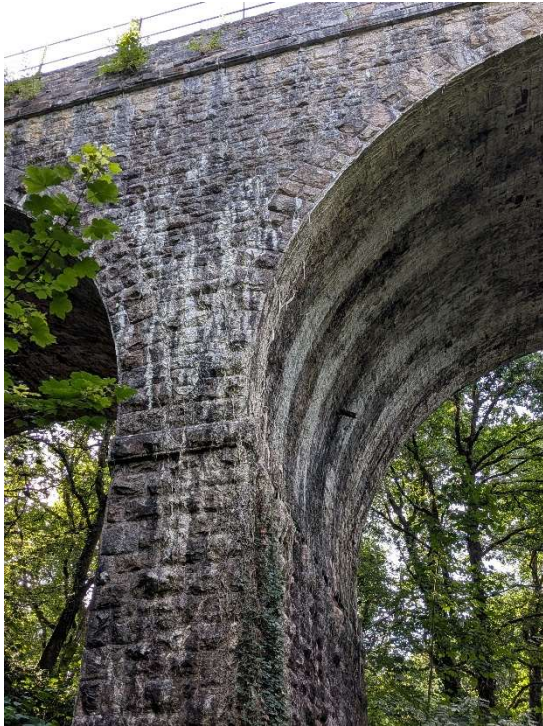
Often, we also see a clear horizontal line in the arch soffit. Here, something quite different is going on. We have very clear striping of the soffit, with lime coating under the spandrel walls, and in four further strips across the width. The gaps between, where there is much less lime, are darker. Looking back up, these strips start just off the crown on each side, and tend to peter out a little above the arch springings.

These stripes are pretty clear evidence of internal spandrel walls. Rather than filling the spandrel – the gap between the arches – with rough masonry up to some level, then soil fill above, longitudinal walls would be built up over the lower, full width masonry backing. Normally these would be positioned such that each rail was directly over a wall. The resulting structure is profoundly different from an arch with fill over.

It's interesting that we have thick white staining under the walls, not in the gaps. The walls, presumably built with lime mortar, provide a source for more calcium carbonate, but I would expect the flow carrying that through the masonry to be greater in the gaps. Perhaps it is: if the flows are high enough, less will be deposited.

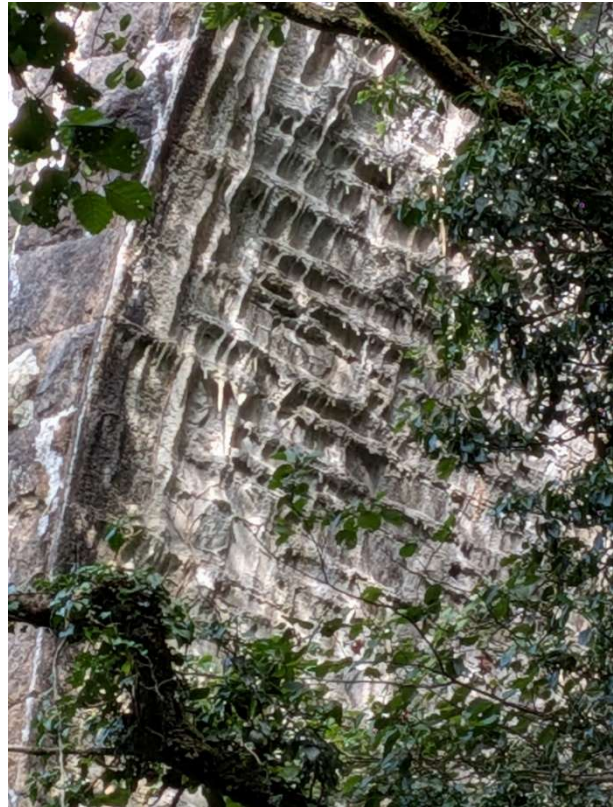
As we left, one area (right) caught my eye. Here we seem to have deeply eroded stone faces with mortar standing proud, suggesting that the stone is sacrificial to the mortar. Not what we would wish. I wonder whether this is original mortar or later pointing. The fact that it stands so far proud may indicate that it is original, as C20 cement pointing is rarely more than superficial.
