Bridge of the Month No 113, May 2020 Lexden viaduct, Colchester.

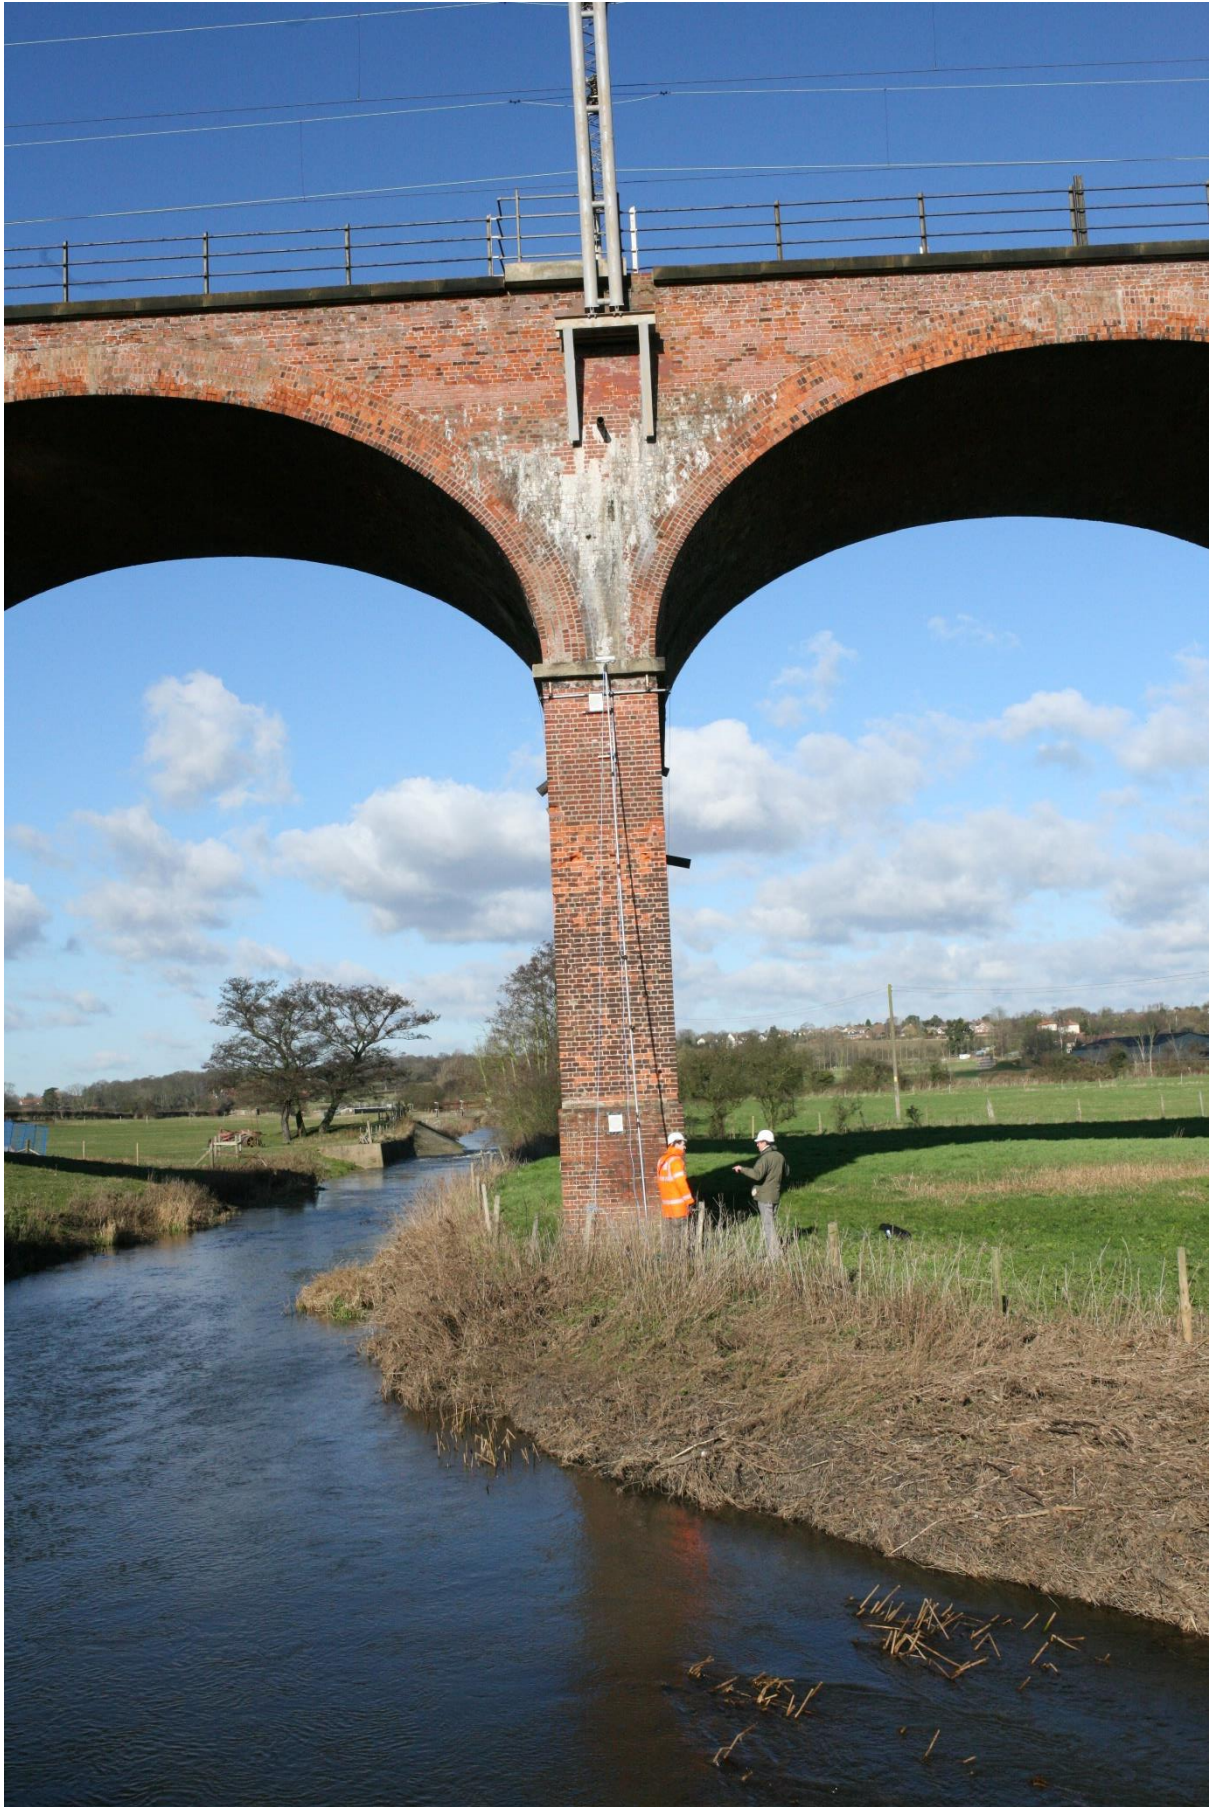
Here is the rig in place, the photograph taken from the location of the video camera. The zoom was doubled with an extra lens and we were able to frame the A4 target exactly from this range.

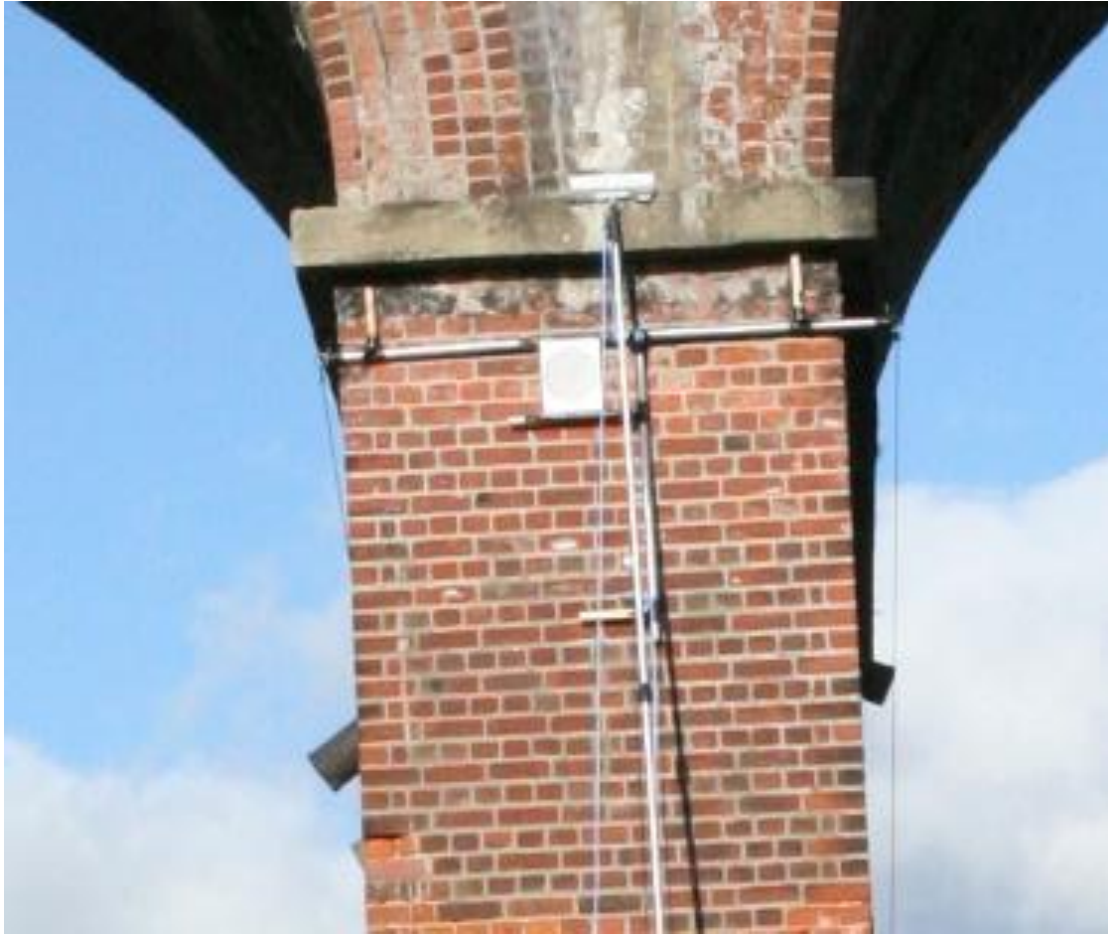
Zooming in close lets us see how that worked. The rings only show as a grey disc because the resolution here is too low.

Once we had captured the video, we left the rig in place and retired to a local café where we processed it to obtain peak deflections left and right and confirmed that they were closely in scale with the effect of a rotating pier measured just above ground level. Only then did we take the rig down. The whole kit was packed up and carried from Exeter and back by train. At least £100k saved to be spent on a more needy case!

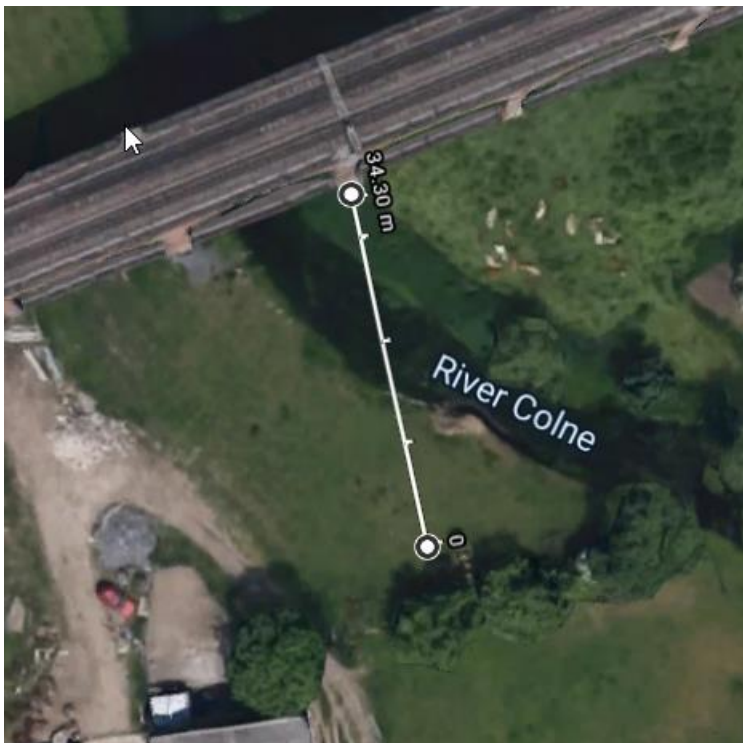
The scale of movement could be calculated directly from the fringes and did not depend on knowing the camera distance, though the distance was about 30 as shown below.
