Bridge of the Month 122. Feb 2021 Monklands Glen, Airdrie

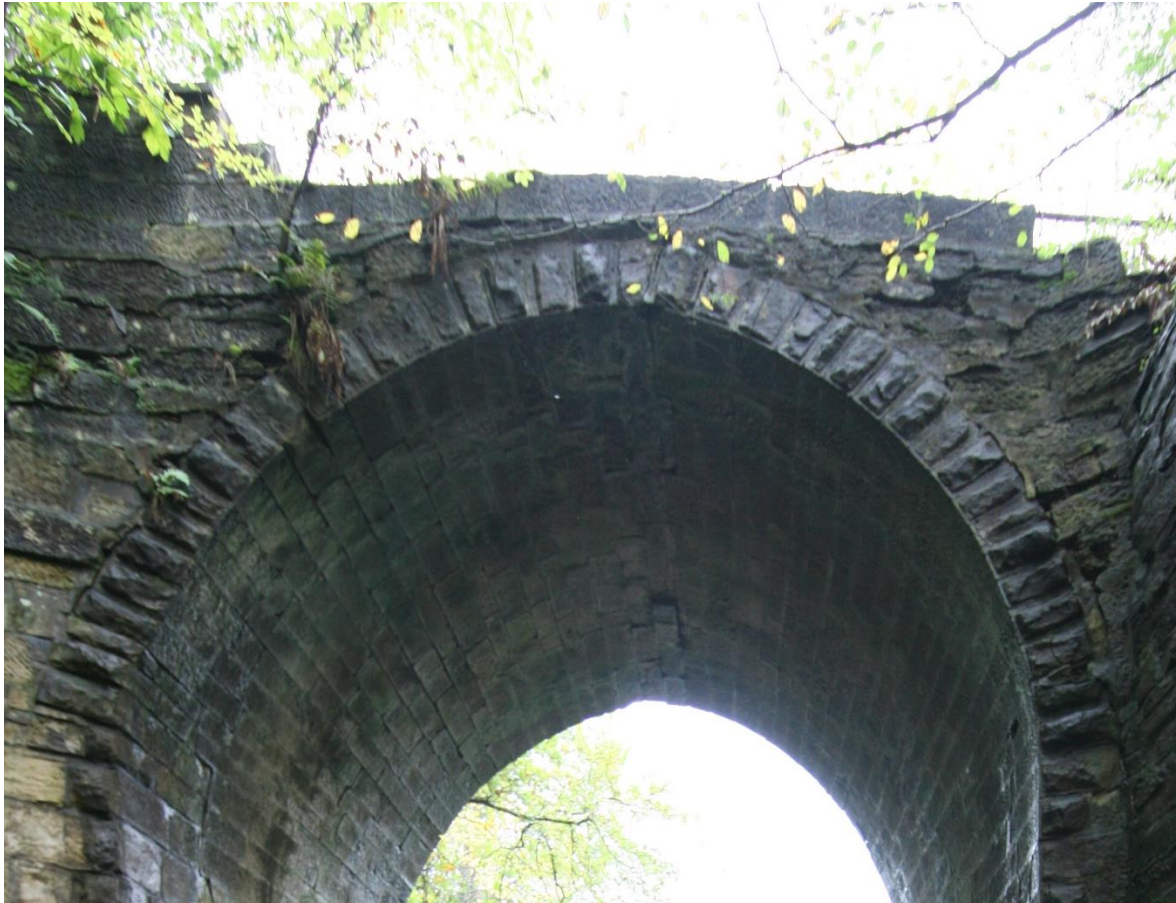
A pointed arch? Not originally, that's for sure. This is on a flood plain, but the river is right at one side against a cliff so the road comes across at high level and has to be approached on a high embankment (to the left in this picture).

Now we can see clearly what is happening. Just to the right of the crown there are two joints wide open at the top. There are two diagonal cracks going up from the arch at the right where the wall has lifted on the arch. At the left, the stones are better bedded and the pattern is rather different.

What I think is happening (if I were there again I would take more photos and get a 3D model to test) is that the arch is humping through the span as a result of the span being squeezed. The edges are held down by the spandrel walls, so there is a hump across the width too. The large stones means that the dome can open certain joints and allow a stone to drop.
