Bridge of the Month 130. Oct 2021 Staward Bridge, Allendale

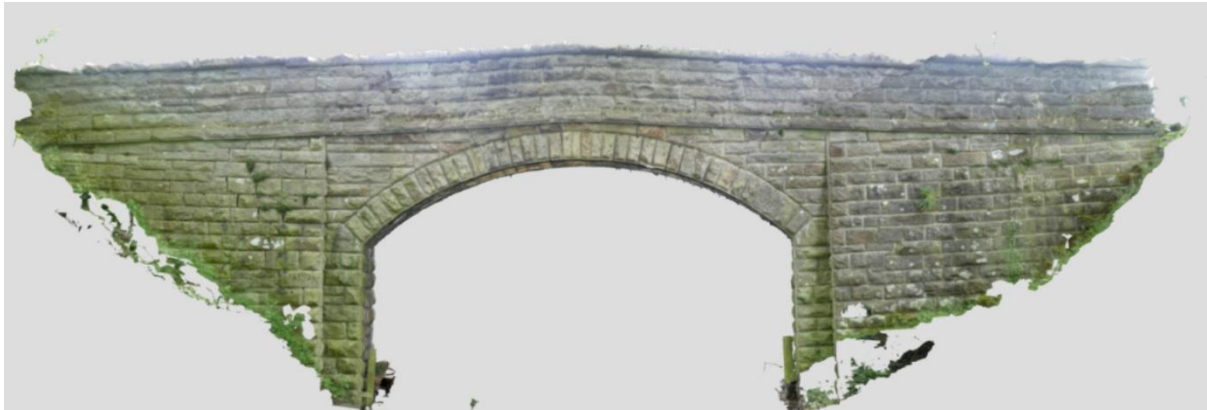
The photographer had written guidance but no training. The result is remarkable, but not perfect, and we must interpret with care. We start with a quick check over the model, something which engineers should *always* do with surveys of any kind, even ours!

The white patches are where photographic cover is limited in some way. This results in large triangles in the model, which we filter out when we produce models, as it is better to have holes than the false appearance of completeness.

We can see that there is something strange going on in the parapet top left of the span and a closer look at that will inform us of the sort of errors that can develop in these models.
