## Bridge of the Month 131. Nov 2021 Clyst St Mary

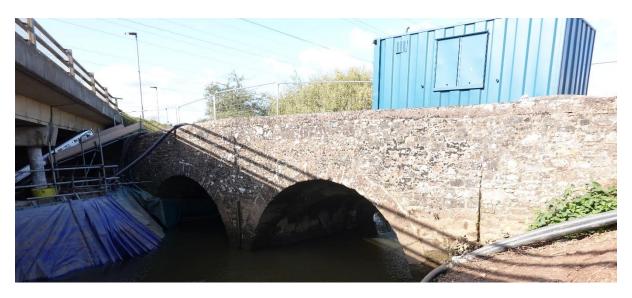
The main course of the Clyst is at the city end (west) where the "new" bridge is undergoing substantial repairs. Note how the new actually cuts across the old. I suspect the causeway continues for some distance under that embankment.
