## Bridge of the Month 133. Jan 2022 Preston upon the Weald Moors

BILL HARVEY ASSOCIATES LTD

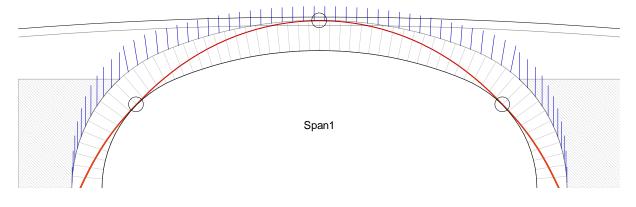
I should also say a little about the shape because it was declared to be an elliptical bridge but clearly isn't. Three centred arches were used over canals because they provided more headroom for the horse towing the barge. It is perhaps worth drawing those two different shapes with the one to four span to rise ratio that this bridge has. First the actual three centred shape.

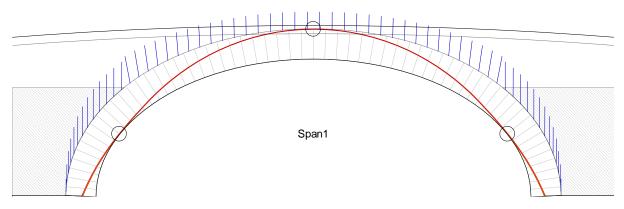
This is what a semi-ellipse looks like.

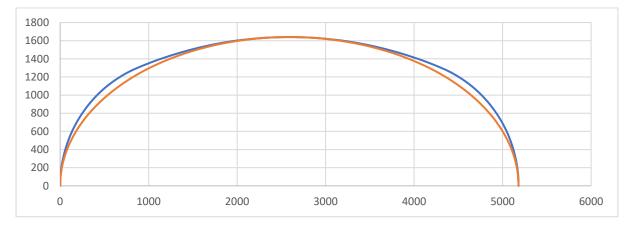
Here are the two curves superimposed.

As you can see the elliptical curve falls below the three centred at about the point where a horse would wish to walk.
