Bridge of the Month 137, May 2022 Great Musgrave

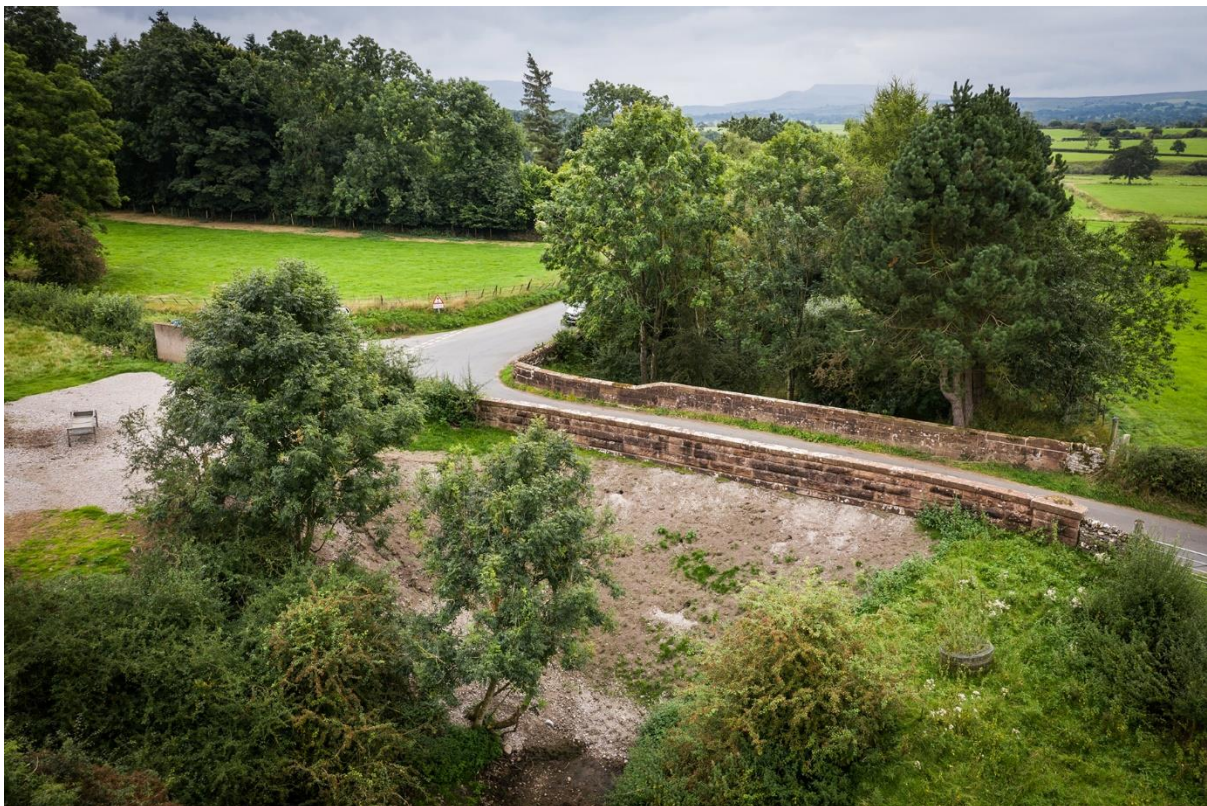
And here is how it looks now.

But there are other issues. There is no possibility that the infill produces an enduring tight fit support for the arch. If the loading, and associated movement, is capable of damaging the bridge, that damage will continue and will manifest in breakup of the pavement. The damage will be impossible to repair.
