## Bridge of the Month 138, June 2022 Melkington

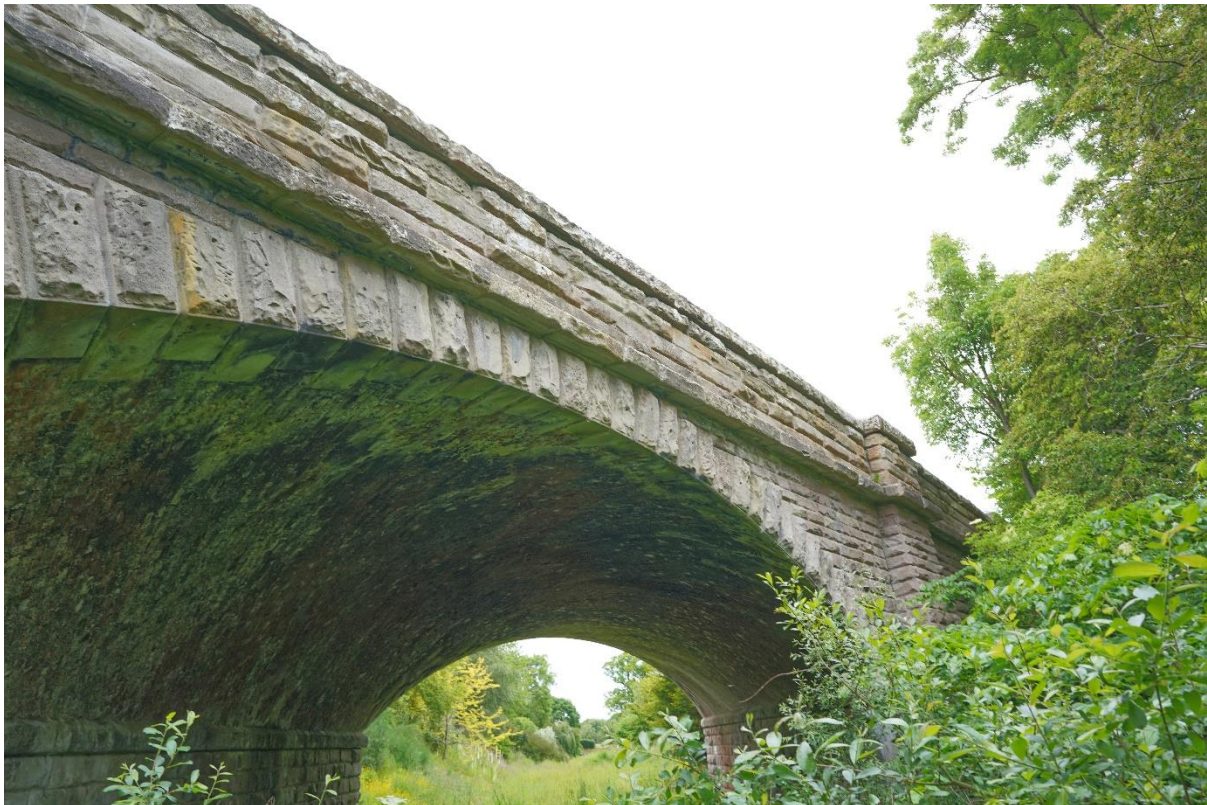
Well, that is quite a turnup. The fill is to be removed from Gt Musgrave. Still, having made a detour to [Melkington](#) to see one of the other candidates for infill, I might as well report on it. The journey north via Coldstream took me on a long-remembered route, at some cost in time. The site is quite overgrown so I couldn't get the broad shot I would wish to start. Here is the best I could do.

Skew bridges, road over rail, are usually built on standard square span centres except when the skew gets so severe that setting it up becomes expensive and complex. If the standard bridges are segmental (as here) square centres will result in a stretched, elliptical skew span. I suspect that this view is showing a squashed ellipse on the square which means circular on the skew.

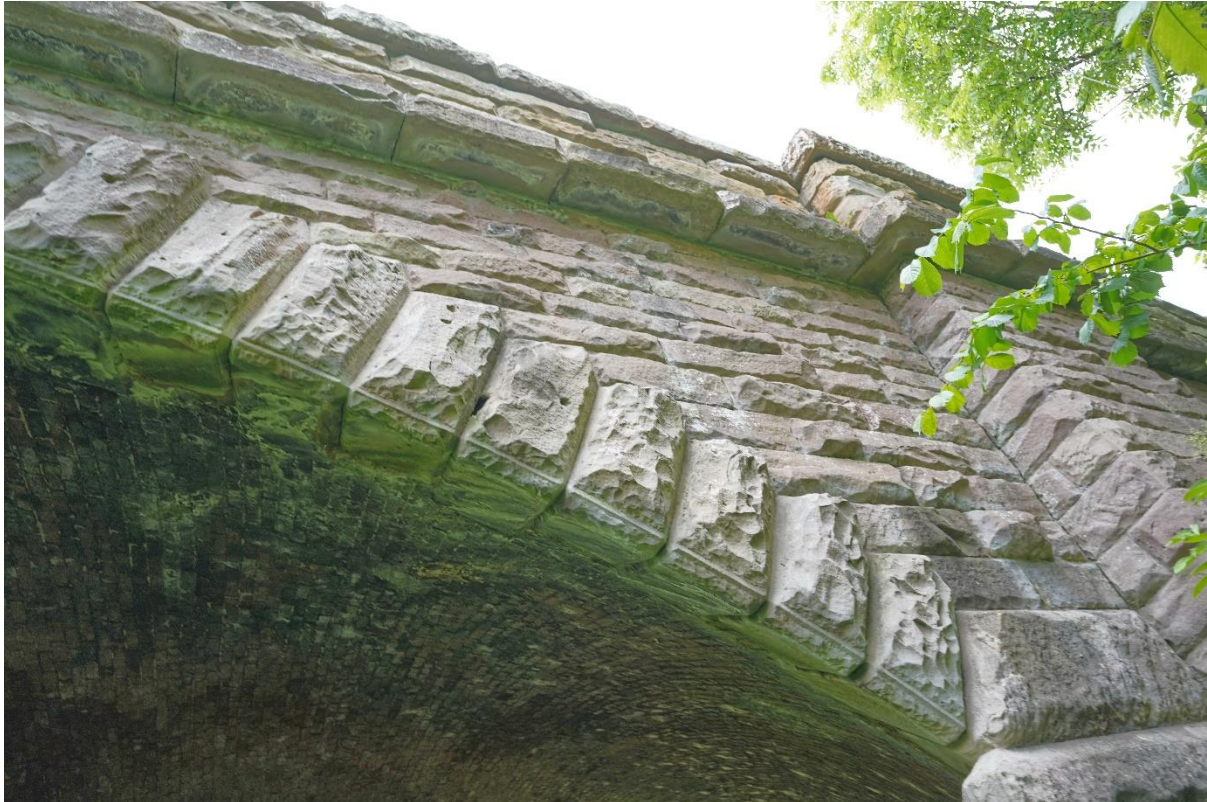
First, how beautifully dressed the stone is.

At the corner above, the skewback naturally forms a solid piece for the arch helix to sit on. At the opposite corner, construction is much more complex, with a double voussoir cut into the single stone.

This picture also shows how the voussoirs project about 25mm below the brick arch. That must have made for some interesting centring.
