## Bridge of the Month 140, July 2022 Aberfeldy

The bridge, full title [Wade's Bridge Aberfeldy](#), was built in 1733, the crowning glory of the military road network built under General George Wade as part of a move to suppress the highlanders after the 1715 rising. There is rather more about the history and construction [here](#).

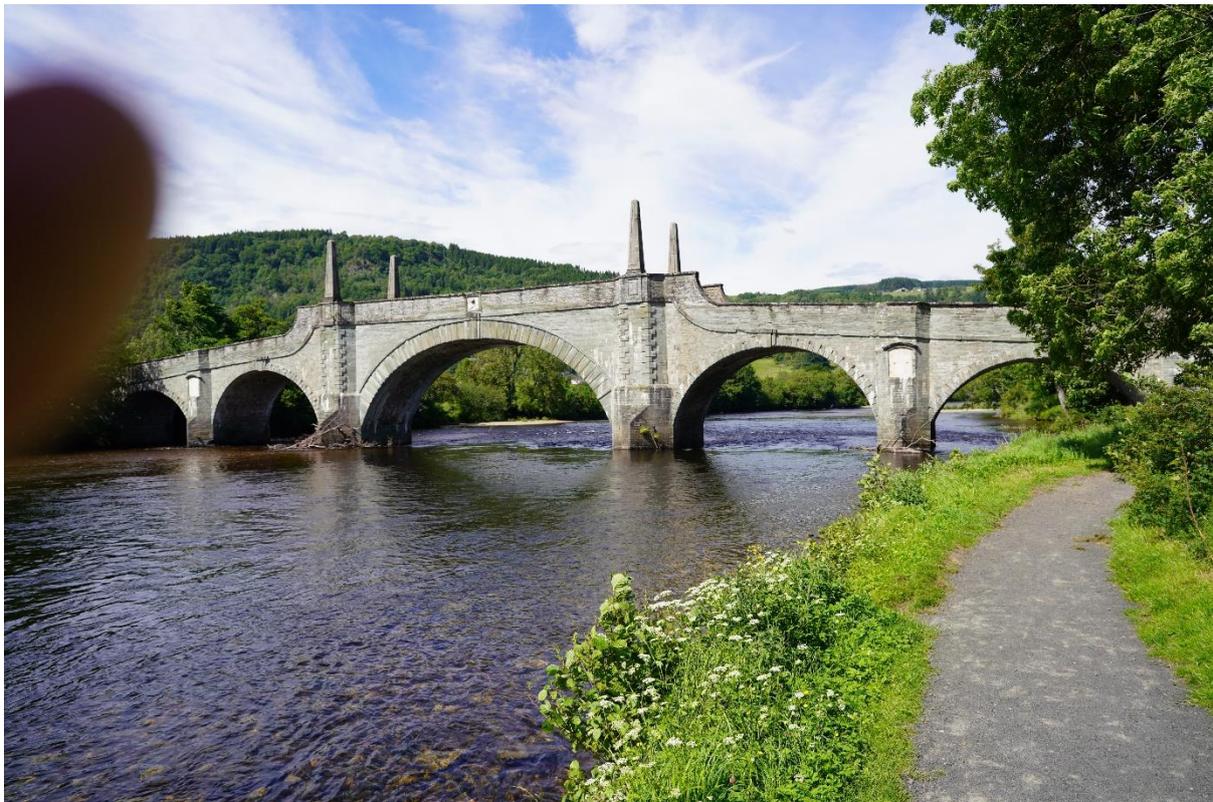
Sorry about the finger. The chemotherapy has left me with debilitating peripheral neuropathy and even taking photos is harder than one hopes. This pic, taken on 21<sup>st</sup> June 2022 is the best upstream elevation I have.
