Bridge of the Month 151, July 2023

Another bridge near West Linton

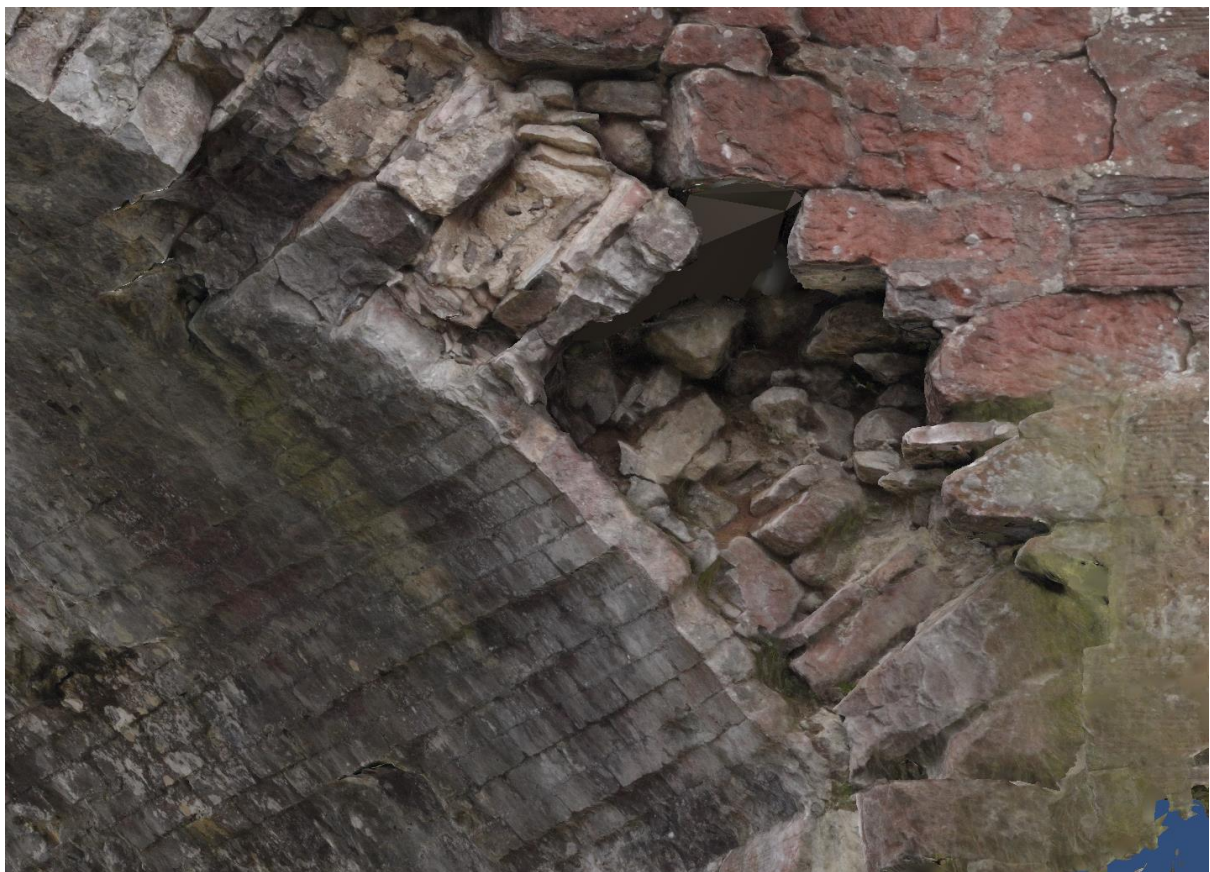
I nearly forgot to include a plan view (above). Notice the unusual plan shape of the wingwalls, with a sharp initial flare than a more gradual widening. To encourage recalcitrant cattle into the gap?

The flare closest to the bad ring damage is cracking (right).

There is no sign of it at other corners, so this is probably just a consequence of the nearby movement and loss of support, but plan shapes like this are prone to damage that doesn't normally affect masonry bridges too badly. Recently I've seen damage in a step in parapet – sharper than this one – and outward leaning wing walls that I suspect are driven by cyclic movement causing ratcheting effects.
