Bill Harvey Bill Harvey Associates Ltd and OBVIS Ltd

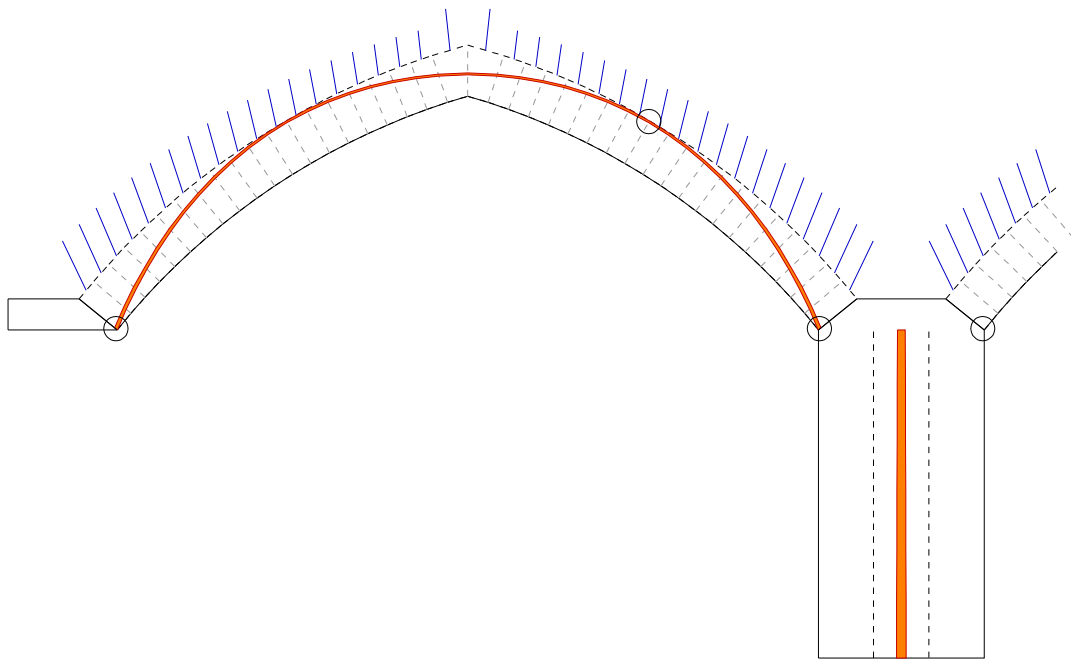
Next comes a stepped course, broken at the water spout but with a make up layer on the near side.

From there down, the courses seem to continue through the pier but break up and stagger to this side of the spout.

It looks very much as though this pier has partly failed and tilted a little. Whether that was caused by loss of the span or whether the span simply distorted to accommodate it, the outcome is a distorted arch and a patched spandrel. The fact that the pier does not seem to have settled suggests that the span might have been lost and the pier tilted before it was restored. However, the shape of the arch itself and the mortar loss in the ribs around the quarter point might point to the arch remaining in place but distorting substantially.

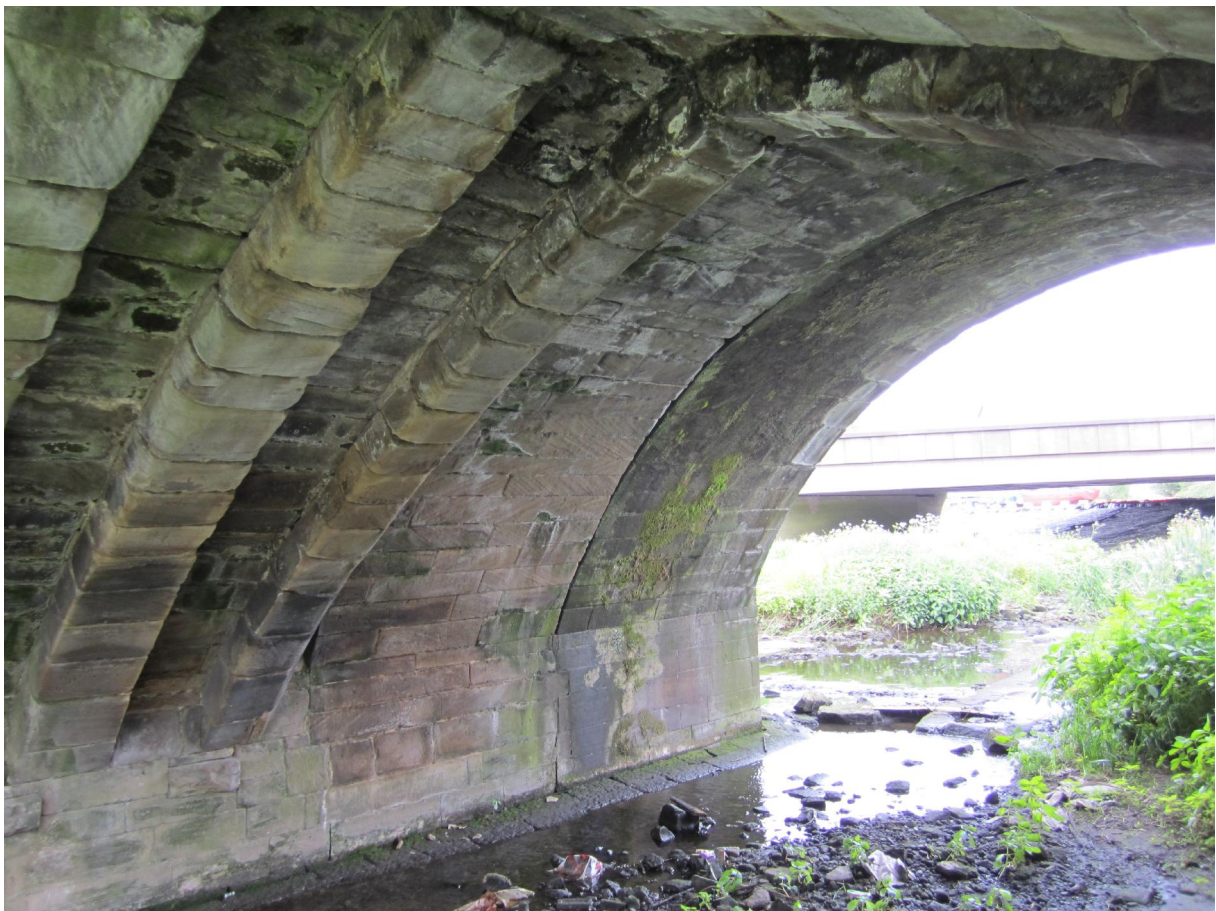
The picture above shows corbels (some broken off) for support of the centring, though it is hard to see why they would be necessary on such low piers. The fact that they do not line up with the ribs raises further questions! Below, it is easy to see how the widening was accomplished. On a closer look, both above and below, the river bed seems to have been paved. No doubt this would provide a good deal of protection against scour, but it would have been expensive and quite difficult. It is probably 18th Century work.

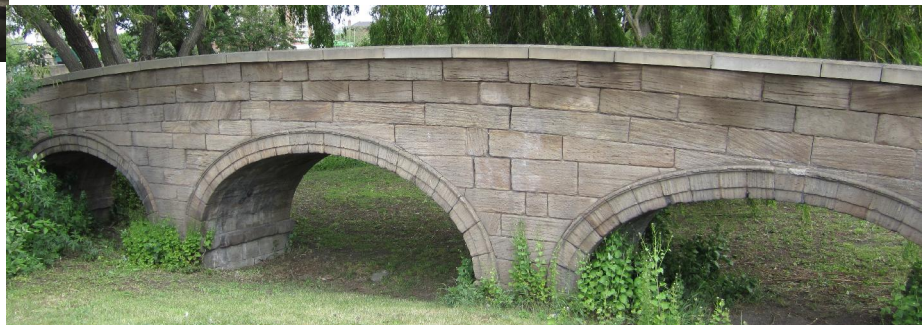
And having said Wakefield Bridges I had better include one shot of the 18th Century "Pack Horse Bridge at the south end.
