Bridge of the Month, November 2013 Bargower Test

Bargower test bridge

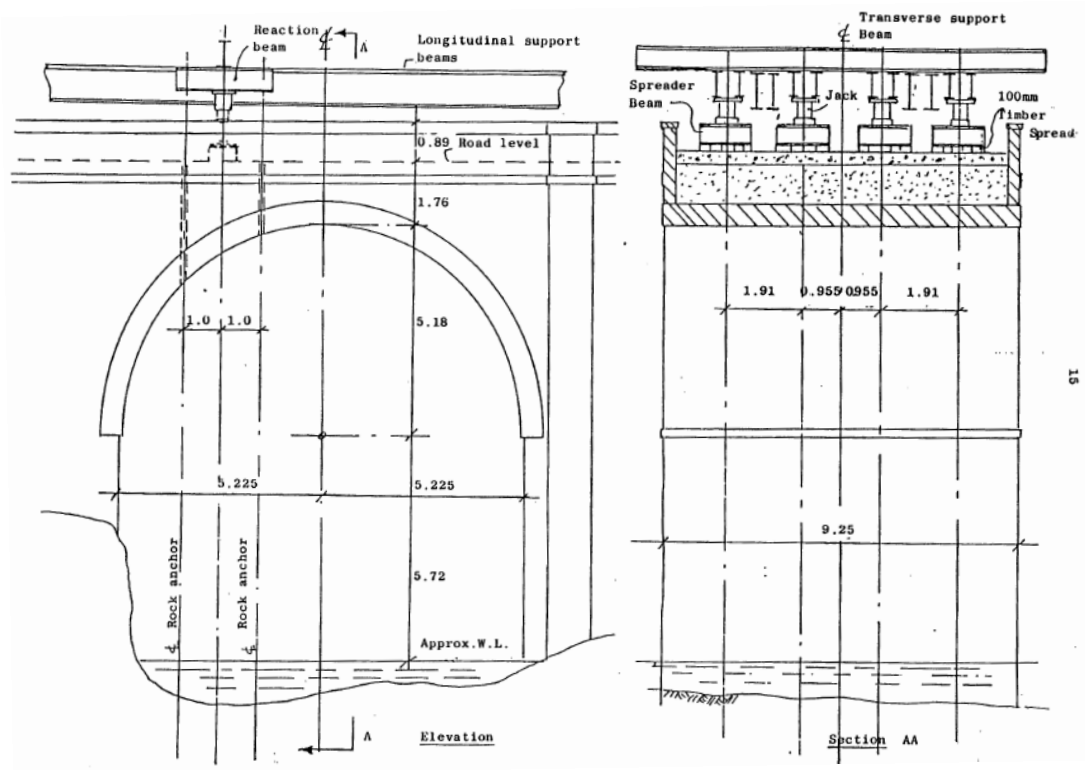
A further sketch shows 54 voussoirs round the ring, giving a width of almost exactly 1ft in the intrados, which seems sensible. The tabs in the photo above are survey targets for displacement measurement. The one to the right is near the crown, that to the left about 7 voussoirs away, which

would mean roughly at the quarter point. Since the spandrel isn't painted, this is the East side, so the same view as shown below.

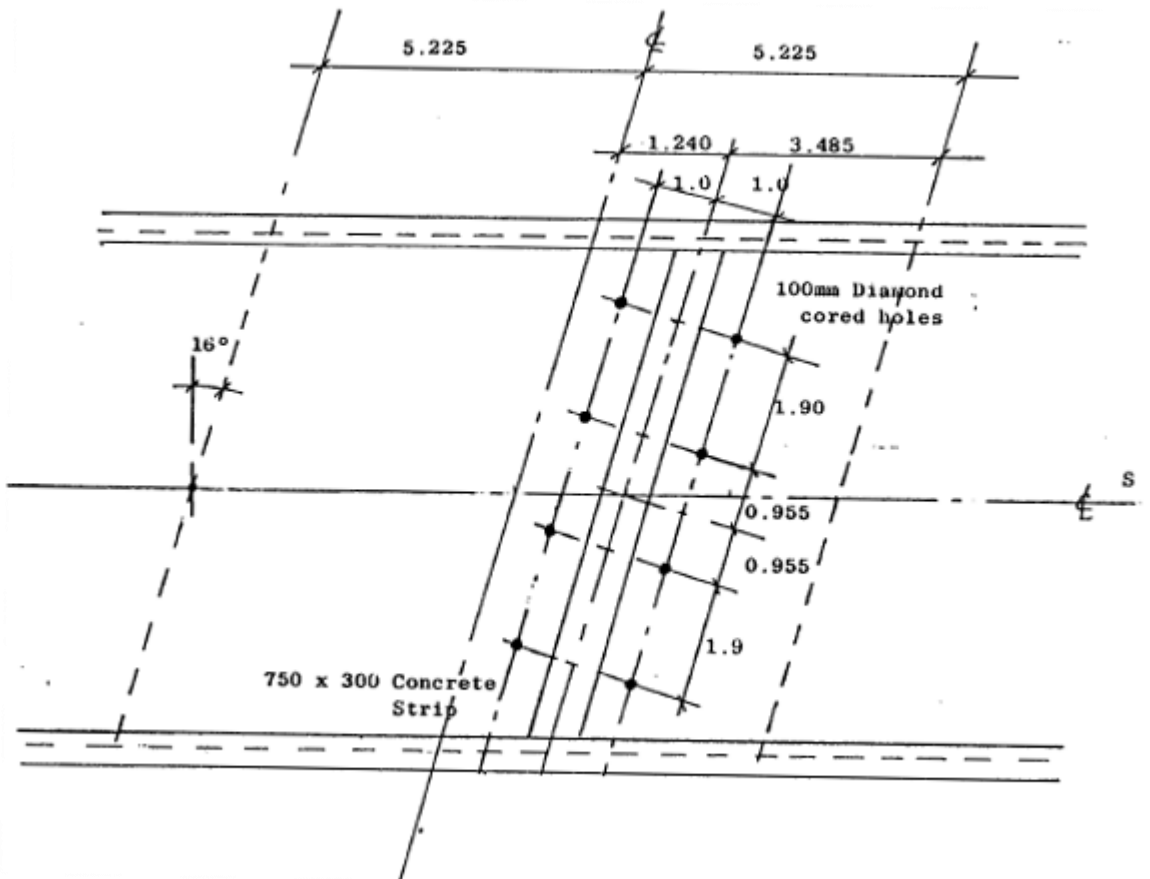
A very simple analysis says that the arch should be able to carry about 840 tonnes. Though that would depend on the material strength used. But the structure didn't fail as a mechanism anyway as we will see.

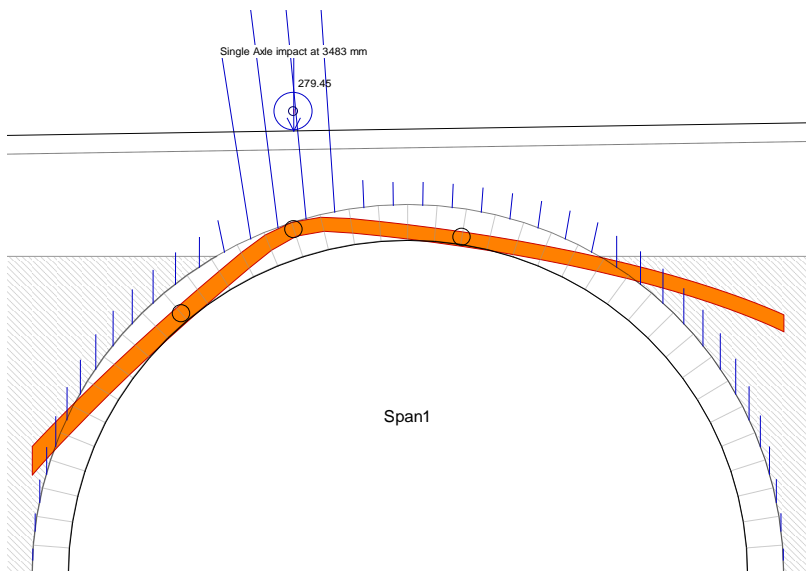
The picture below shows the bridge damaged beyond repair but before failure. At this distance, it remains uncertain what the load was at this point. However, it is clear that the arch proper is carrying a considerable amount of load. There is a visible crack stepping between the inclined voussoirs, somewhat towards the crown from the load. There is also some crushing to the left of the crown and near the right hand quarter point.
