## Bridge of the Month No46, October 2014 Clopton Bridge, Stratford-on-Avon

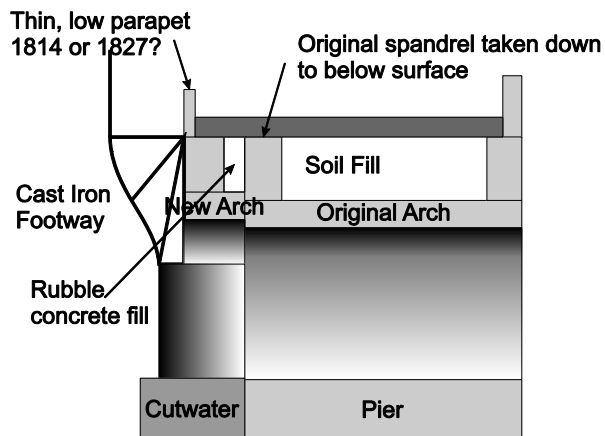
The arch was added in 1814, with the pedestrian refuges removed to make room for them. Then in 1827 a separate pedestrian space was made by adding a cast iron cantilever. The cantilever brackets are tied right through the stone bridge with pattress plates and nuts on the downstream face.

This is the same span viewed from downstream showing the anchors for the cantilever footbridge. Notice also the dramatic change in weathering at crown level. This suggests that the piers are full, not of soil but of something in the range from concrete to masonry.

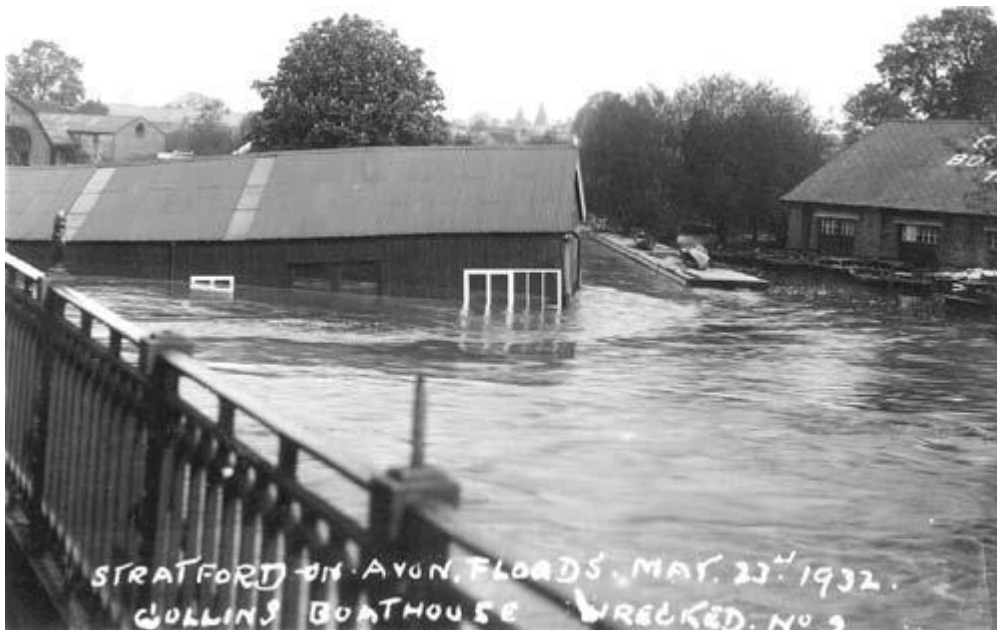
The river floods deep and often, though rarely as deep as in this 1932 postcard looking upstream to the Stratford side.

Even when running full, the water does not reach the crown of the arch except possibly at the upstream edge. As a result the lower reaches of the stonework are scoured clean while the crown gathers dirt.
