Bridge of the Month No 55, July 2015 Manton, Nr Rutland

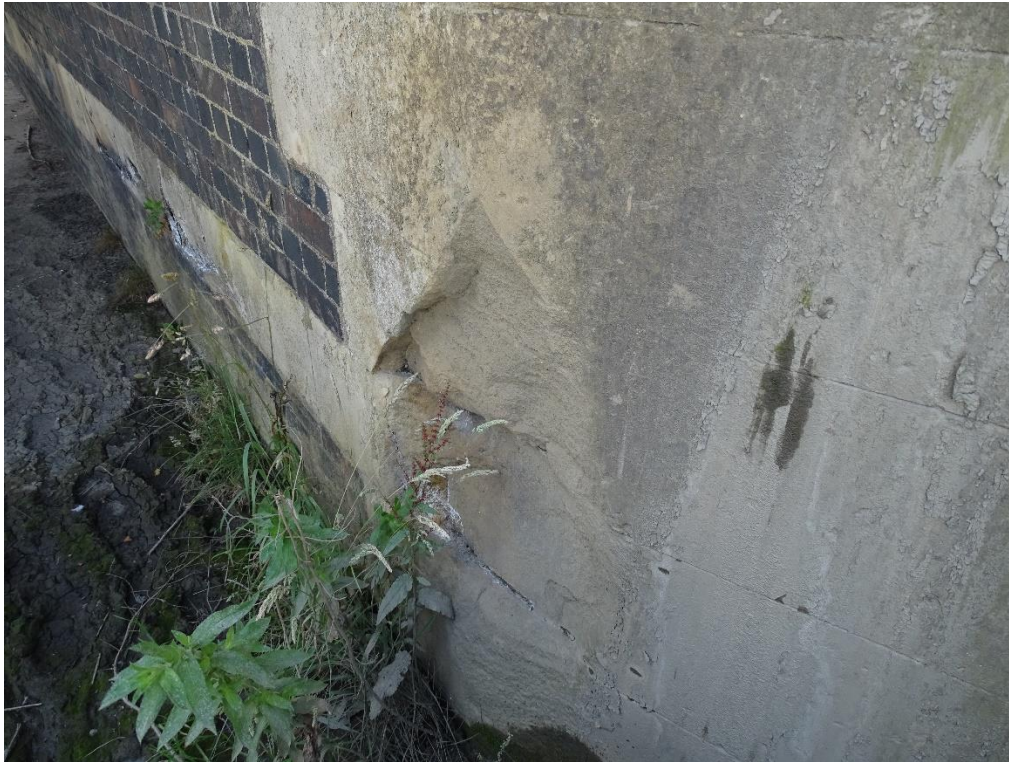
I think we can assume that this damage is caused by the water/mud rather than anything substantial structurally wrong.

While that below, though clearly close to the water supply must also be influenced by stress.
