Bridge of the Month No72, December 2016 Moco Farm accommodation bridge 3

Bridge details

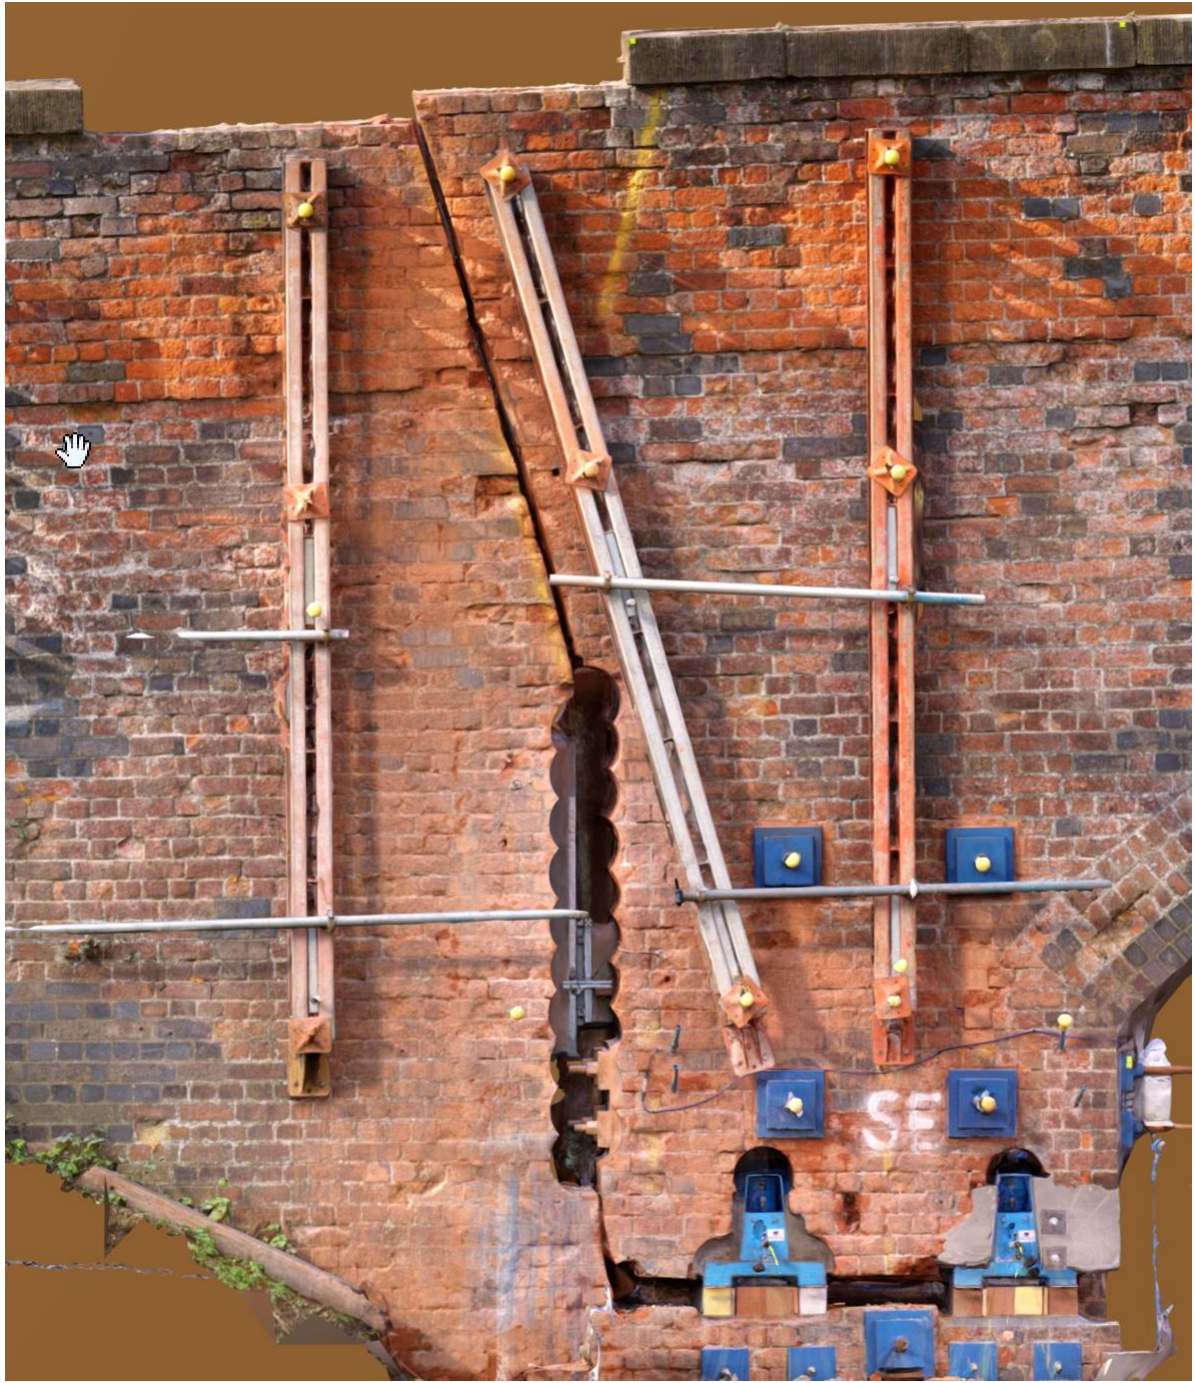
Ahh, but just before I go. I was asked for a better picture of the bearings to show how they relate to the structure as a whole. I think that this the the best I can offer. Its from a 3D model created by Hamish
