Bridge of the Month No75, March 2017 Twemlow

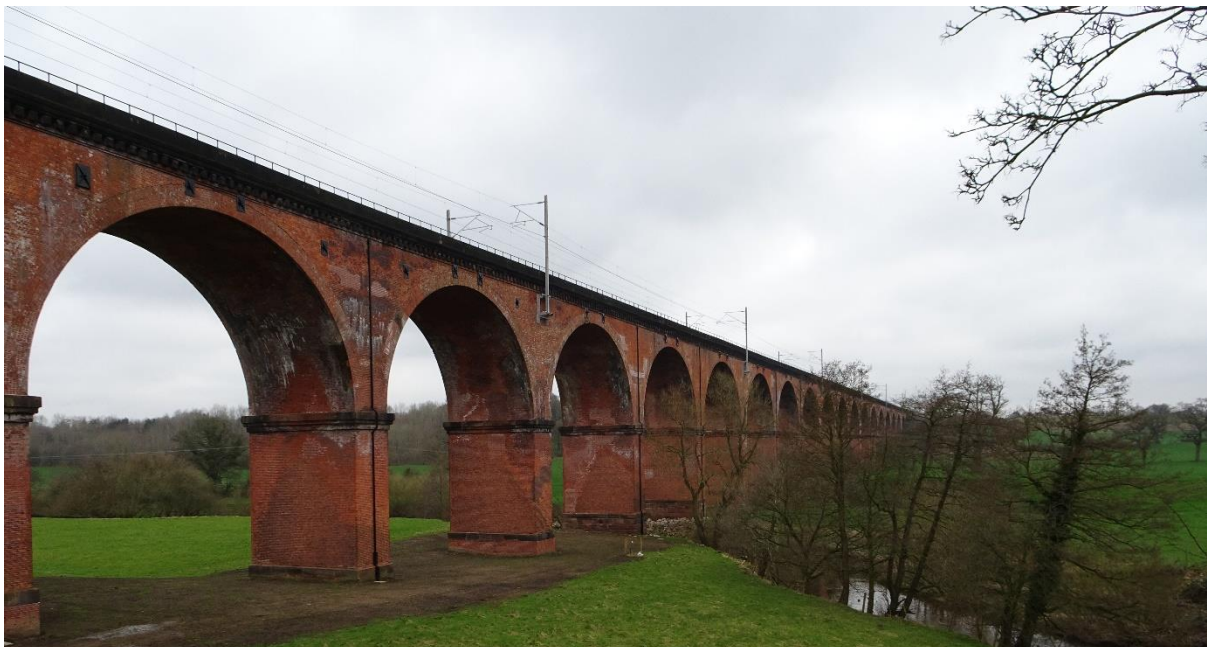
The first thing to note is the stable it comes from. Same line, same engineer as the famous Stockport viaduct but with the advantage, from our point of view, that it is a bit lower (so accessible) and hasn't been widened. You will find it [here](#), just outside Crewe. As you can see below it is substantial.

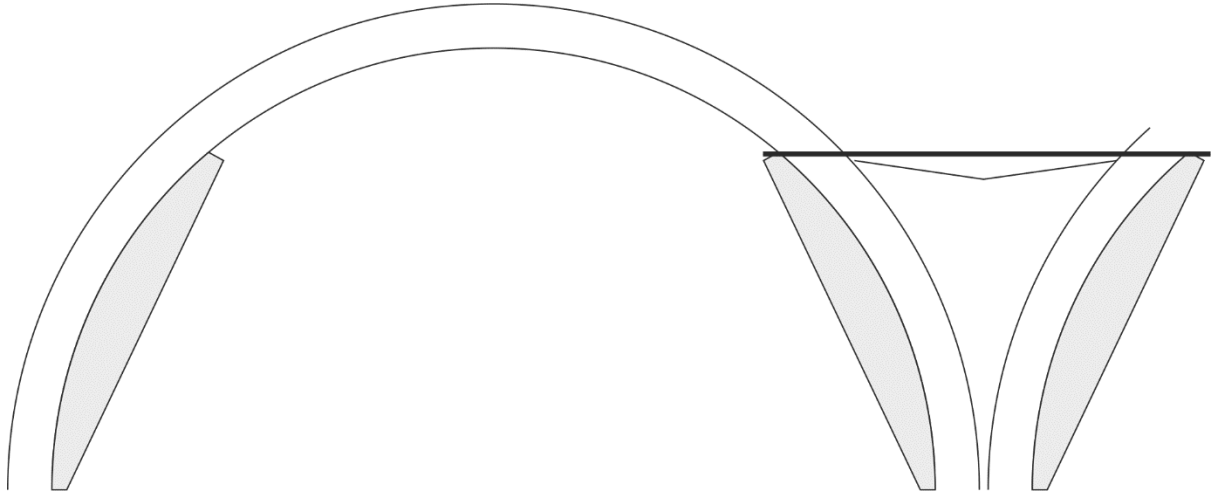
63ft spans (which these and Stockport are) are large and demanding of centring. Twemlow, being lower and in a rural setting, might well have been a warmup, with the centres reused for Stockport when it got up to level. And the 30ft radius here is really quite close to what I assumed on the viaduct through Manchester, so just possible they were cut down. Or even, that for these large semi-circular arches pier stability was greatly enhanced by building the pier section between light centres simply tied at the top, in which case 40ft span centres would naturally be immediately available.

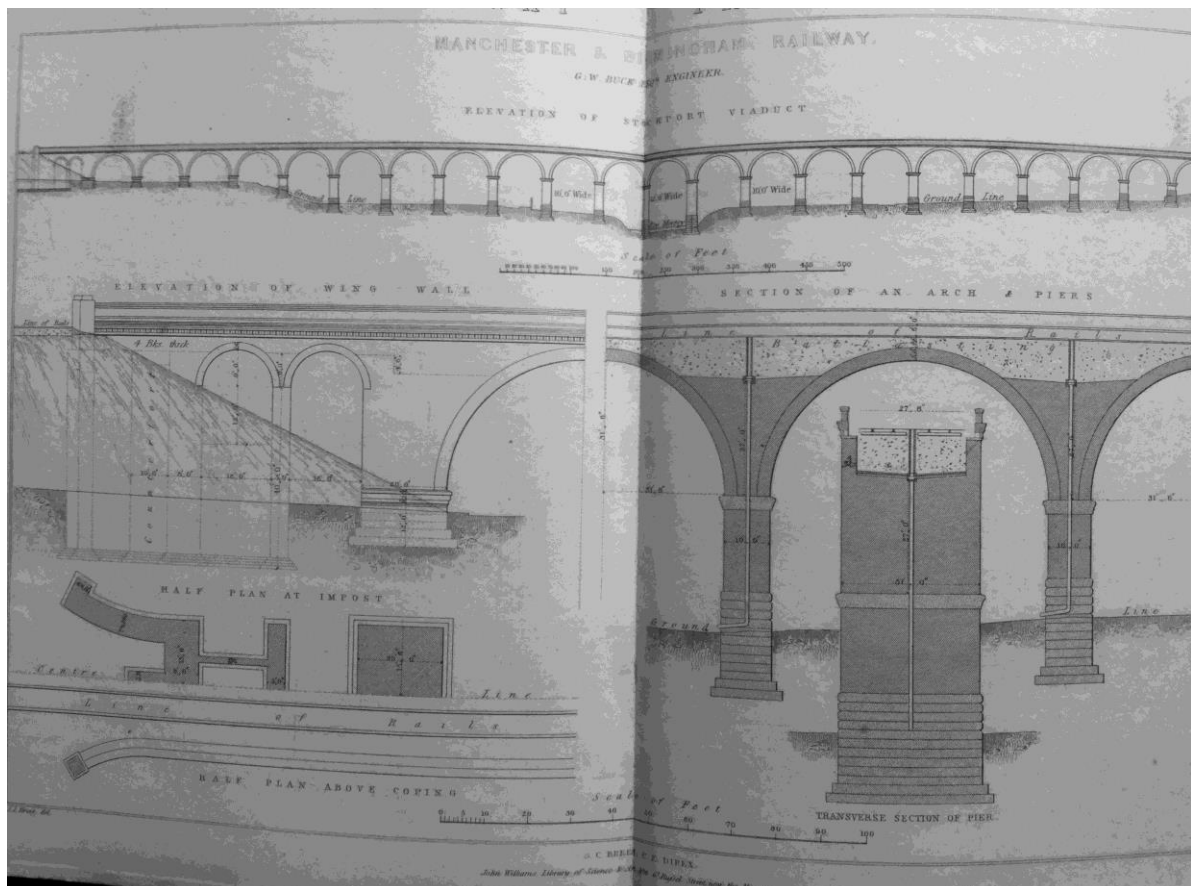
Now back to that second picture. There is a lot of water coming out from the brickwork above and below the stone plinth. We can sensibly assume that the plinth doesn't go right through and that the

water is therefore coming down through the brickwork. Buck took his backing to about half depth As shown in the sketch, and sloped it down to the centre of the pier where a drain ran down to ground level. On the drawings he shows a larger pipe running up to the surface to allow the drain to be kept clean. I wonder whether those have been buried?
