## Bridge of the Month No81, September 2017 Railway Viaduct Nr Todmorden

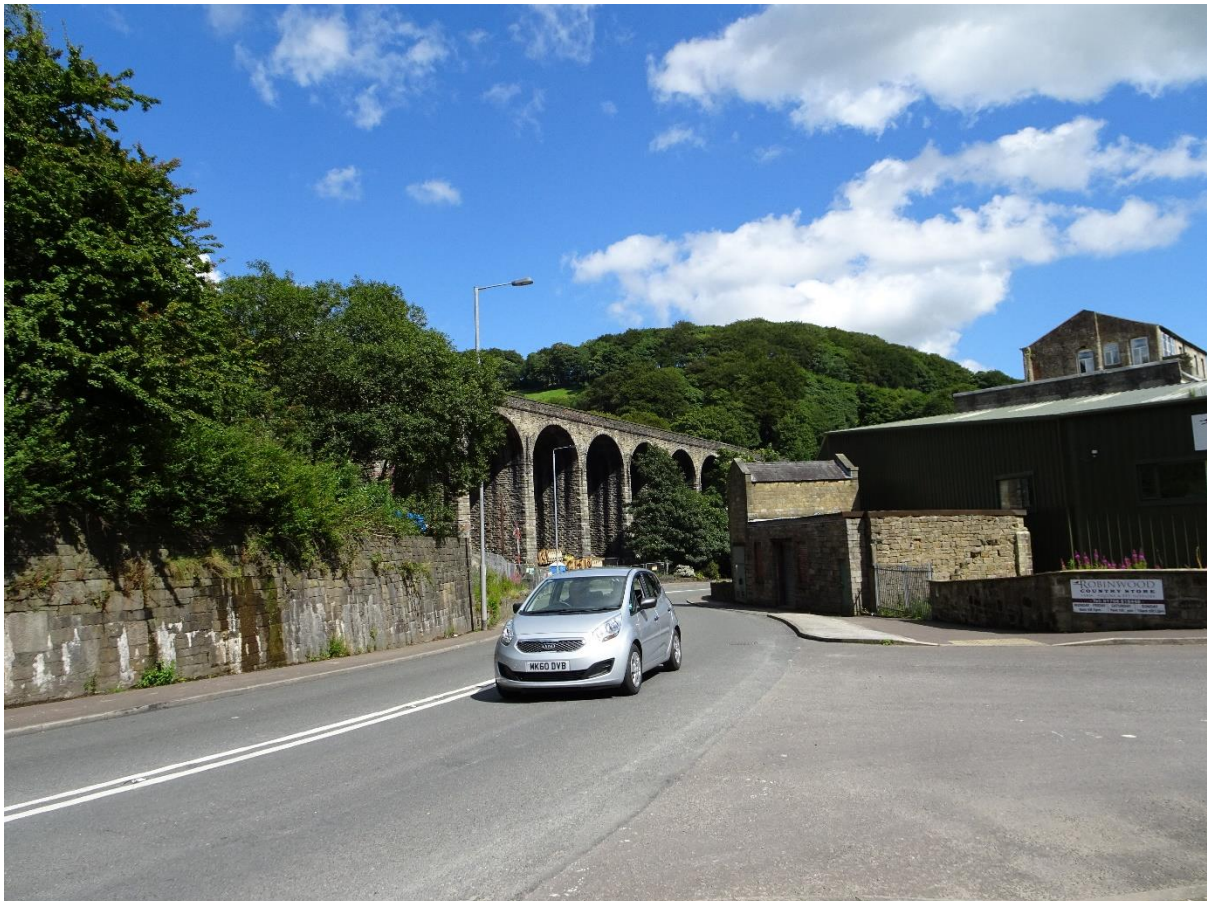
At the end of August, I had a couple of days at the Scottish Lime Centre in Fife. One bridge from there has already featured but I took the opportunity on the way north to stop by in Cornholme to look at a very skew bridge I had interacted with through Archie-Help some years ago but never seen. Just a mile before that I was brought up short and suddenly pulled off the road and parked [about here](#). In this picture, you can't see why:

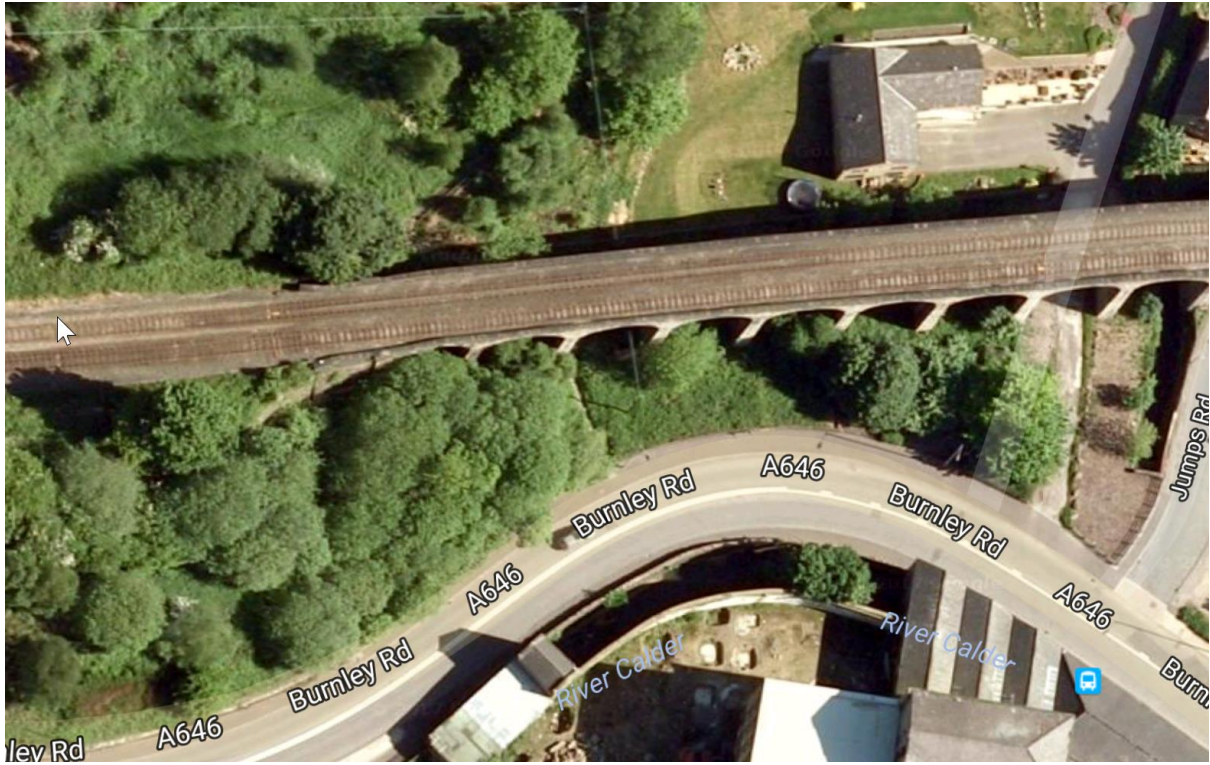
And what does that reveal, timbers between those steel rings, but much more significantly, look how the shape of the rings changes from sharply pointed at this side to a smooth curve at the far side. The abutment has rotated in plan, not just slid down the slope. I think that kink is visible here in the Google Maps satellite view. You can also see why it might have happened, with the abutment perched on the steep end of a spur.
