## Bridge of the Month No85, January 2018 Dean street, Newcastle

BILL HARVEY ASSOCIATES LTD

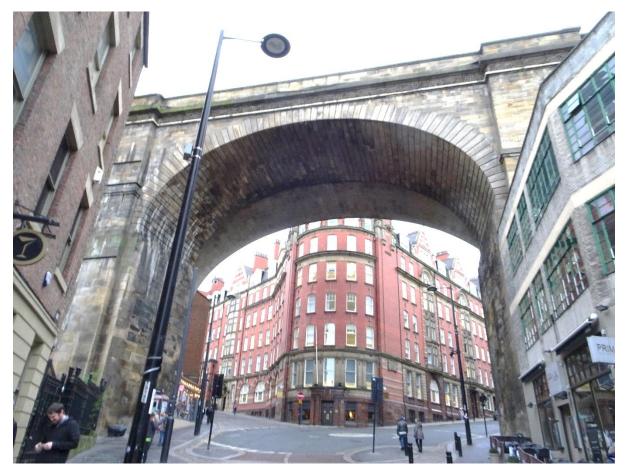
This is actually two bridges for the price of one. The original (1848) is of (local?) sandstone and must have carried the two tracks north from Newcastle station on the way to Edinburgh.

It must have been quite magnificent when new. It looks to be semi elliptic. There is a nice photo <u>here</u> from high level which also shows the approach viaduct.
