## Bridge of the Month No86, February 2018 Kohukohu, New Zealand

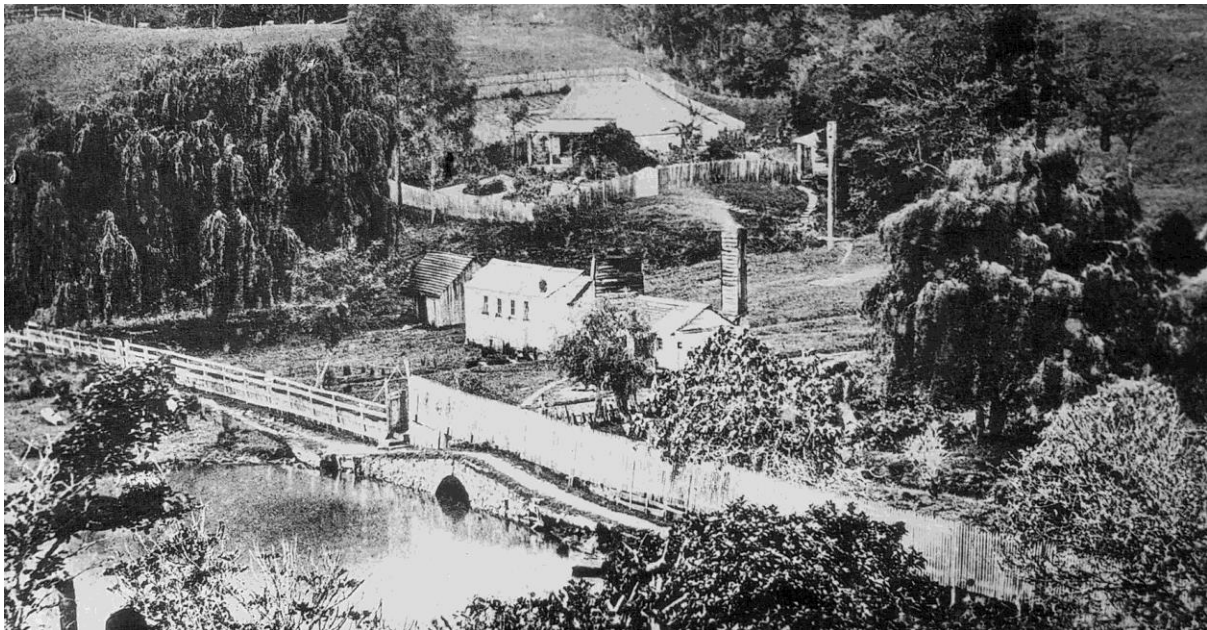
Location first: [Kohukohu](#) is on the north shore of Hokianga Harbour. Start by zooming out on the location and appreciate that. Liz and Pete's farm is [here](#). The bridge itself is now wedged [between the school and the bowling green](#) with access along the stream bank from the main road. It wasn't always so wedged as this photo from 1860, taken from the display board, shows.

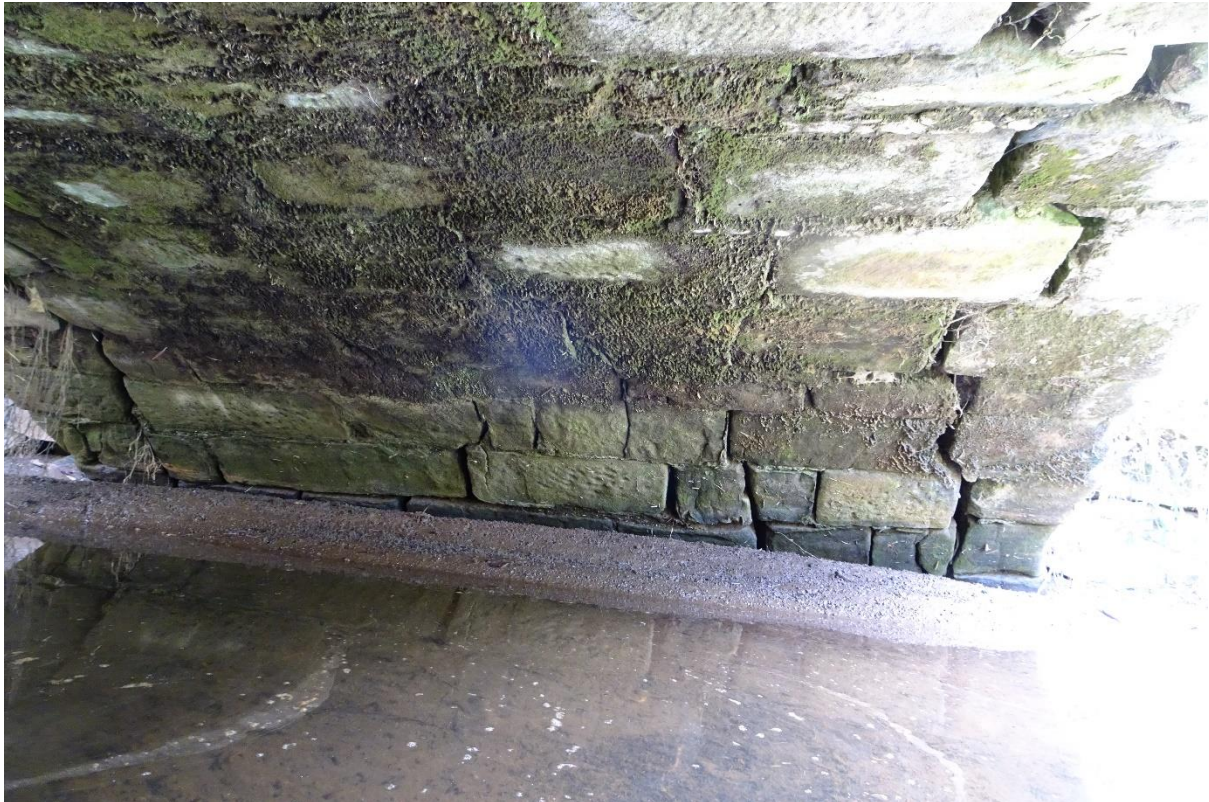
By extending the pole under the bridge I was able to get a good view of general condition and some useful details.

Here we see the northern half of the arch and it is immediately obvious that the curve continues into the silt. There is a substantial crack/joint opening at both edges, the right hand (downstream) one is most visible. It is much wider at the crown than at the end and moves steadily out towards the edge at the end as well. This is surely caused by pushing out from the crown.

Note also that there is a second crack about 500mm in from the edge which is closed two stones up from the silt and quite wide by silt level. This is surely caused by foundation movement, with the edge being held up on slightly firmer ground or having some form of bigger foundation. It would be interesting to know whether this very soft ground was piled to support the bridge.
