Bridge of the Month 114. June 2020 Bowland

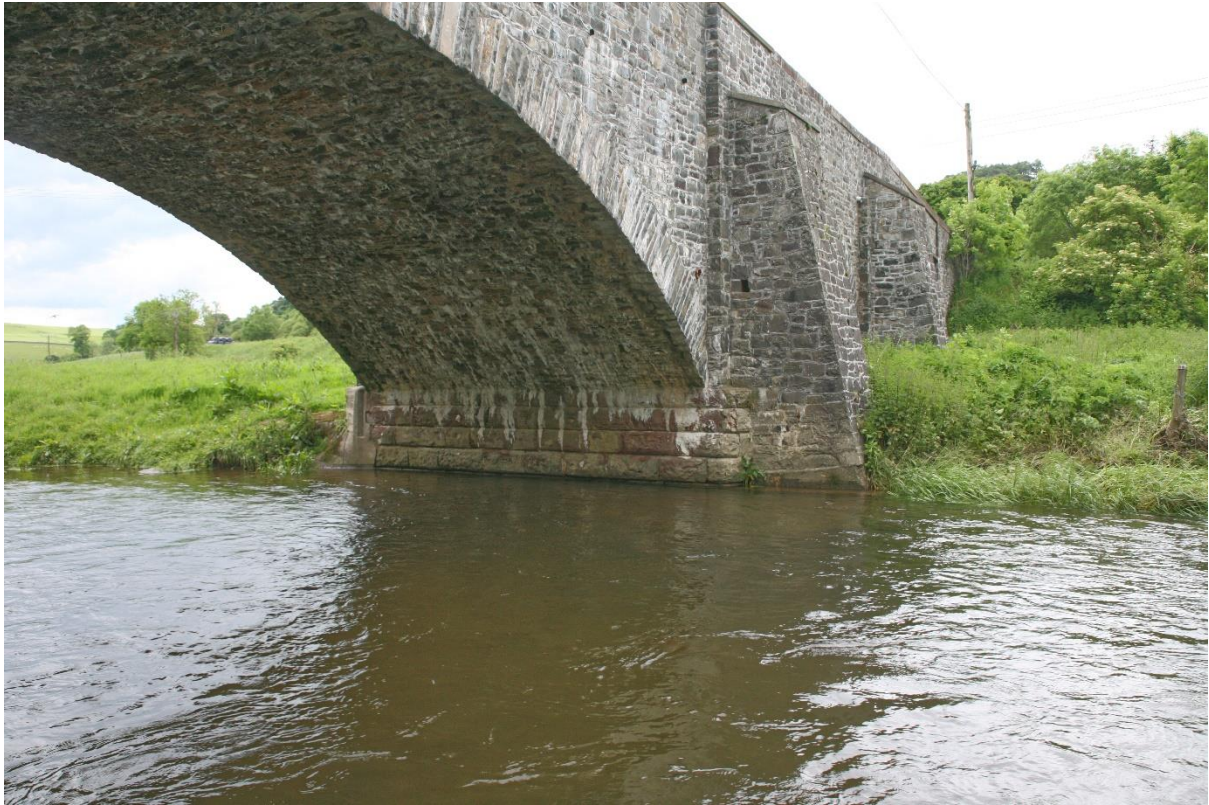
This shot from below barely shows the soffit but provides an opportunity to shout out for Affinity Photo which has amazing powers of enhancement. See below achieved in three keystrokes.

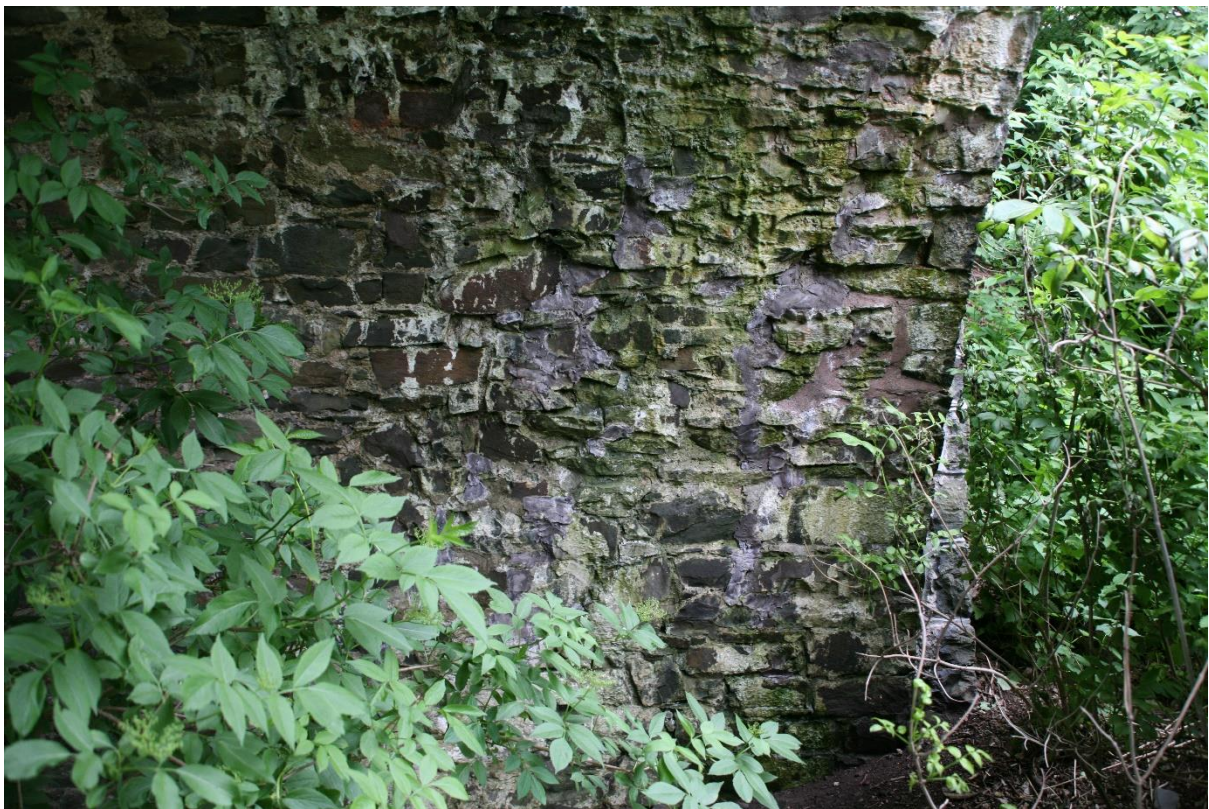
Here is one of the flatter side spans.
