Bridge of the Month 144 December 2022

Rugley

AKC/99 Rugley Railway Bridge is part of the Historical Railways Estate, a collection of structures on disused railways now managed by National Highways, and subject of considerable press coverage in the last year or so. I was visiting friends near Rothbury in the Christmas holiday and took the opportunity to take a look.

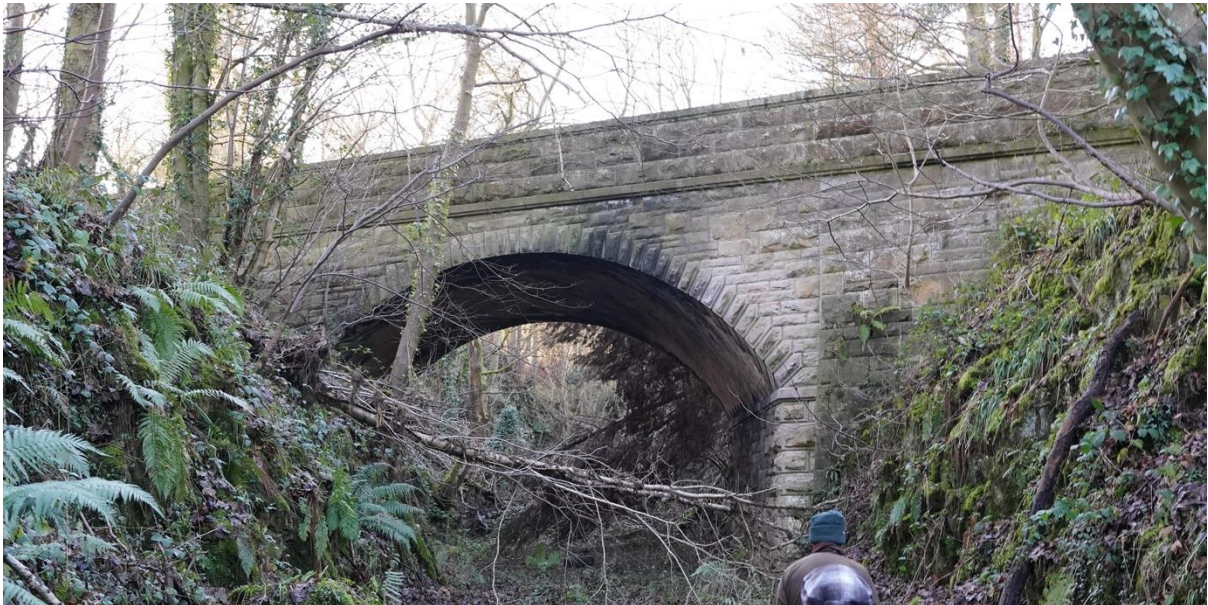
The bridge is near Alnwick. The railway here runs in a cutting through rock. The cutting is only wide enough for a single track, but the bridge is wider, first impression is that it was built to allow twin track, perhaps because a modest additional cost kept the option of later widening open.

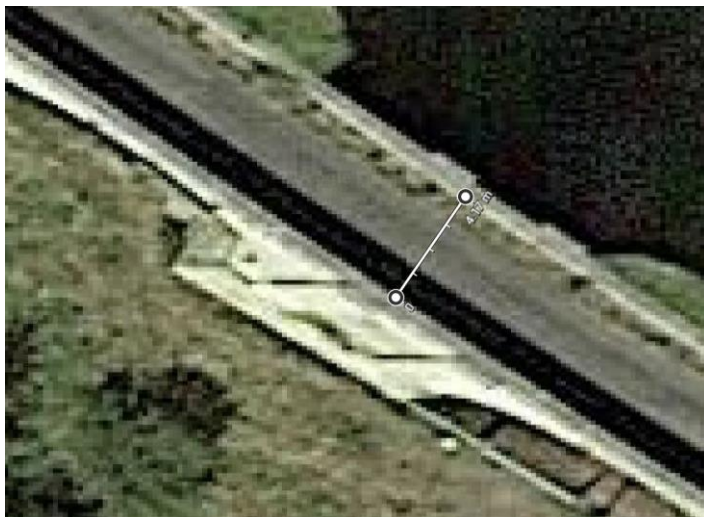
Following the winding course of the line away from Alnwick, we come to Edlingham viaduct, which in Google Maps measures around 14ft between parapets. So there were limits to the amounts the railway were prepared to pay for this future option.

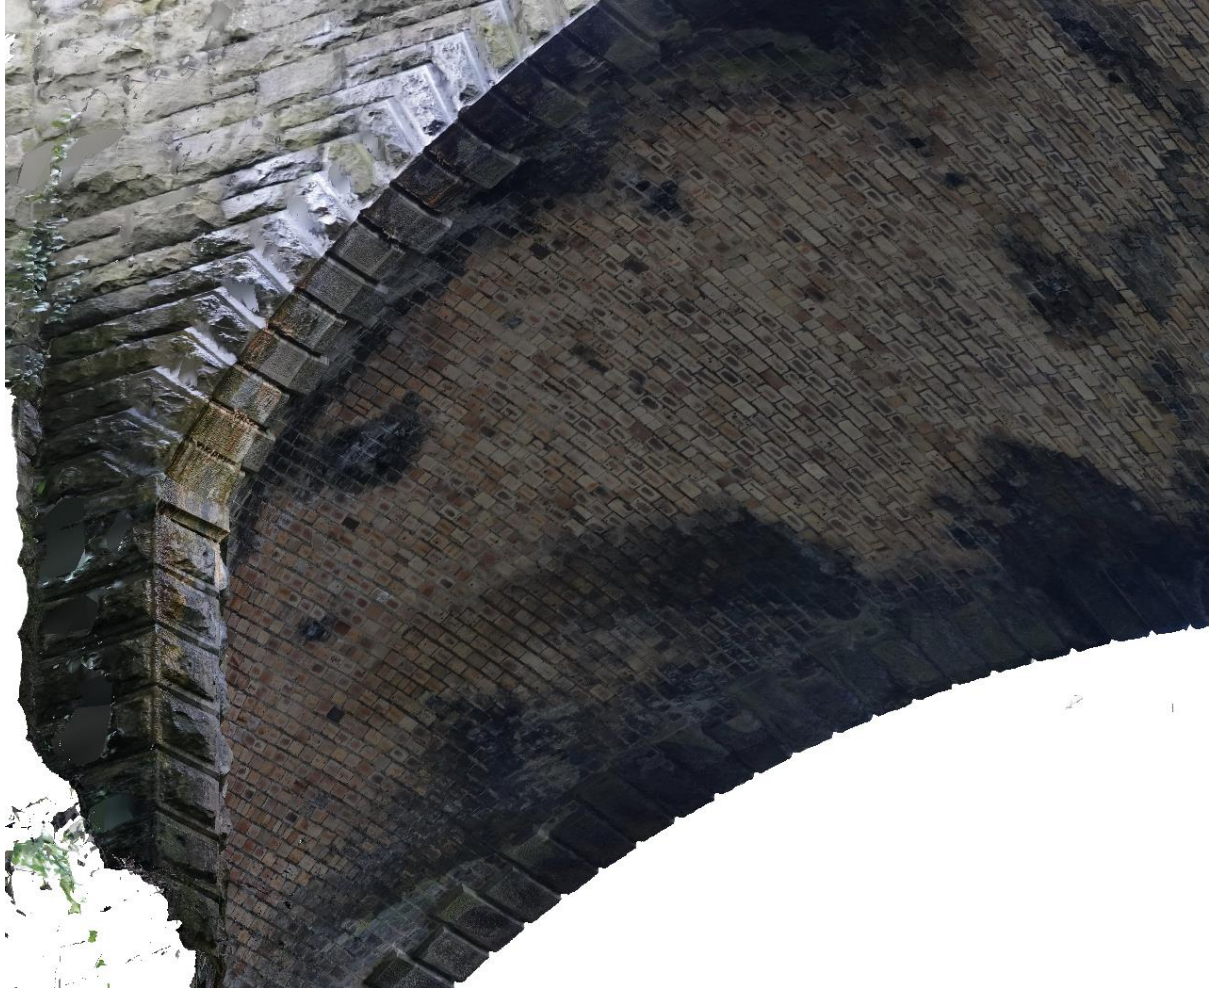
The bridge is well built from a mix of local sandstone and brick. The barrel is of a yellowish brick, presumably of good quality as it has suffered little surface deterioration. The barrel edges, abutments, spandrel walls and parapets are sandstone. Most of the stone is rusticated; the edge voussoirs and abutment quoins stand proud (of the brick ring, especially), and have dressed edges. The acute corners of the bridge are cut back, avoiding the otherwise sharp angles.
