Bridge of the Month 153, “September” 2023 Plessey Viaduct, Northumberland

Over the weekend of 7-8 October 2023, a section of wing and spandrel wall collapsed at [Plessey Viaduct](#). This is a very serious issue, and it seems reasonable to devote the overdue September Bridge of the Month newsletter to it.

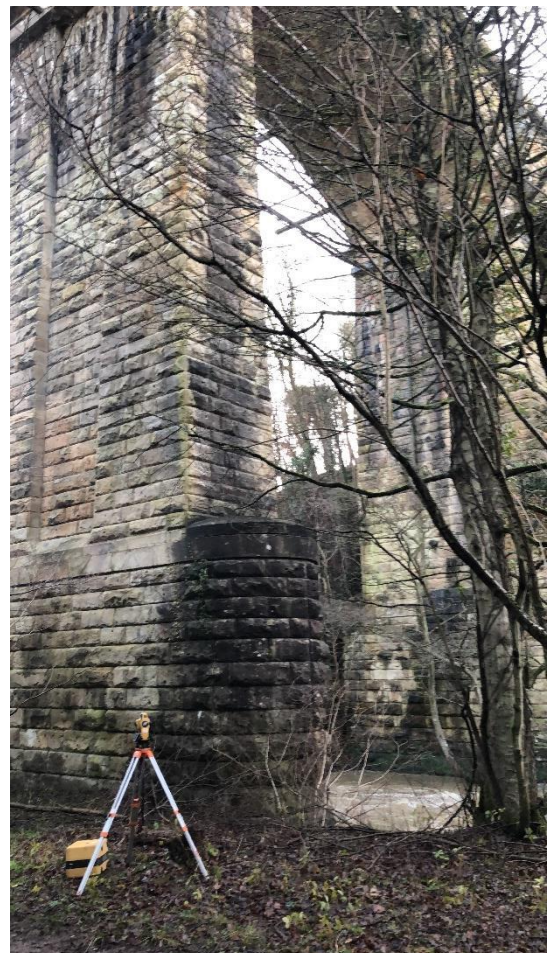
The viaduct does not lend itself to general photography, except perhaps from the air, as it crosses a steep wooded valley. The photo below gives an idea of scale.
