Bridge of the Month 157, March 2024

Old Leckwith Bridge

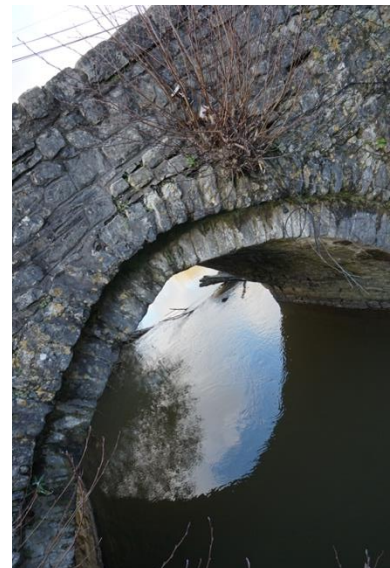
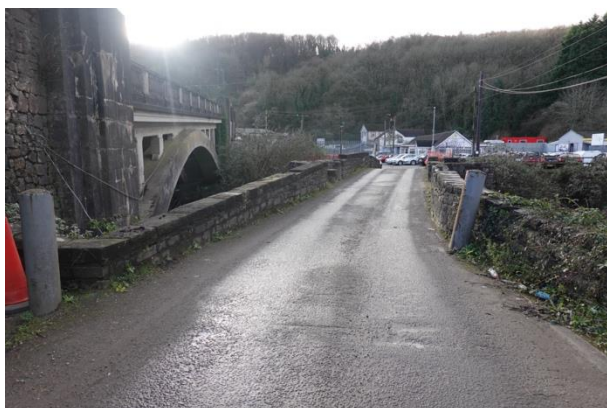
The southwest span (below left and right) has a corbelled ring on both elevations, but the upriver elevation (below left) still looks a bit different, with thinner (or longer) and better dressed stones.

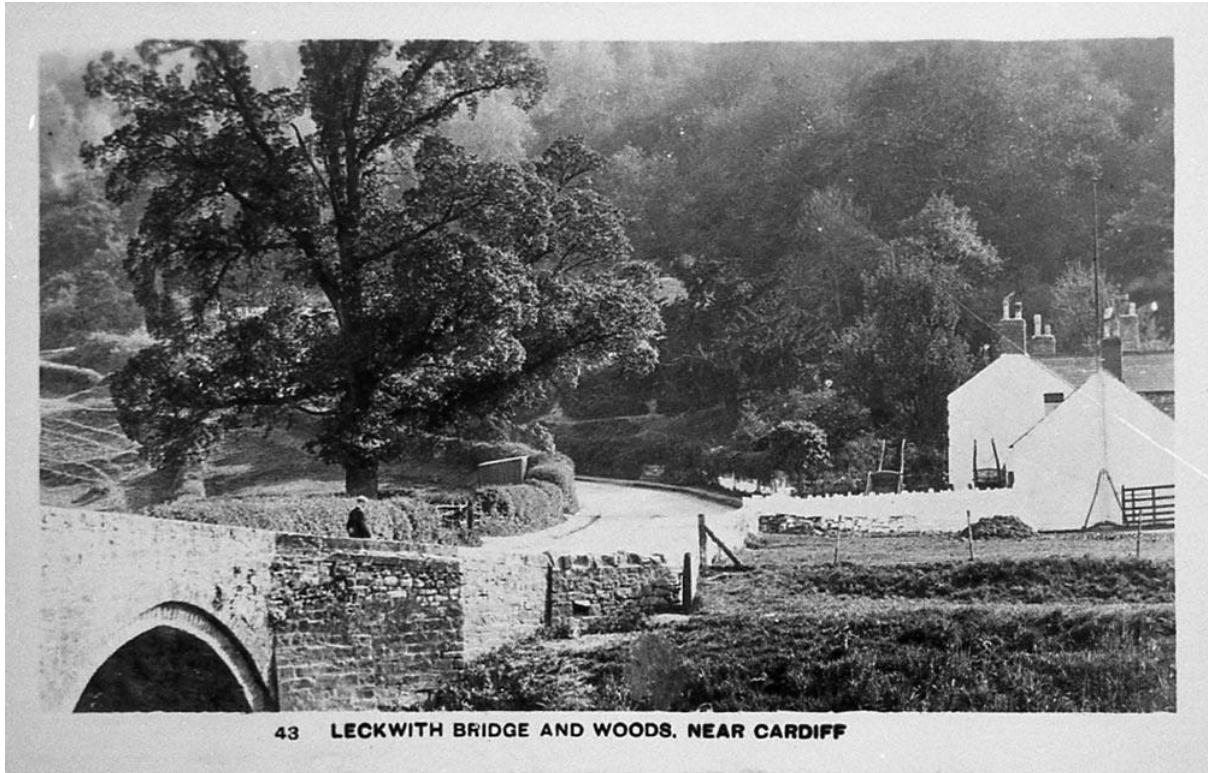
43 LECKWITH BRIDGE AND WOODS, NEAR CARDIFF

Looking along Old Leckwith Bridge from the north-east we see substantial bollards, an inadequate attempt to protect the bridge from traffic. Also visible is the 1930s bridge to the left (south). In the distance, the old farmhouse is visible among more modern buildings. The nearer gable in the late 1800s photo below ([People's Collection](#)) has been demolished. The one visible arch of the bridge looks much as it is today, though the slope seems more pronounced.
