Bridge of the Month 158, September 2024

Monnow Bridge, Monmouth

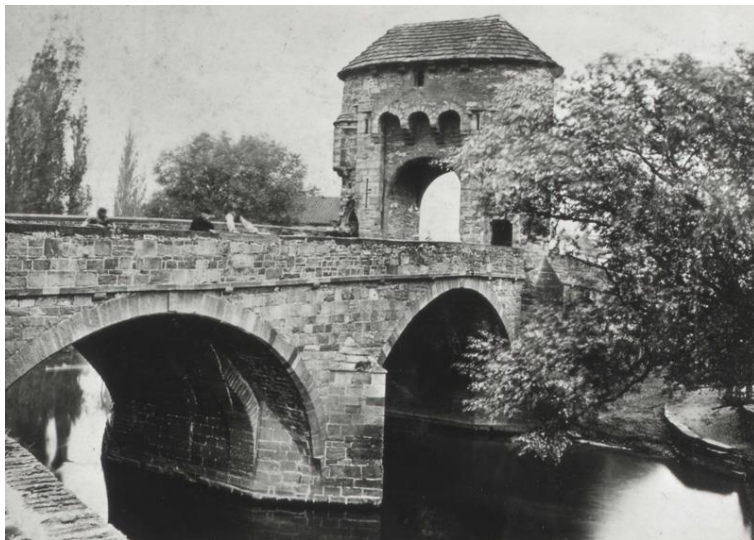
An 1866 photograph shows both passageways and the downriver widening clearly, and the parapet line on the upriver side does not seem to deviate, so the widening is surely present there as well. The bridge now is little changed from this view, apart from local repairs.

Modification of the landscape around the bridge continued longer. In the 1866 photograph, it seems that the east span is at

least partially obstructed and might be completely blocked on the downriver side (the tree branch obscures the view). Either would tend to encourage scour.

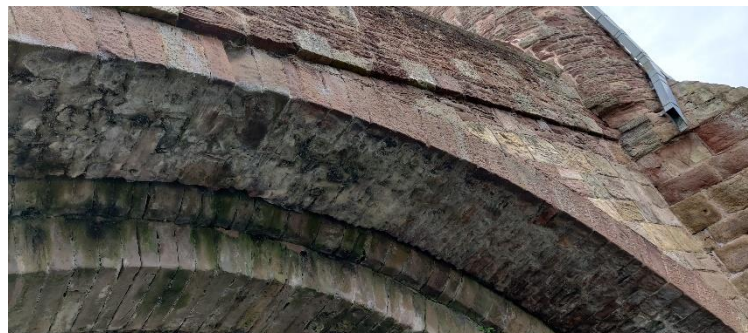
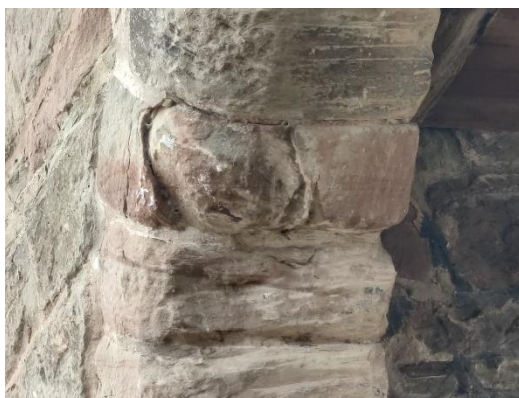
The widenings have a similar general design, but the details are different. The downriver widening (above) has a tapering chamfer on the corner between elevation and soffit. The ring face here is formed of contrasting stone with alternating voussoirs. The upriver and earlier widening (left) seems more functional in approach.
