Bridge of the Month 161, January 2025

Baledgarno Den, Angus

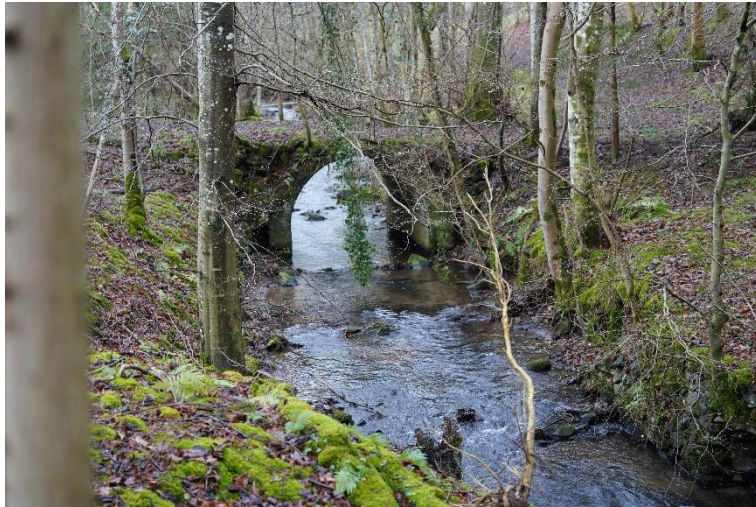
This surely isn't a bridge: it is too narrow, needlessly long span, and there is a proper bridge just upriver. For water control? Perhaps, though in what way wasn't clear.

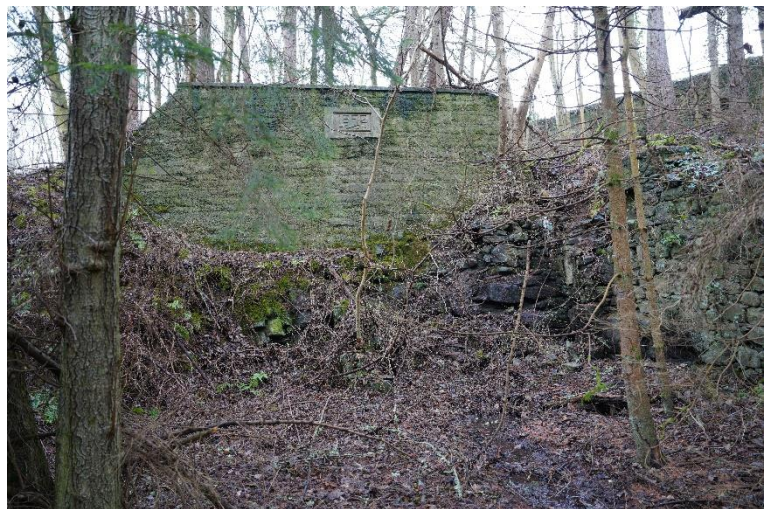
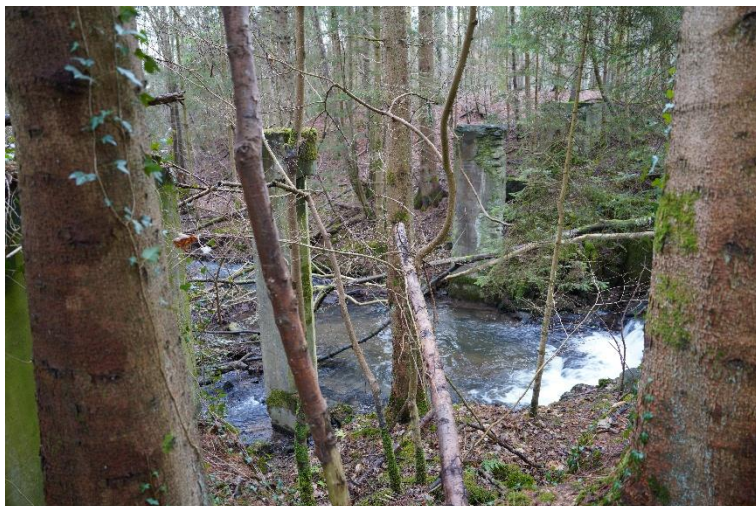
The prevalence of concrete raises questions about the dates for all this. Then a quick look at some unusual ruins across the river gives us a hint: there was concrete in use here by 1892. The wall just visible through the trees to the right may be a dam. I didn't get behind our dated wall, and I'm not sure of its role.

Next up, some mysterious columns. I thought these were concrete again, but in the photo the far one appears to be stone with render. To carry a mill leat, I suppose.

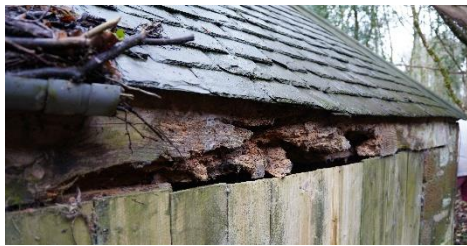
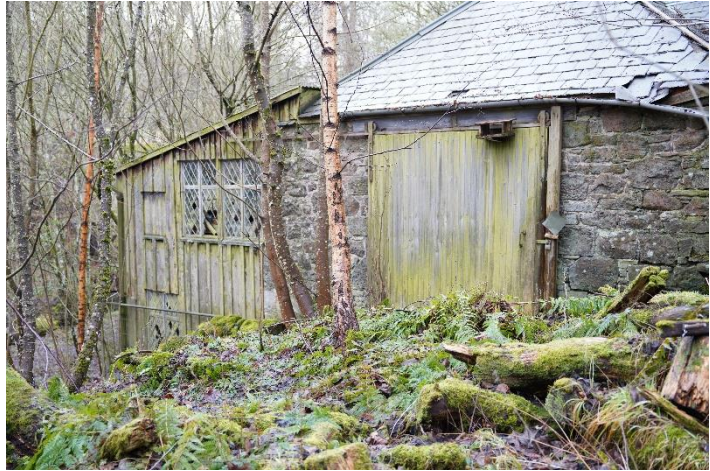
Across the river in timber, presumably a workshop or store, and the mill itself in a mixture of stone and timber. Leaded windows, damaged but not completely gone, must long predate the plastic gutter. Sadly the rot is well developed.
