Bridge of the Month 165, January 2026

Bridge at Semer Water, North Yorkshire

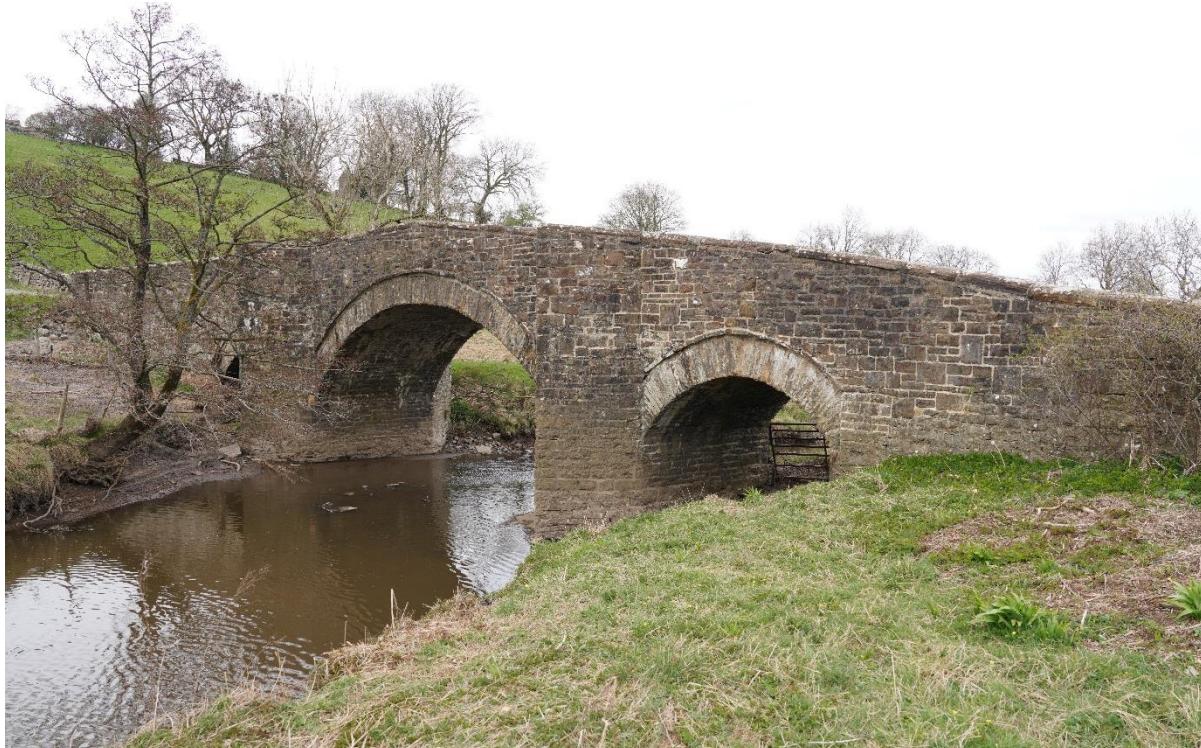
A pretty, workaday bridge carries Stake Road over the river Bain where it flows into Semer Water ([Google maps](#)).

The expressed arch rings look chunky. We can't tell whether that thickness goes all the way through the width, but there is no obvious change in masonry visible on the soffit.

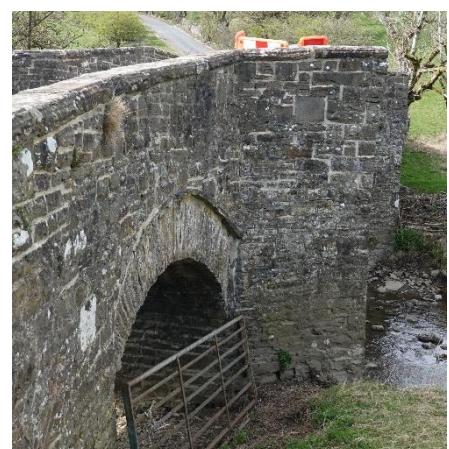
The approach from the north (in the distance, left) is downhill and turns sharply onto the bridge. There is a bend at the south end as well. The glimpse of orange barriers over the parapet is a harbinger of some sort of damage...

A closer look reveals more recent damage: cracks and displacement between the spandrel wall and the corbel over the ring; a further displacement in the spandrel wall, and a diagonal crack in the cutwater.
