Bridge of the Month 163, May 2025

Alikianos Old Bridge

BILL HARVEY ASSOCIATES LTD

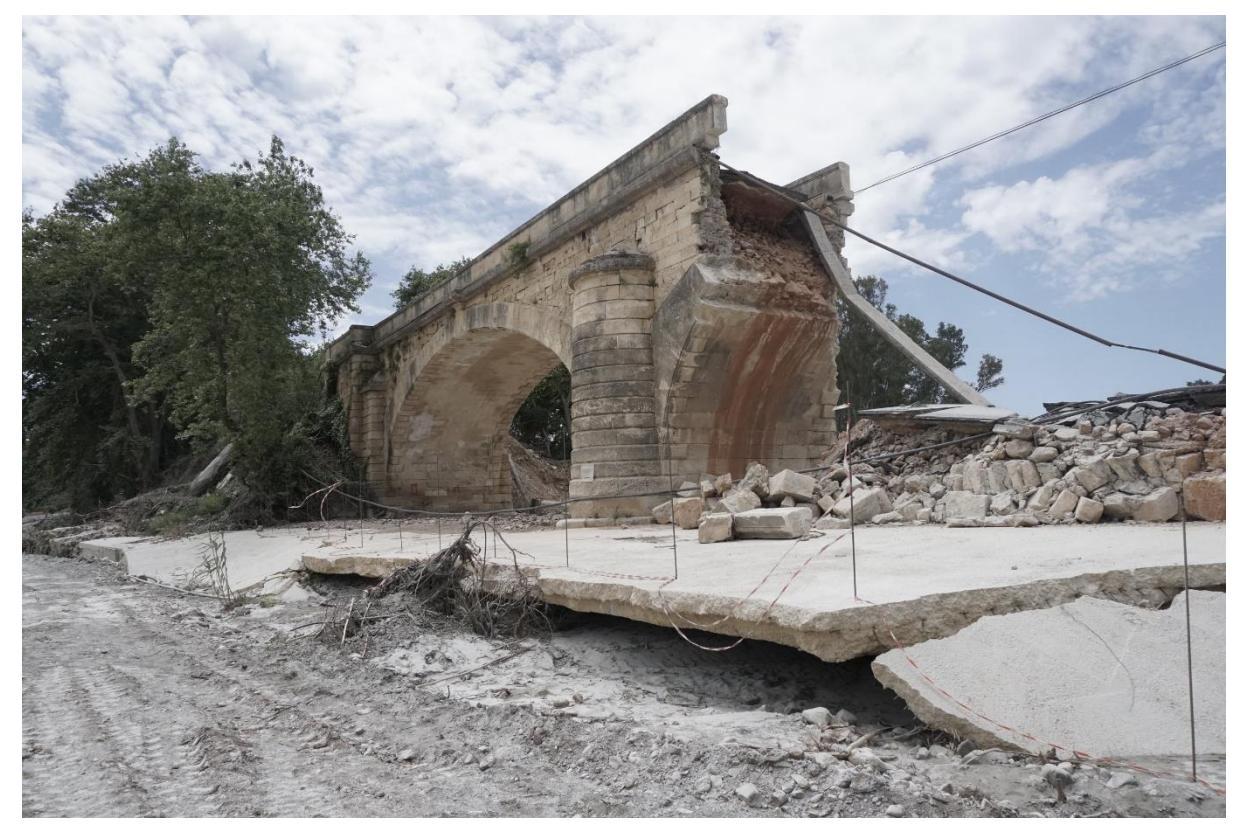
Back in 2019, Bill wrote about the <u>then-recently-collapsed bridge over the Keritis river at</u> <u>Alikianos, in Crete</u>. I had been to visit, and taken enough photos to build a partial 3D model of the remains. This is how it looked then:

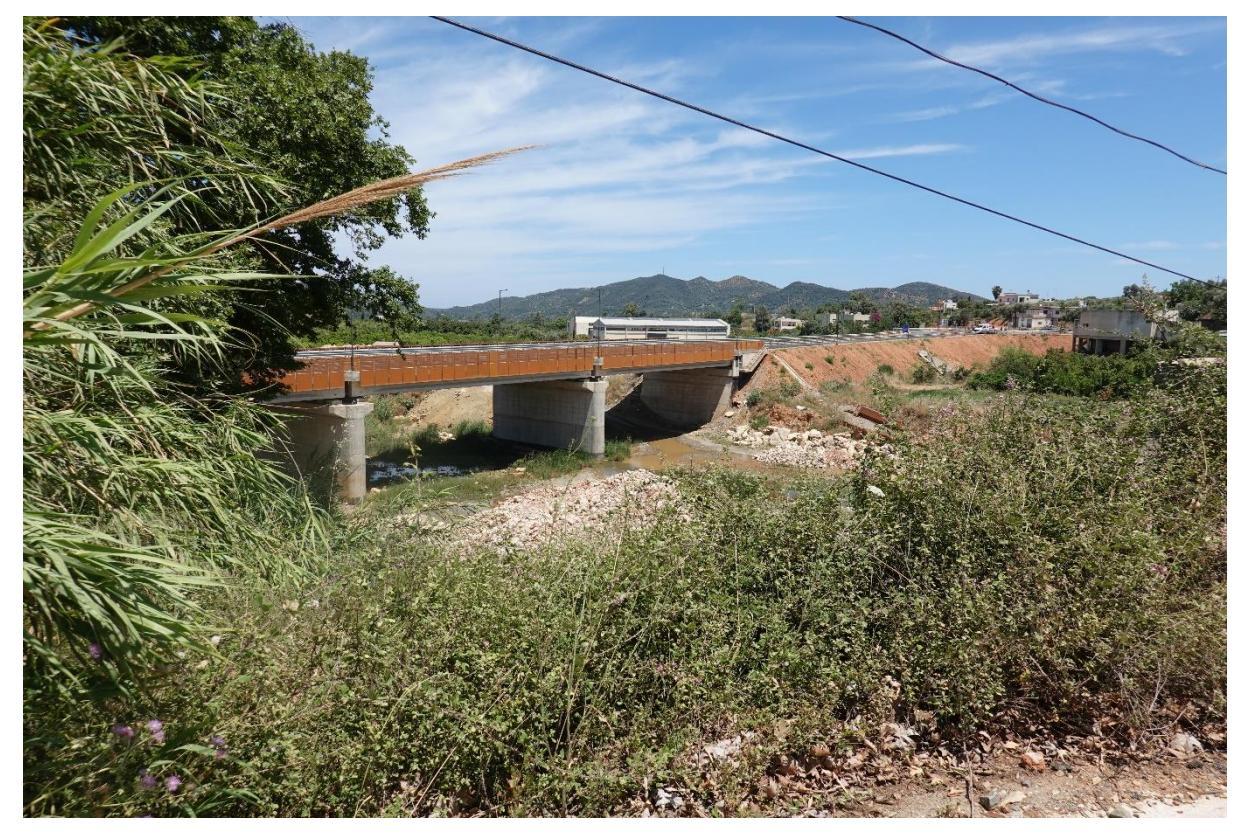
Being back in the same area, we popped back for another look. In recent years, this has become <u>Old Bridge of Alikianos</u> on Google Maps, to distinguish it from the nearly complete new bridge just downriver. The temporary Bailey bridge remains in place for now.

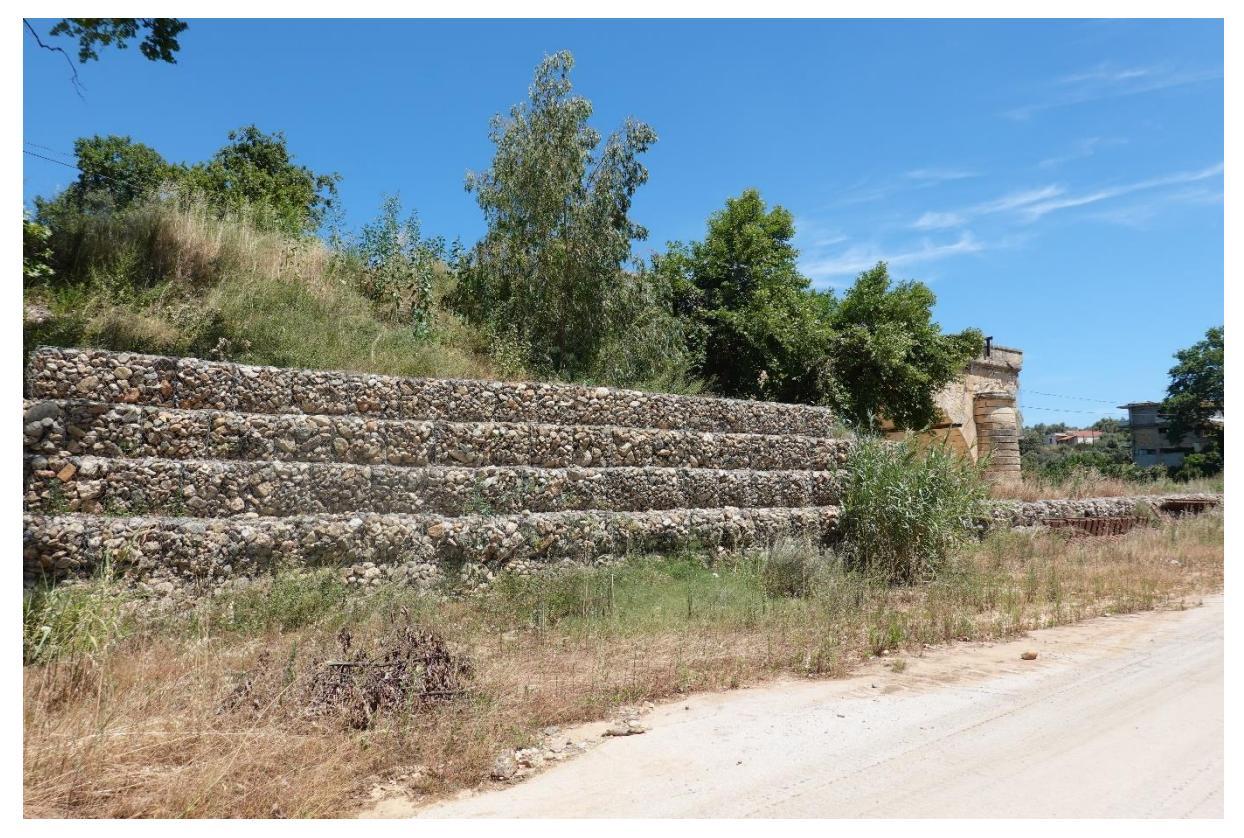
The area around the remaining span of the old bridge has been protected by gabions. There has been talk of rebuilding the old bridge, but there is no evidence of this to date.

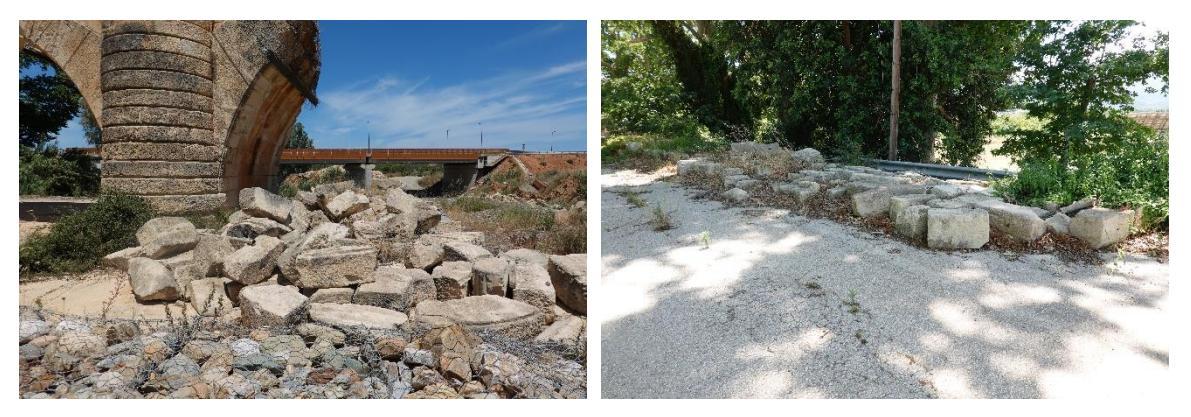
The collapsed remains have all been cleared up. Some of the larger stones are collected in piles either adjacent to the remaining pier, or on the old west approach road.

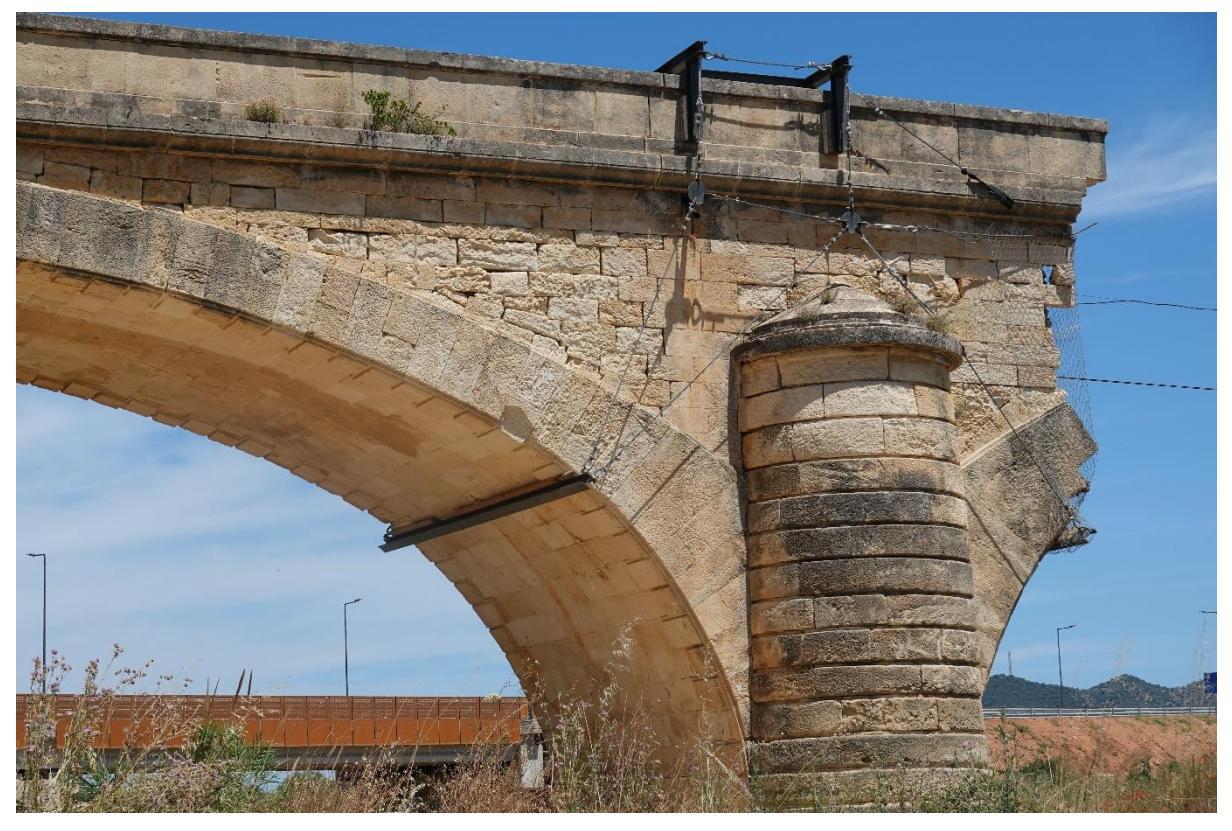
One trigger for revisiting was seeing a photograph in which some sort of temporary harness was visible over the pier. This appears to be solely to anchor a wire net for the purpose of stopping material dropping from the broken end, presumably a public safety measure.

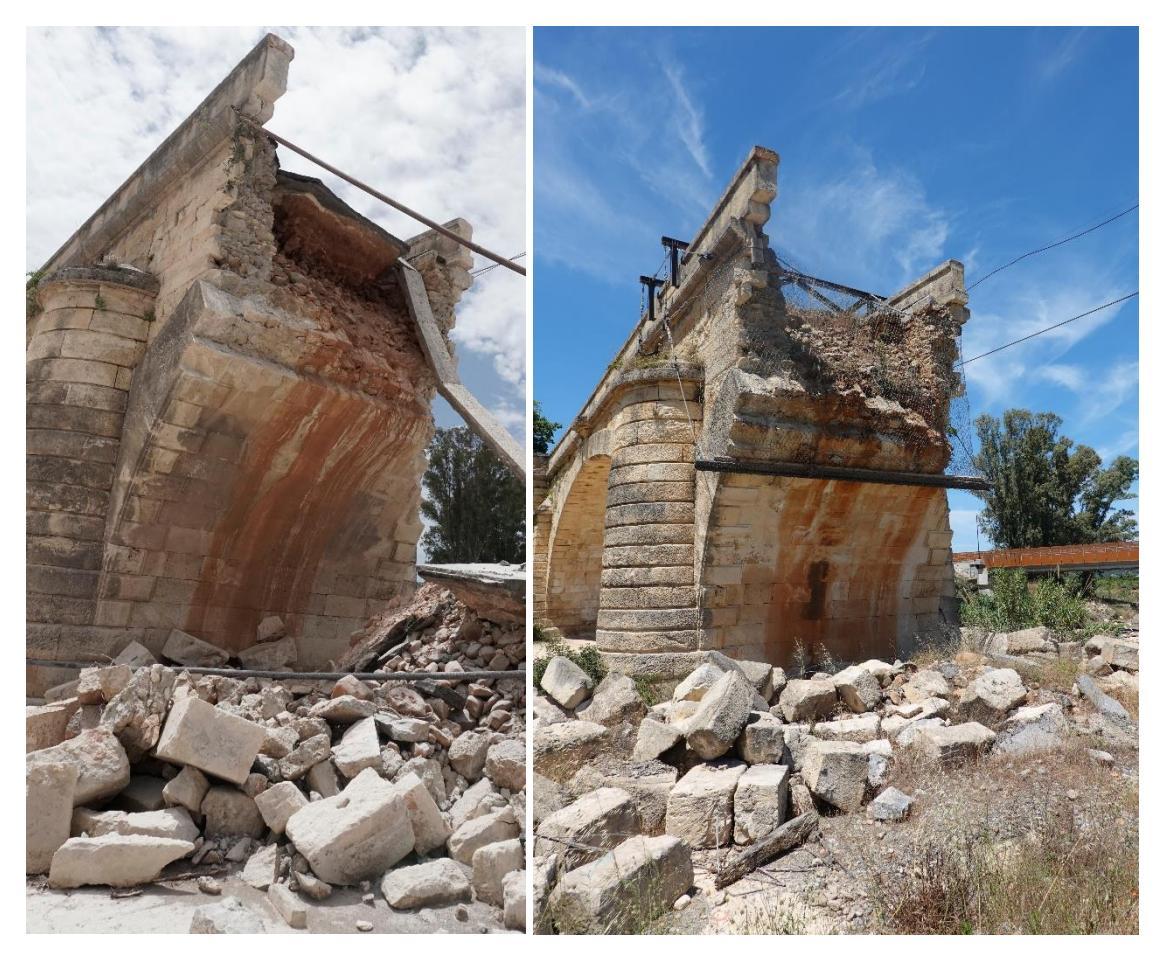
Comparison of photographs of the break before (left) and after (right) shows that while the arch itself has not lost any more material, the road surfacing has broken back, and some of the inner face of the right spandrel wall has been lost.

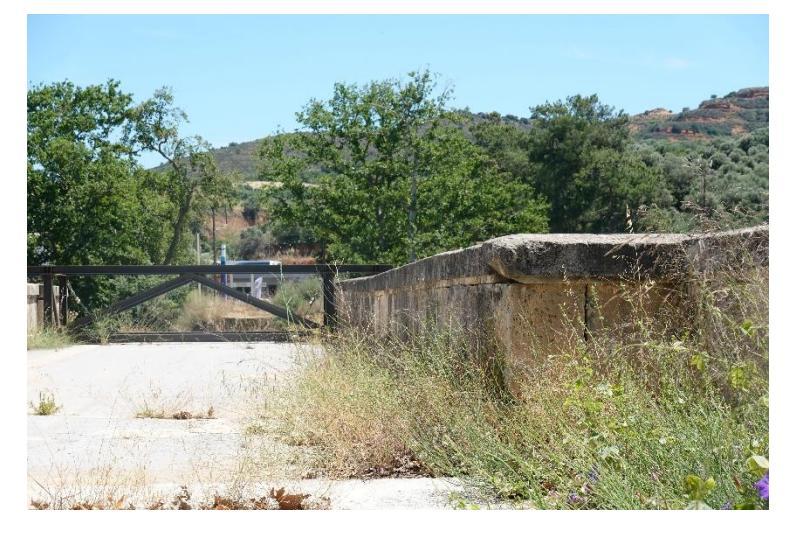
The loss of the thrust from the next span obviously creates a concern regarding the security of the pier. The fact that it has lasted until now must serve as some reassurance, as does the lack of serious distress in the masonry.

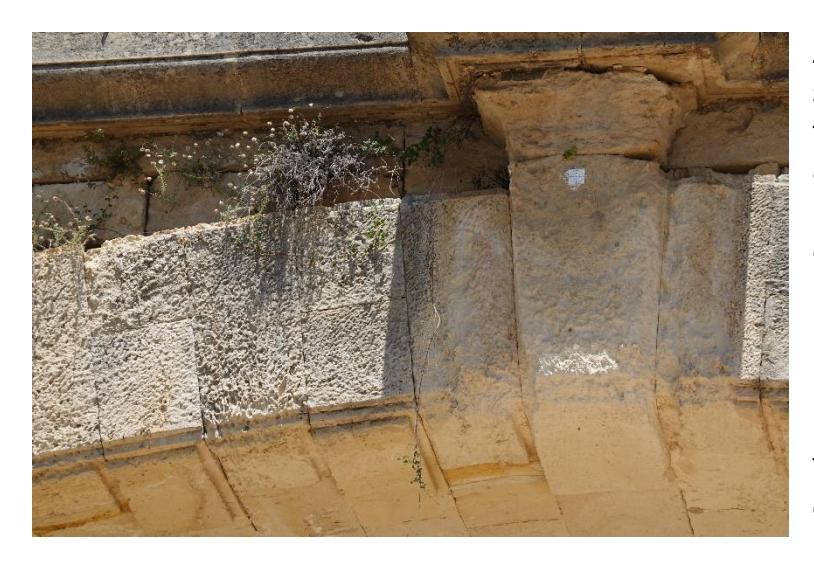
From below, the impression is of a dip to the crown in the string course. That is confirmed from above by sighting along the parapet (from a position of relative safety off the abutment).

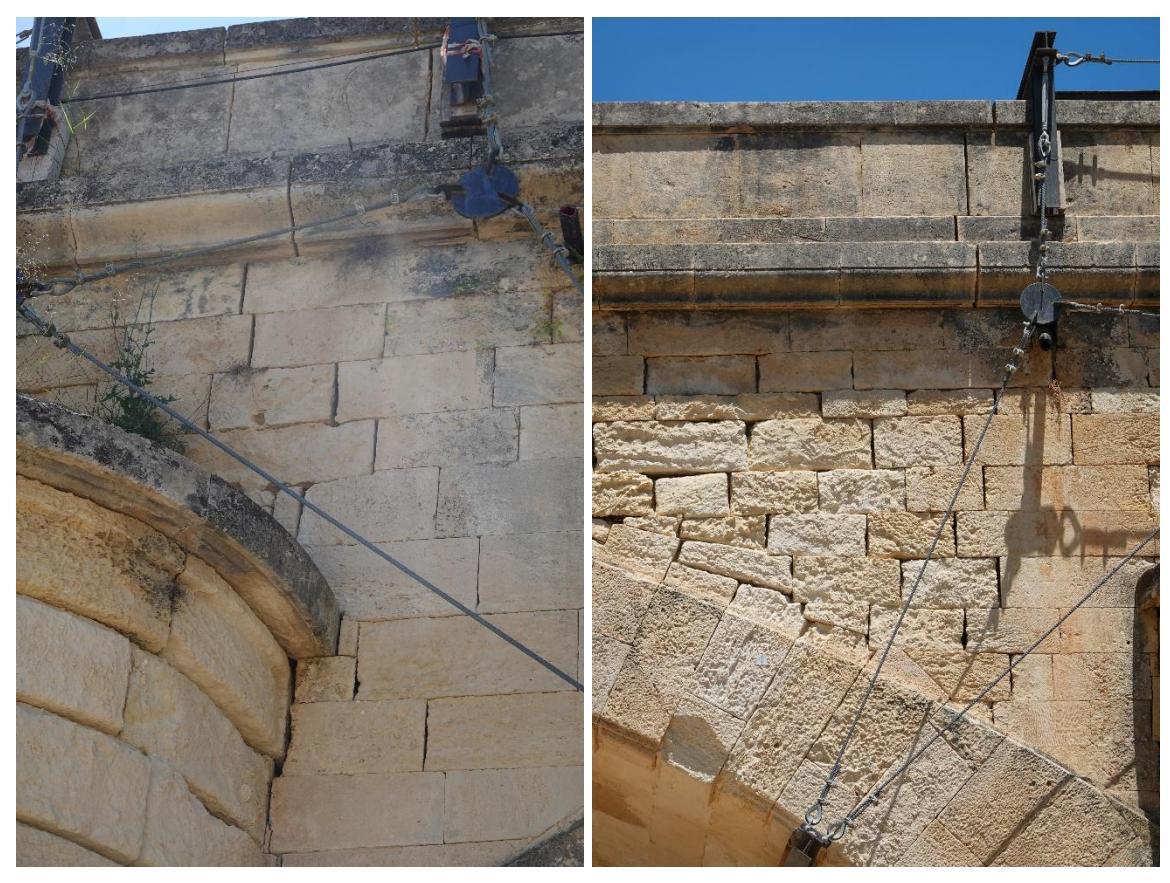
A joint opens slightly to the soffit one voussoir away from the keystone on the south side at the crown. I would be hard pressed to claim this was visible at the north.

The crack behind the pier is clearer, and plainly visible on both sides of the bridge.

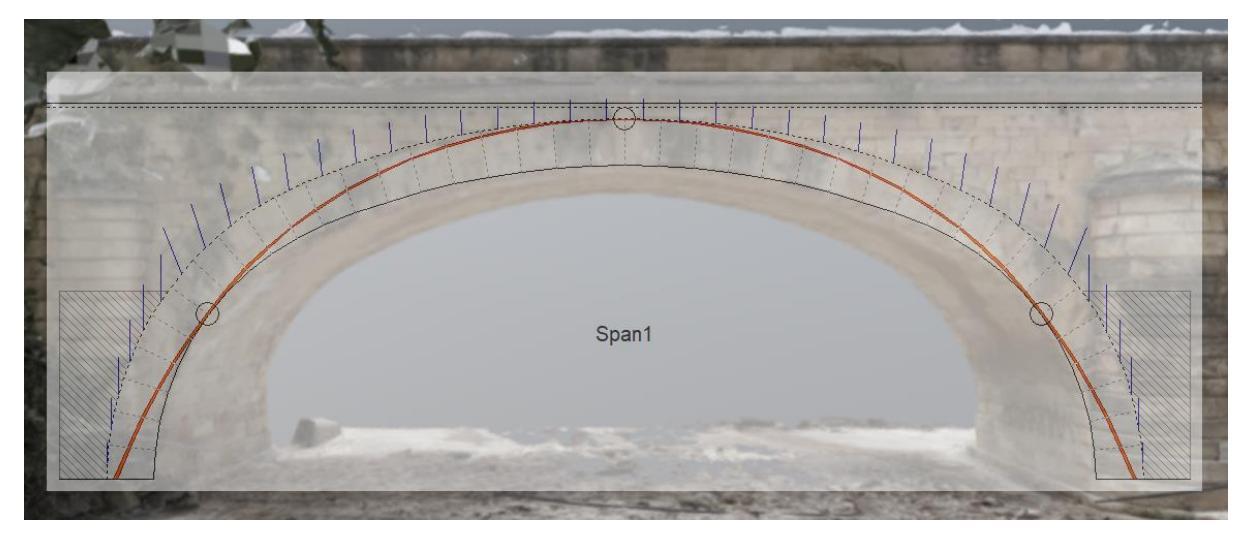
A quick juggle in Archie-M, overlaying screenshots with transparency on a square view of the elevation from the model (an orthographic view would be possible, but I'm not going to spend time preparing that over my tasty holiday lunch) gets us this – 3:1 span:rise ratio, three-centred shape.

That's very rough, but the thrust comes down to ground very much on the near side of the pier. I won't lose any sleep over that.
