Bridge of the Month 123. March 2021 Stow, on Gala Water, A7

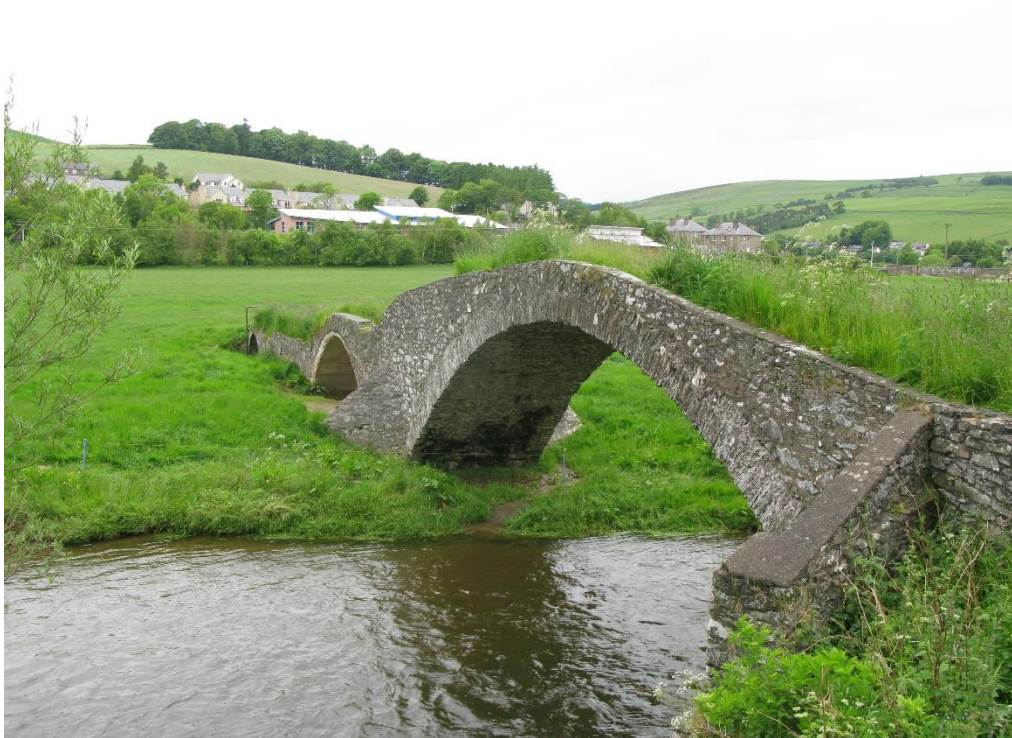
It is known locally as the bridge to heaven. The A7 is behind me in this picture but didn't exist when the bridge was built. The church was on this side and the village, as you can see, on the other, so people needed the bridge to get to church.

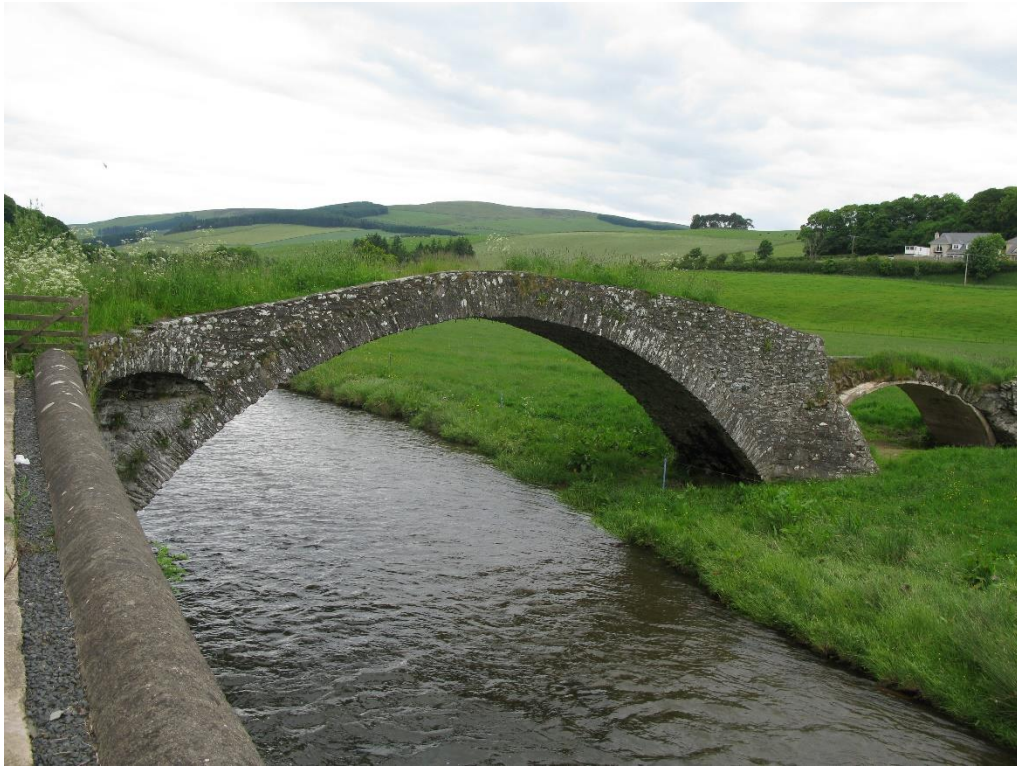
It is a classic Scottish rural bridge, selected stone voussoirs rather than dressed and random rubble walls. There are two flood arches on the far side and they are often submerged. If we look from the other side we can see the results of flooding and neglect.

What was left of the flood span was getting close to collapse before it was lifted back to shape as well as possible and had a concrete ring cast beneath. Not pretty, but reasonably robust, effective and cheap. There is a nice squinch in the near corner, enlarged somewhat below. The enlargement shows the stone of the arch to good effect.

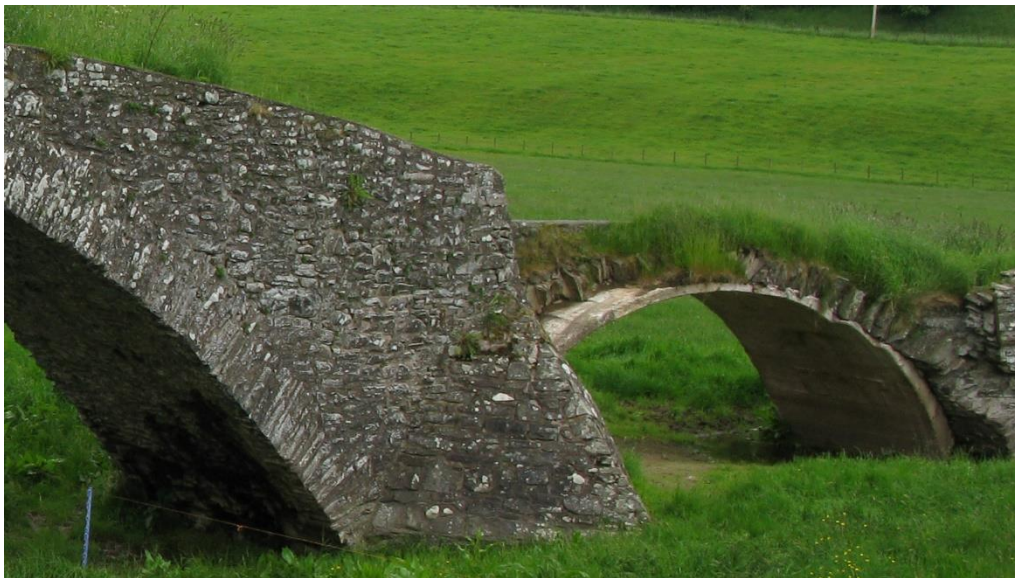
A closer view of the concrete lined arch is also worthwhile.

The loss of material also extends to the second flood arch.
