Bridge of the Month, December 2013 Göltzschtalbrücke

Göltzschtalbrücke

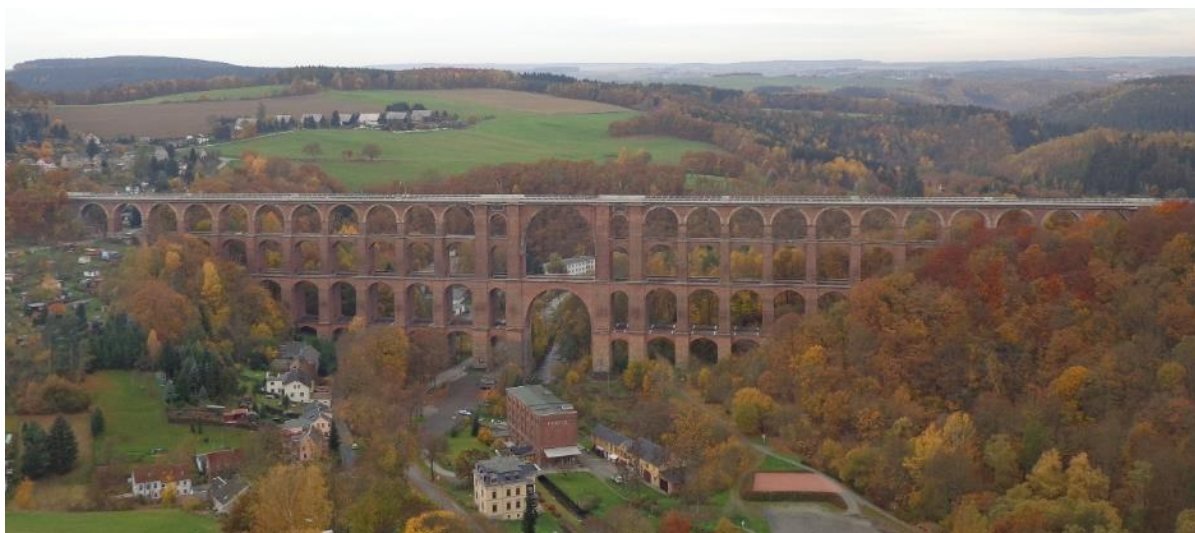
It was built between 1846 and 1851 so is contemporary with many large railway viaducts including Ballochmyle (1846-48, 55.2m span, 53.3m high) and Victoria (<http://goo.gl/maps/Pik2J>, 1838, 49m span 41m high).

The multi-tiered design, getting wider towards the foundations shows a link to the Pont du Gard (http://en.wikipedia.org/wiki/Pont_du_Gard). The complexity here, though, is spectacular. The closer photograph below shows that the piers are solid and widen dramatically to the base, but the stabilising layers of arches are narrower and in pairs.

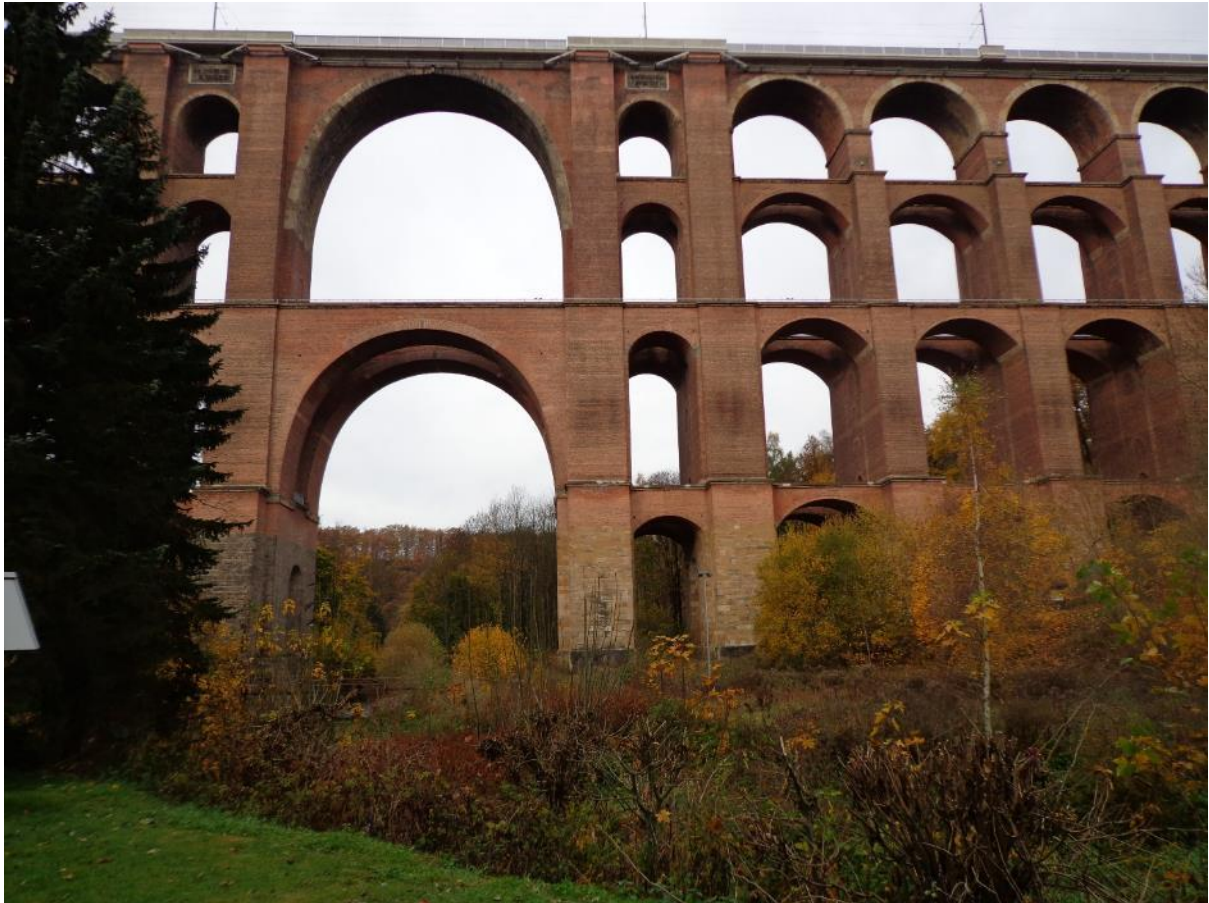
It seems that the original design had uniform spans but the foundations around the river were moved creating one larger span and two smaller in a four span space.

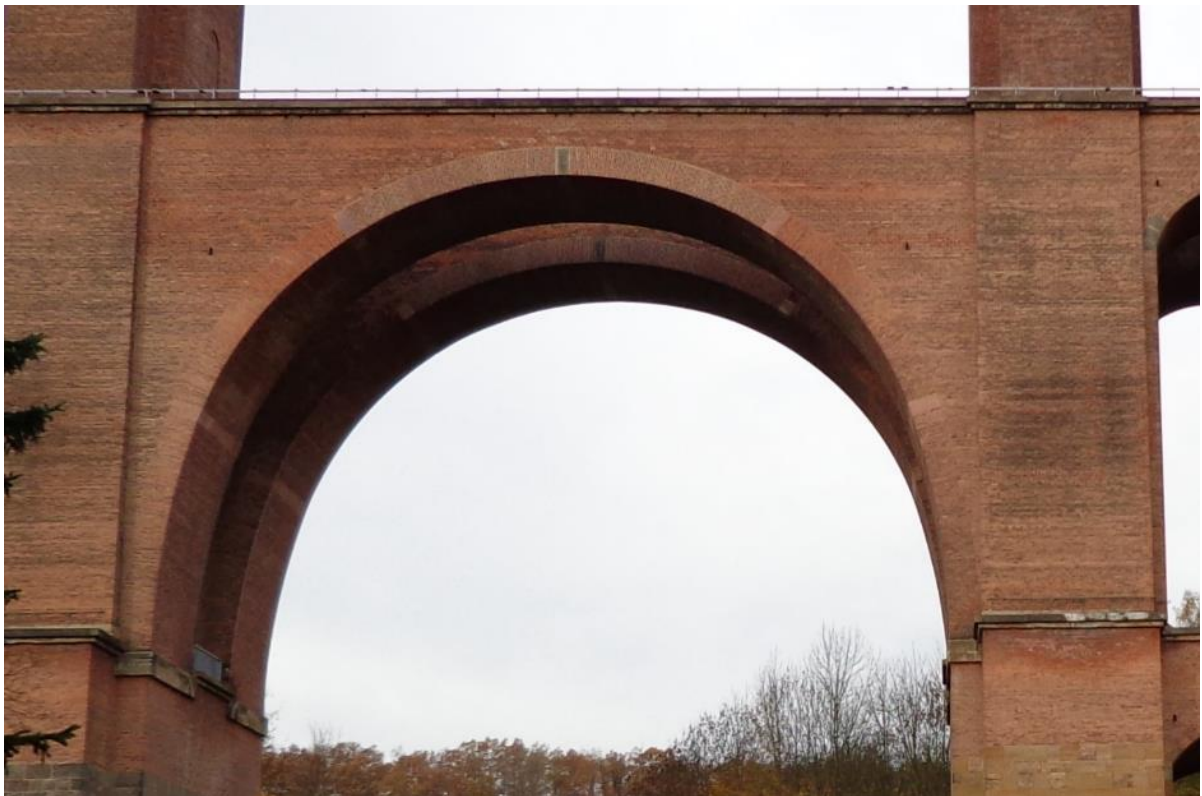
The shape of these main arches is also interesting. All the others are segmental but this seems different. It is clearly somewhat higher than half the span.

Cropping the arch out of this picture and enlarging it suggests a multi-centred curve with stone voussoirs at the changes of radius. Tracing from the drawing suggests 15.45m radius at the crown (ie. part of the curve that would fit a true semi-circle). Then a slightly tighter 13m curve linking to a 28m radius to the springings. The lowest of these could have been built without a true centre, though some sort of guide would surely have been needed.

The photograph above shows dark patches on the face of the pilasters half way up the span. The structure is surely hollow in some degree and this may mark the base of a void.

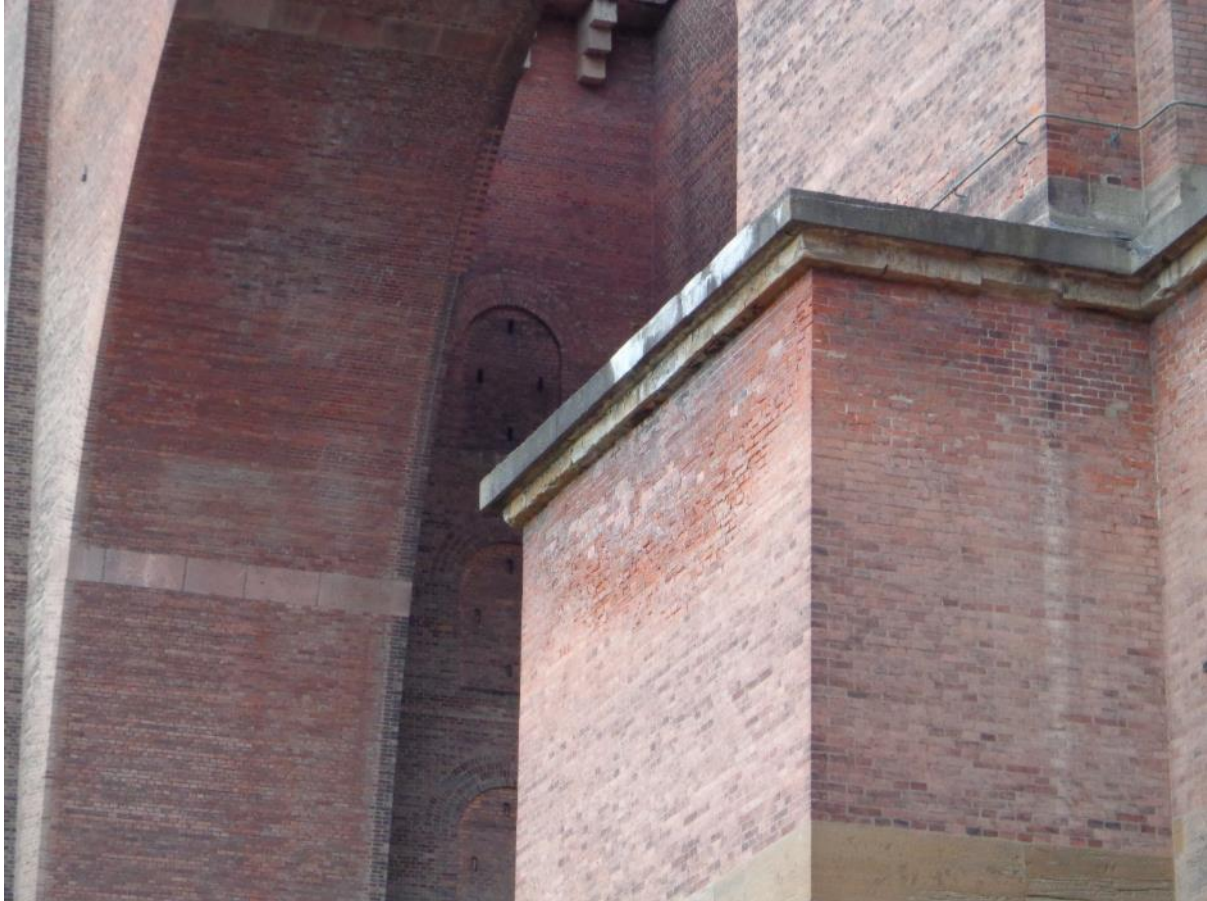
The erosion seen here, though is surely a result of drips from the sandstone capping. The arch seen here is the lower of the two main spans. The clean change of colour one brick in from the edge would usually be an indication of impending trouble and a closer look shows that there is a crack half a brick in.

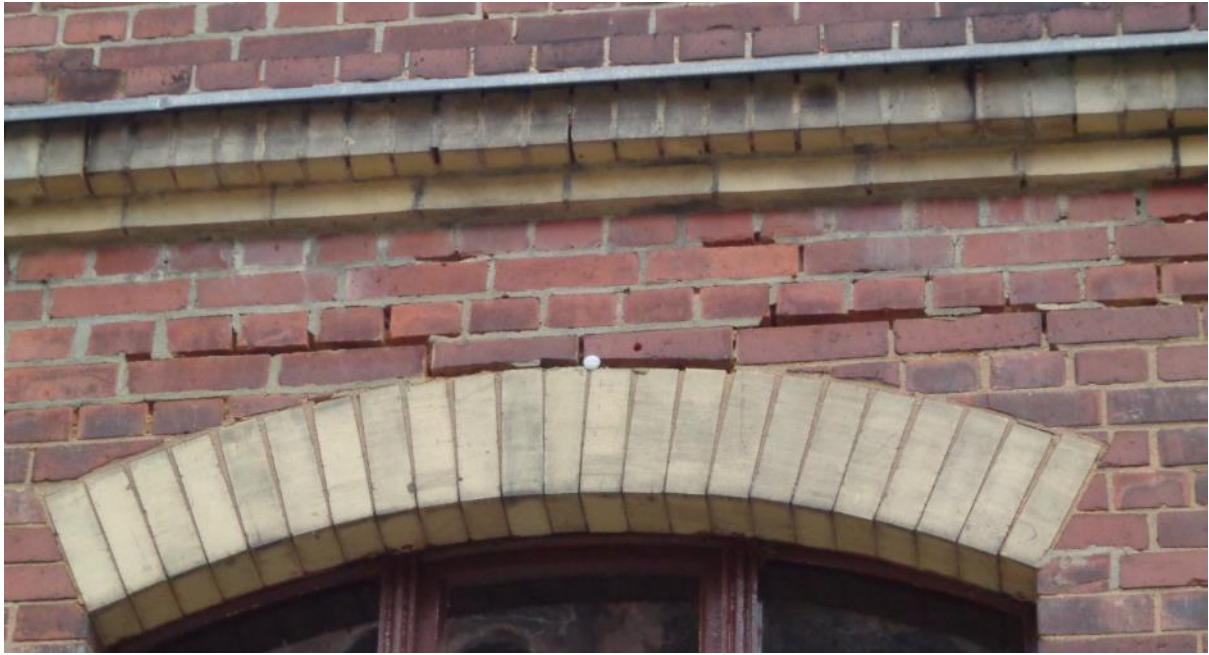
The erosion is matched on a nearby railway building with no apparent chemical mismatch to accelerate the process.

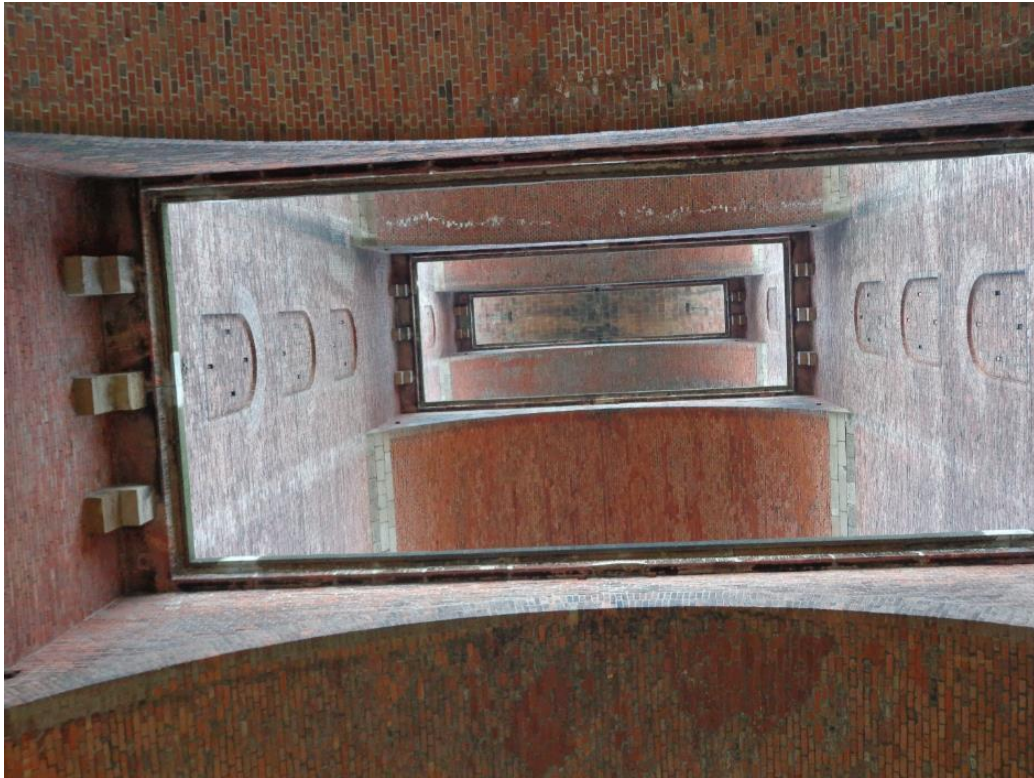
The whole viaduct begins with a stone plinth. This view along the lowest cross arch shows how the rock might dip steeply towards the river making foundations more difficult.

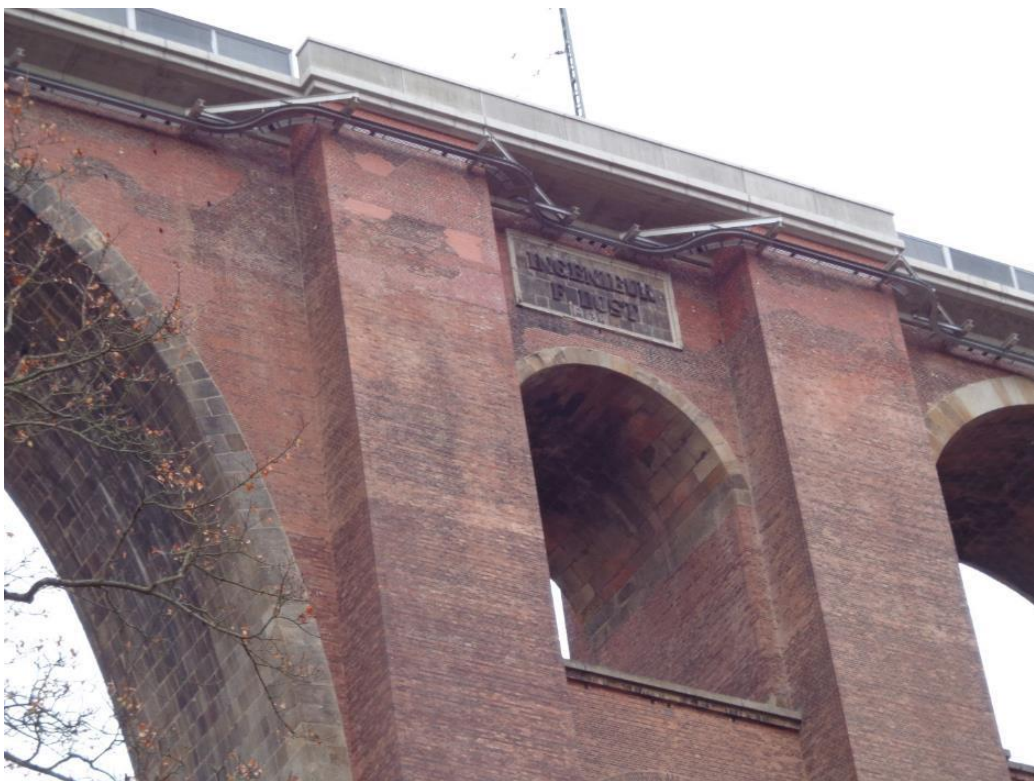
An upward view from the same point shows how the structure is detailed. The blind widows suggest that the piers are voided through most of the height.

The patching seen here shows a considerable level of care for the structure, but so, surely, does that runway beam which will allow rapid access to any point on at least the exposed elevations.
