Cample

Bridge of the Month No51, March 2015 Cample Water, GSW

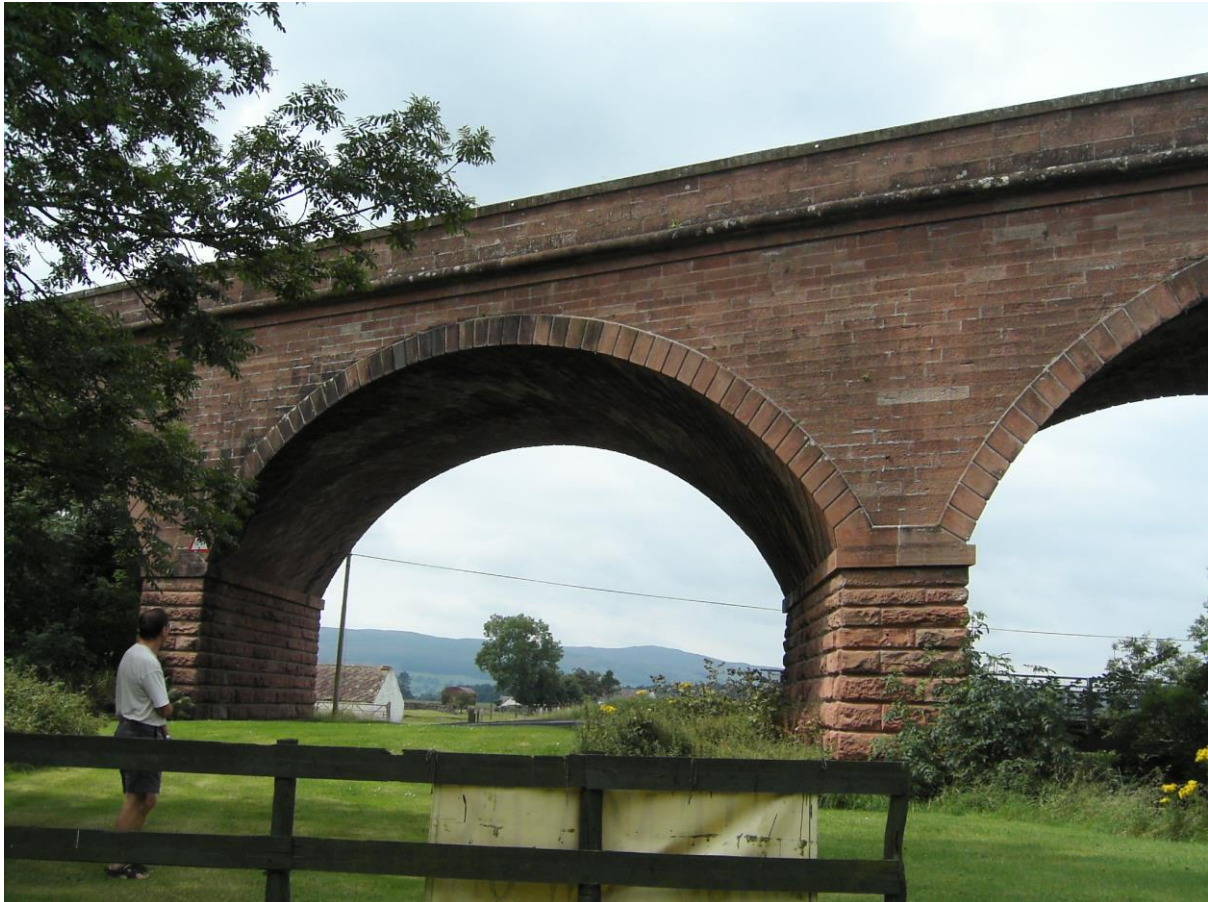
The bridge is skewed to accommodate a river. The road through the middle span barely qualifies as such and must have been little more than a track when the bridge was built. Notice this span is photographed roughly normal to the skew span and the shape doesn't look quite like a circle.

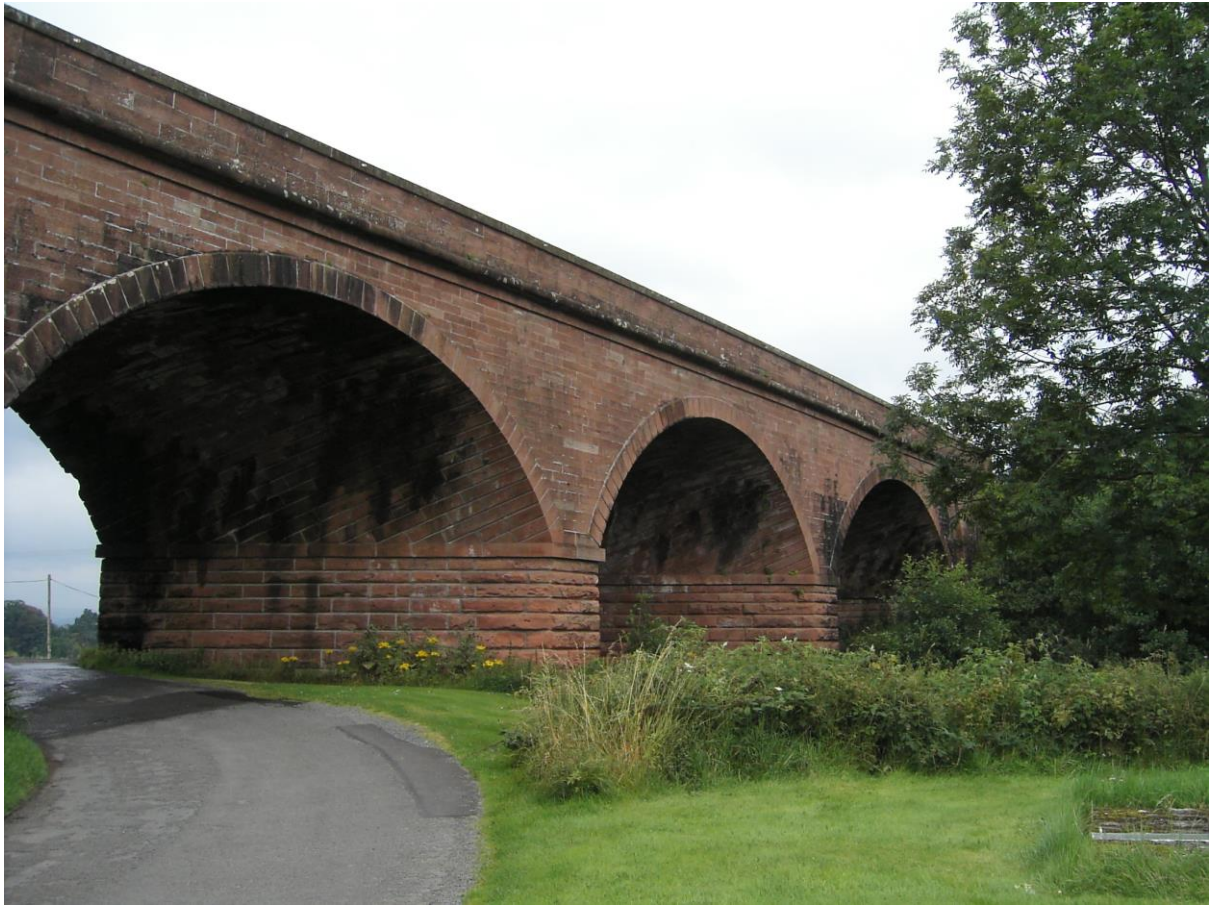
Then next pic just turns sideways to show the other three spans and to look down the line of the road. Note the bite taken out of the acute corner by a high (and presumably hard) vehicle.

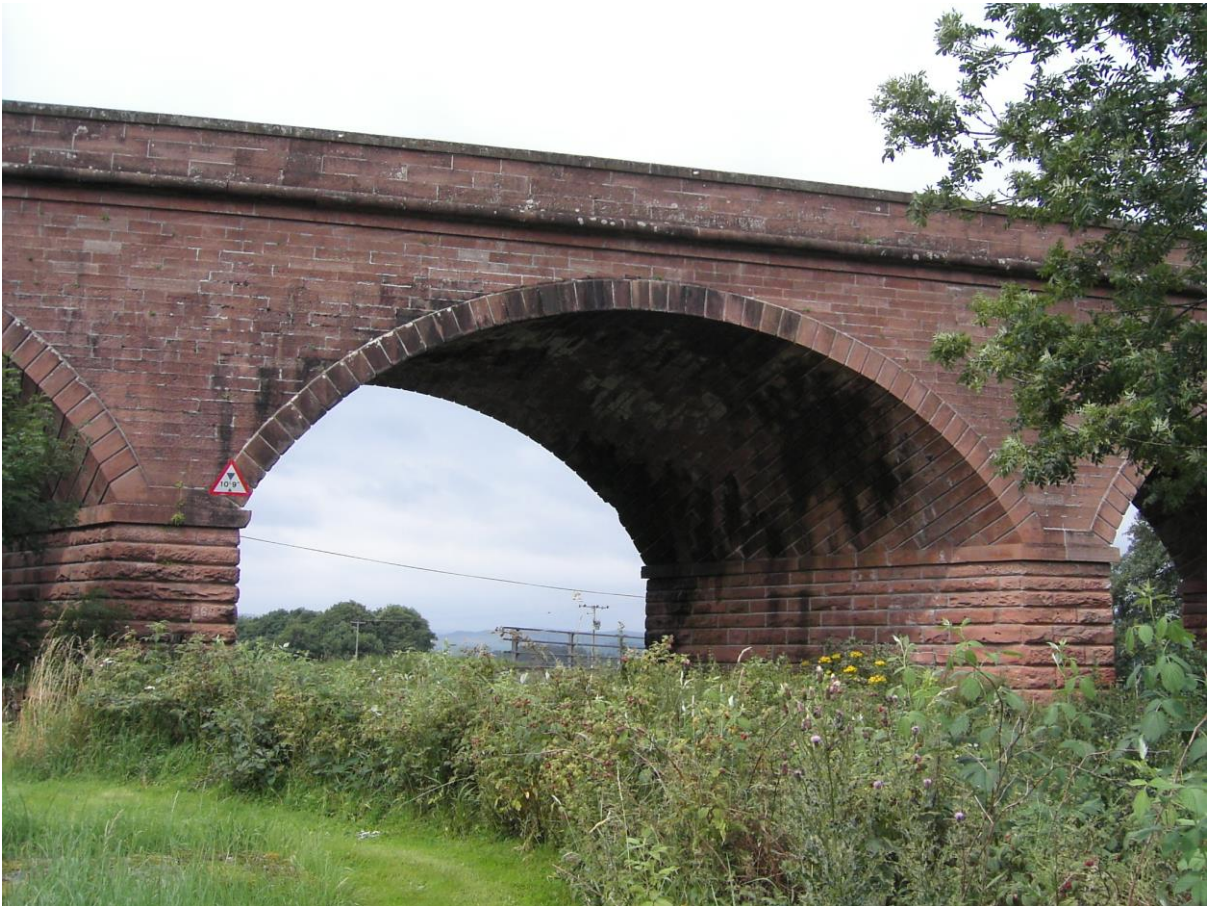
Photo three is taken square to the spandrel and shows that this way the arch is truly circular.

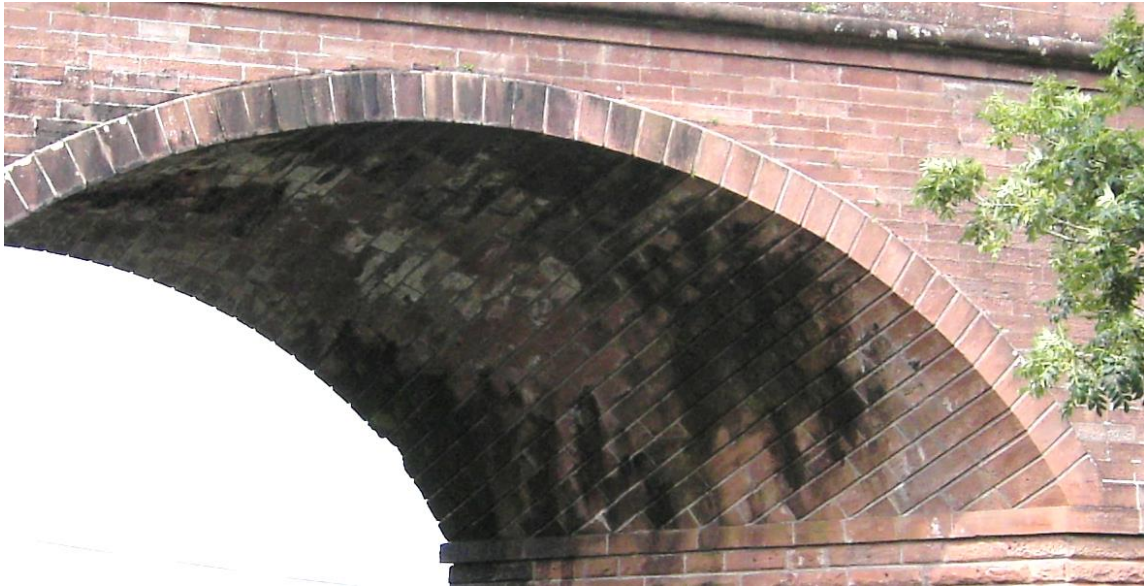
Looking a little closer shows the water stained soffit. Rationalising the stations is hard in a skew bridge but we can be reasonably confident that, as with most of John Miller's bridges, this has solid backing at the bottom (roughly to the top of the water stains) then internal walls and slab covers with the walls passing right over the crown

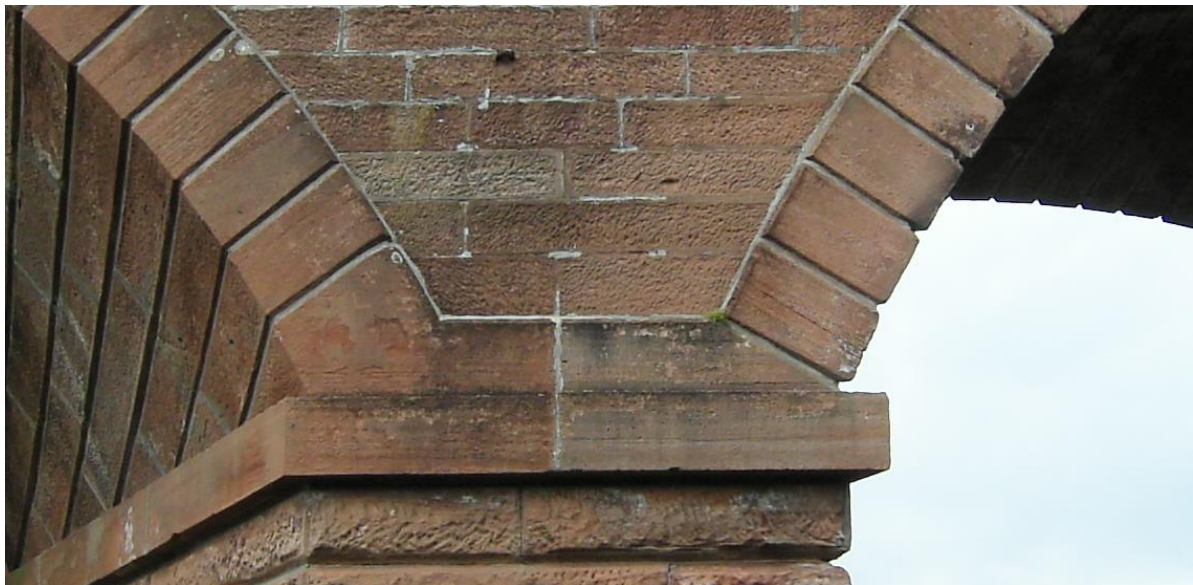
A close look at the skewbacks is interesting. Quite a complex lump of stone, or two, or three.

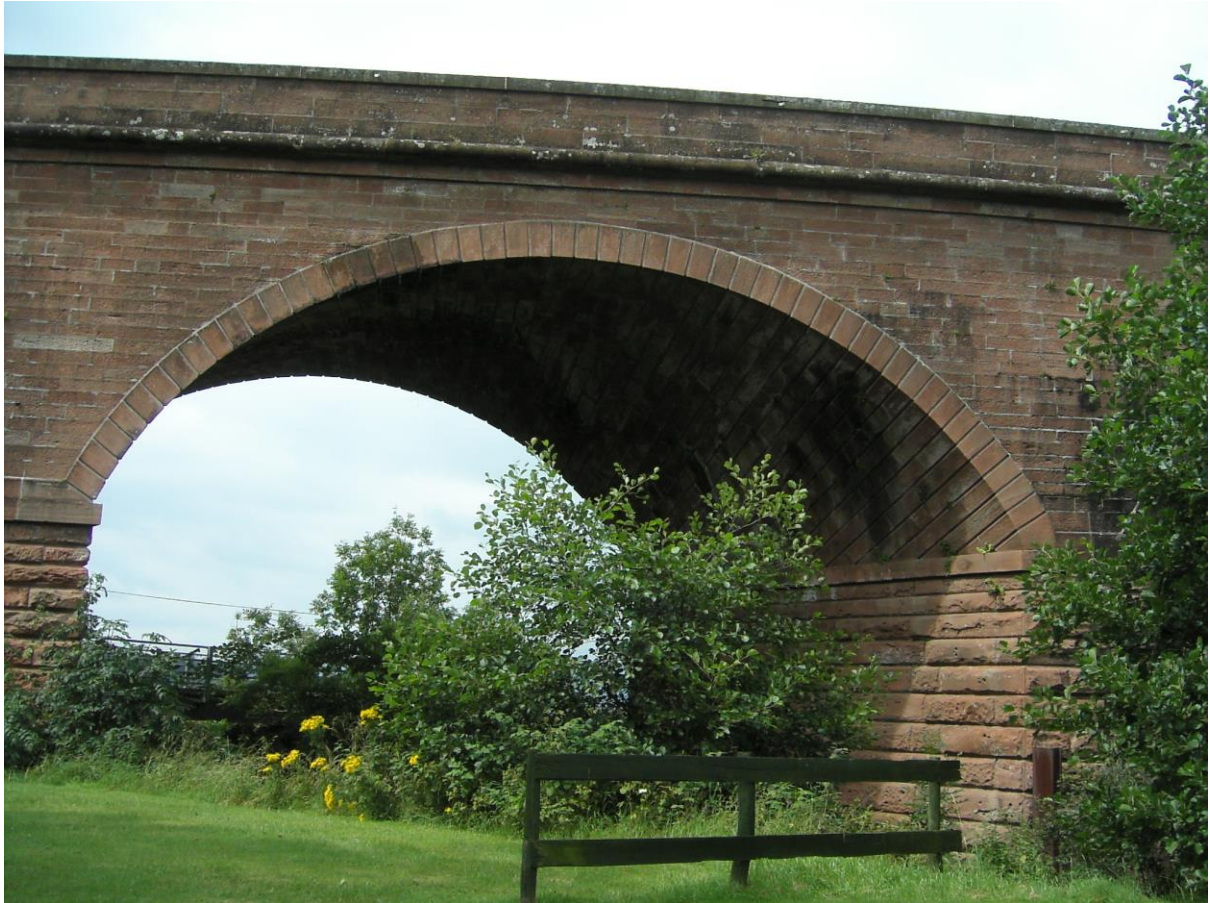
This picture below, perhaps closer to square than the previous one, also shows a line of stain on the spandrel indicating the top of the solid backing.

Now I want to look at the working of the stone. The voussoirs are smooth finished with deep V joints. The spandrel faces are smooth at the joints and pecked between. The string course is ashlar and below that the stone is course and fitted rusticated. Note also how the courses get thinner towards the top giving emphasis to the height. Lets look at some other bridges on the same line.

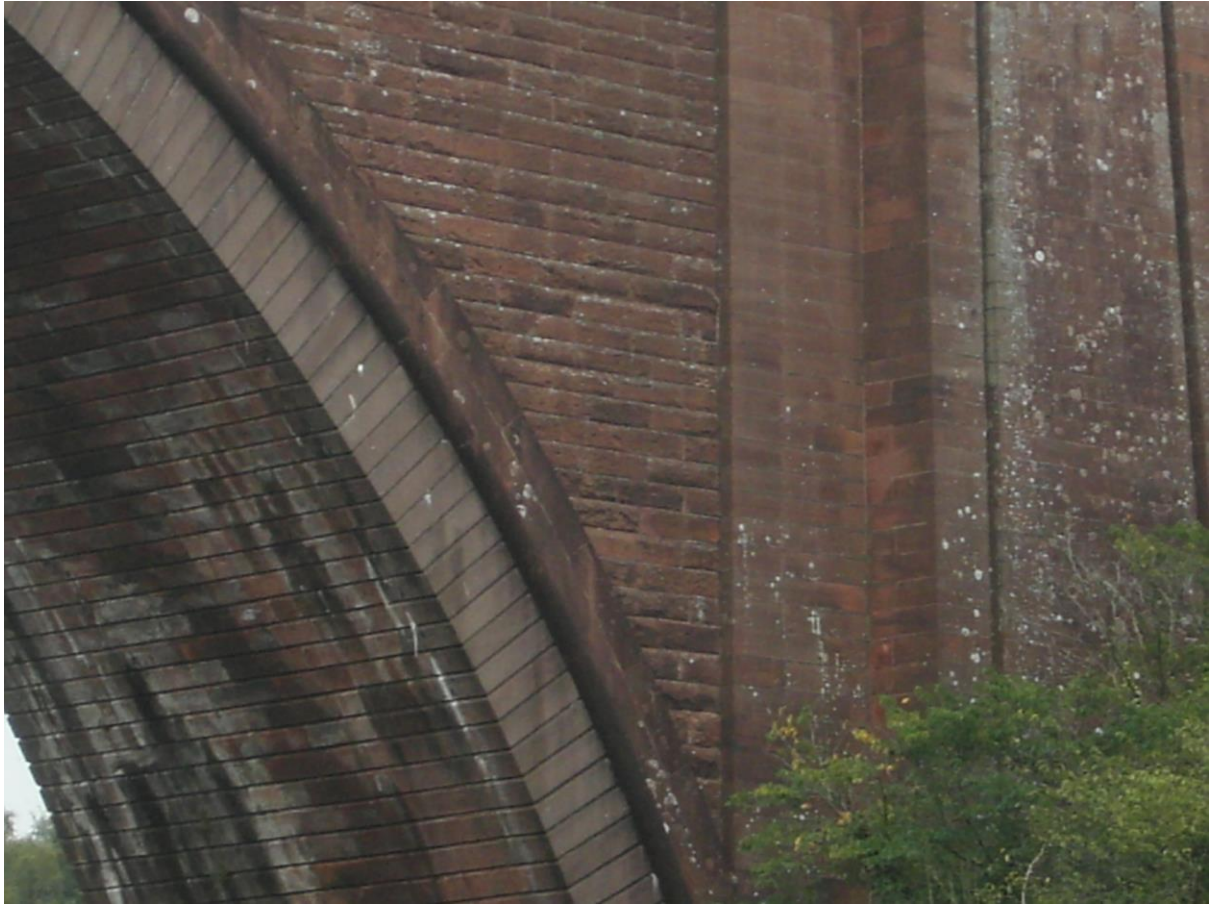
Ballochmyle is vastly bigger and the spandrel walls are rusticated, presumably to break up the massive appearance. There is a string course around the top of the V jointed ring. The huge pilaster (or buttress) and the borders of the spandrels are ashlar, adding further texture.

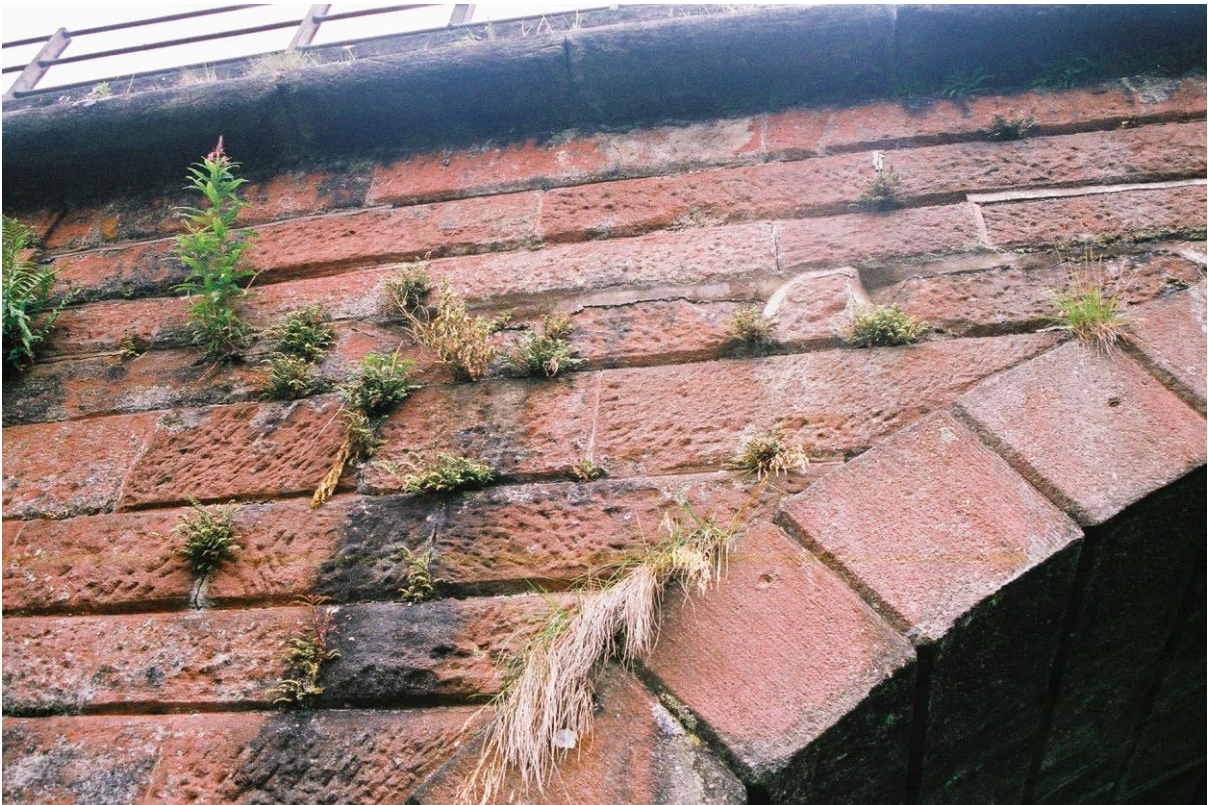
At Crawick viaduct, the voussoirs feature a series of parallel chisel marks creating longitudinal lines. The spandrel is moderately rusticated but V jointed.

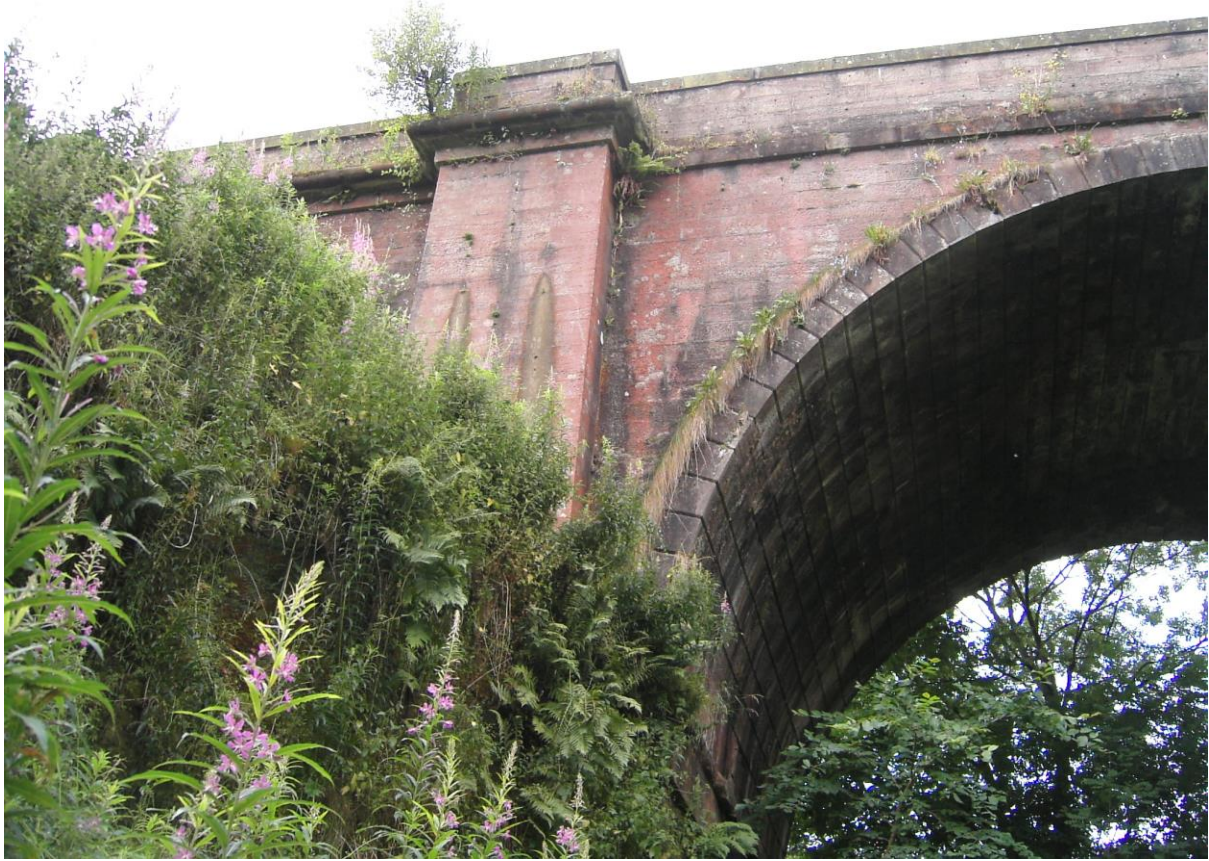
Menock has an ashlar pilaster and smooth pecked spandrels. Note also that the bullnose string course has been almost completely removed.

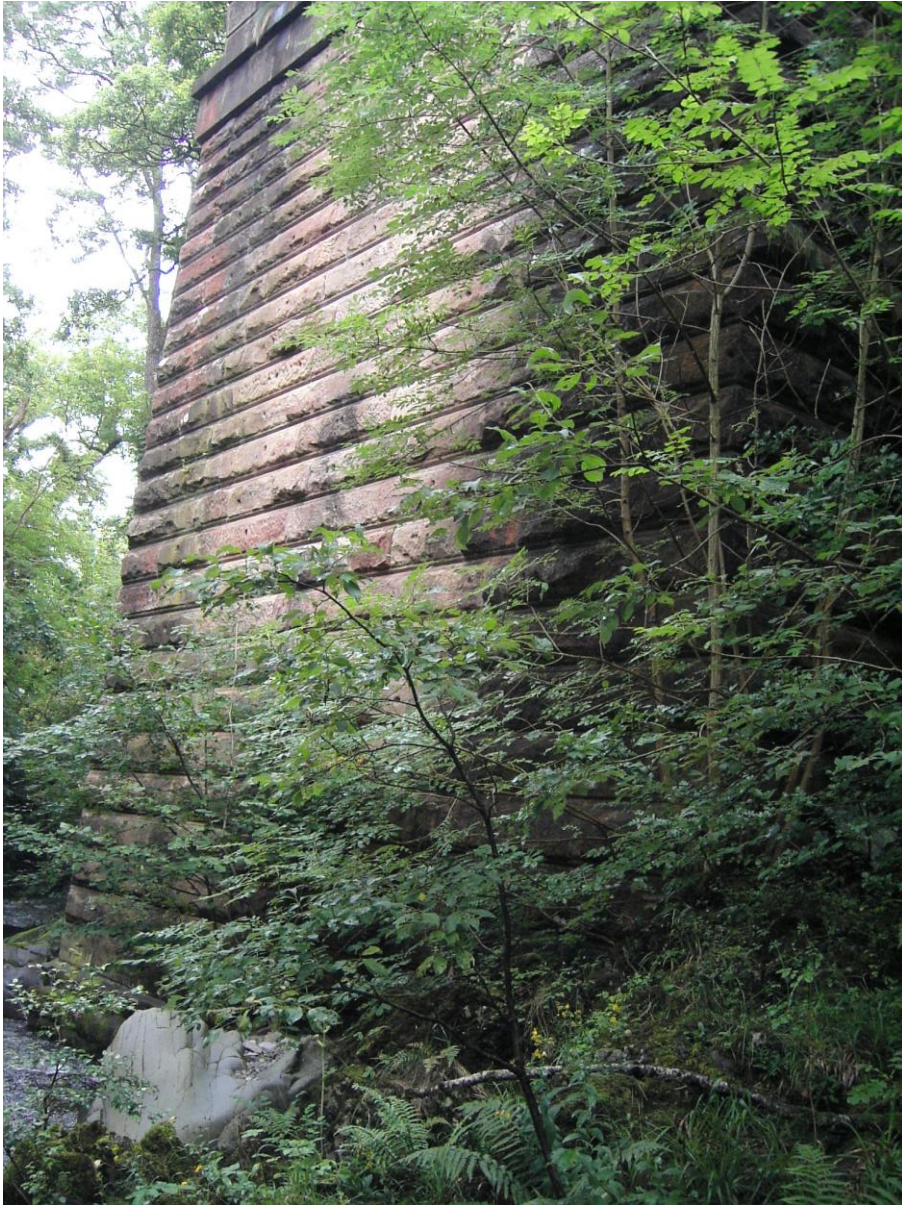
At Enterkinburn (I think) the piers are rusticated but have V joints with smooth borders.

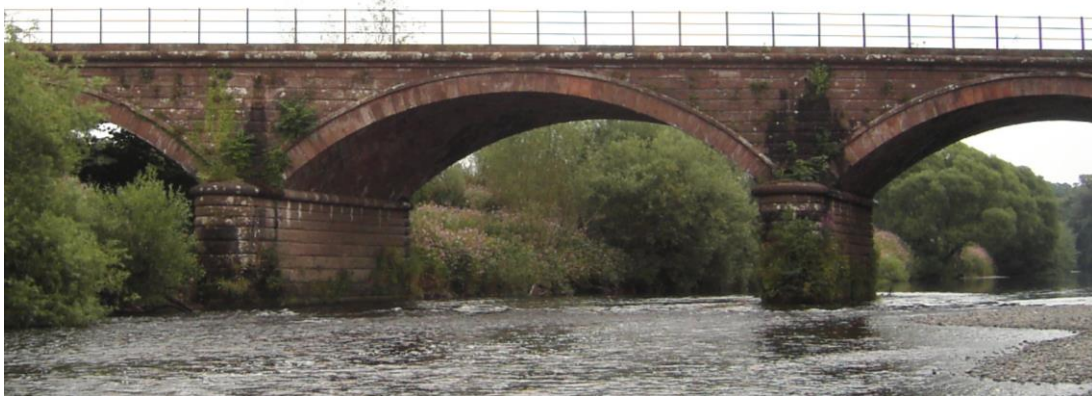
This bridge has a string round the ring, rusticated spandrels and piers, a bullnose string course and NO PARAPET?

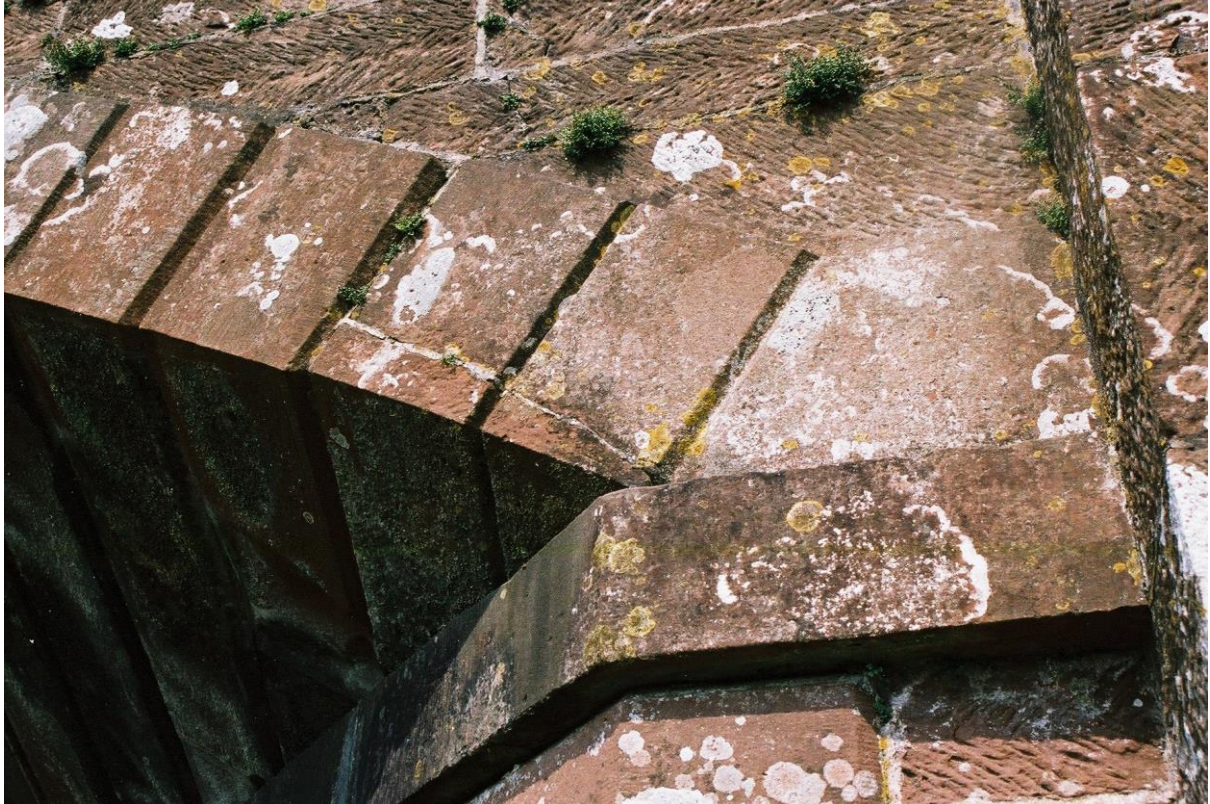
And here, the spandrels are smooth jointed flat stone cut in a herringbone pattern. And the voussoirs stand out from the spandrels and have V'ed joints right round.
