Bridge of the Month No64, April 2016 Bittaford, Multi-Bridges

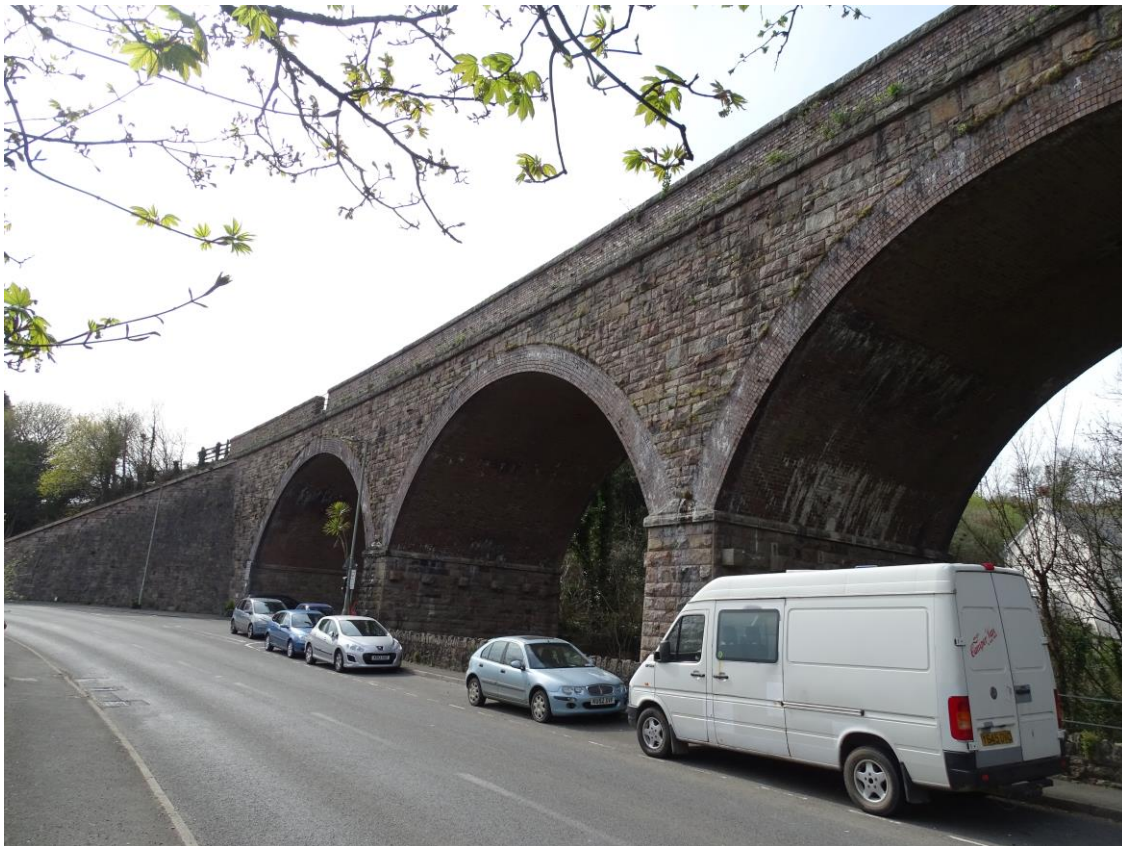
The railway South West of Exeter has some fascinating structures. Much of it was originally built single track, Broad Gauge, and with "Atmospheric" propulsion. Most of the viaducts were built with stone piers and timber trusses, though the latter were more like cantilevers and suspended spans. It was always intended that those should be replaced as they became unserviceable. When that came to, the track was doubled and a new alignment made so the new viaducts could be built alongside the old. At Bittaford, things got yet more complex as we shall see. The viaduct is [here](#).

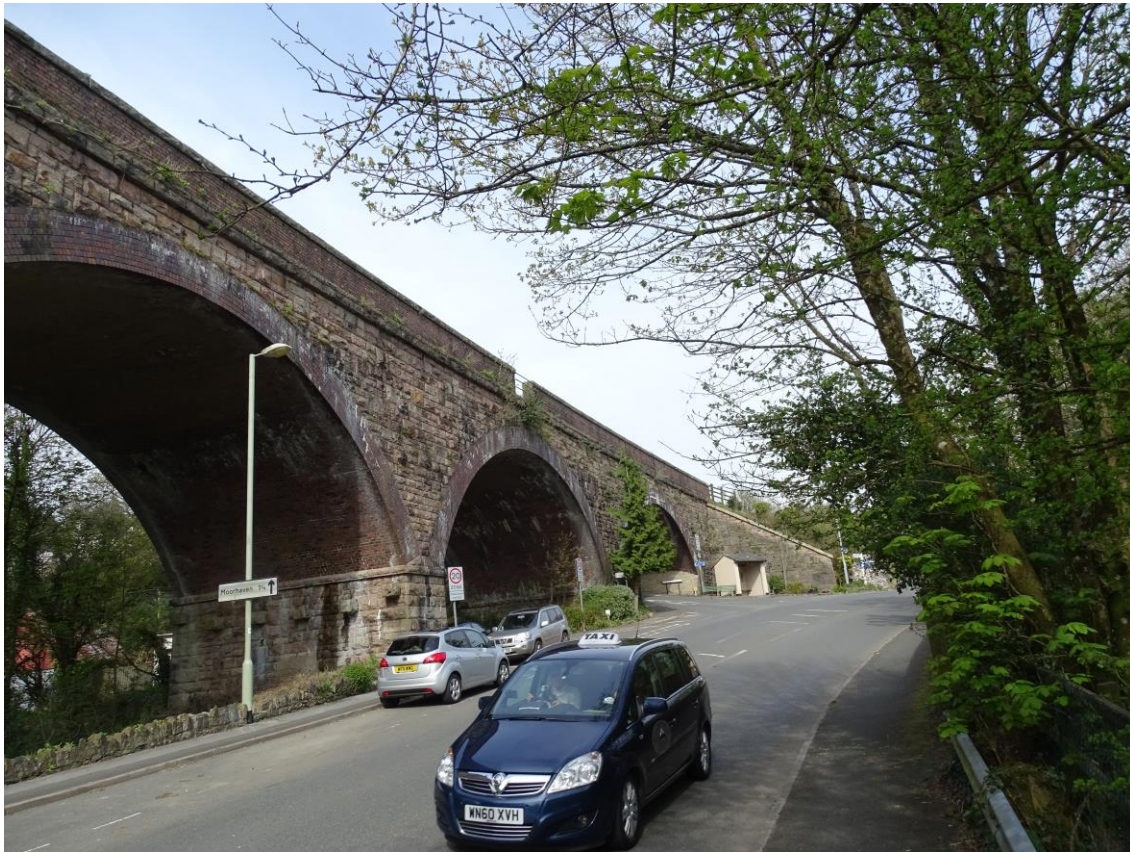
The road runs very close to the viaduct, and there hangs at least part of our tale.

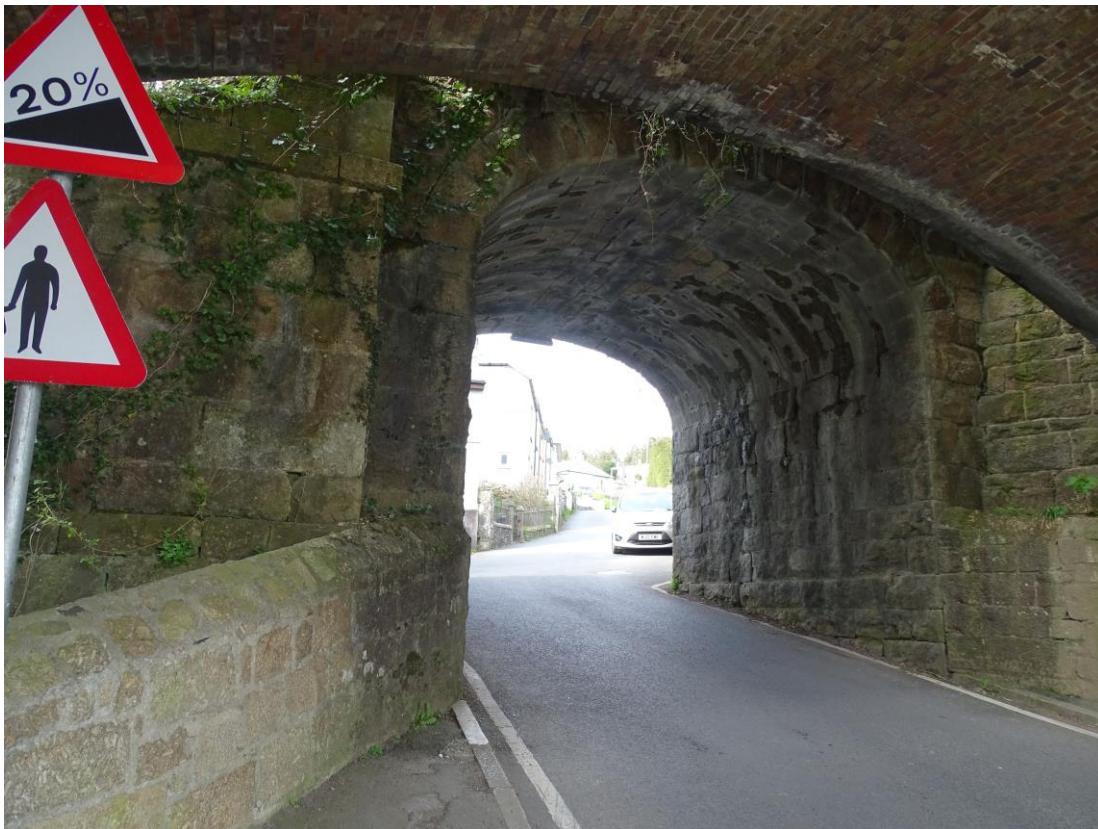
Let's begin by walking up to the end arch seen here. Look underneath and we see another.

Through and around that and things become clearer. This is the end span and abutment of the older timber viaduct. Here is the corbel that supported the diagonal timber struts, with an anchor for a wrought iron tie. The masonry piers were very slender too.

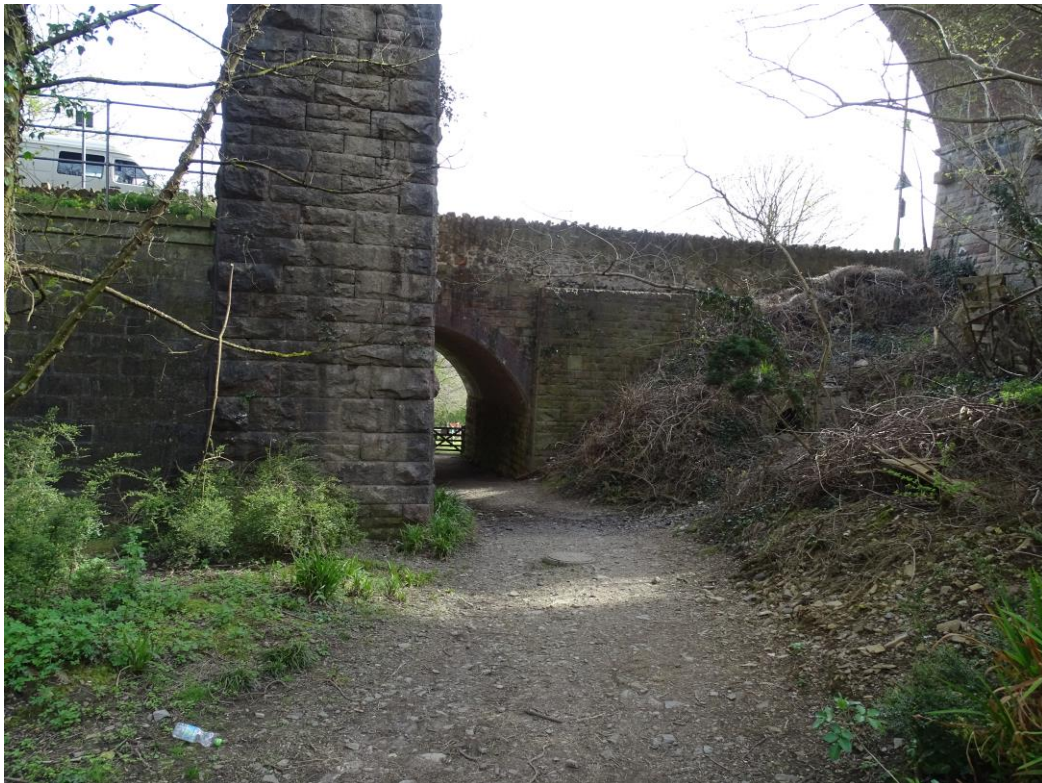
To the left of the pier is a wall, which is close to the near edge. Oh and the white van from a previous photo visible on the road beyond. To the right, and visibly further away is and arch under the road. To the right is a rather nice stone culvert.

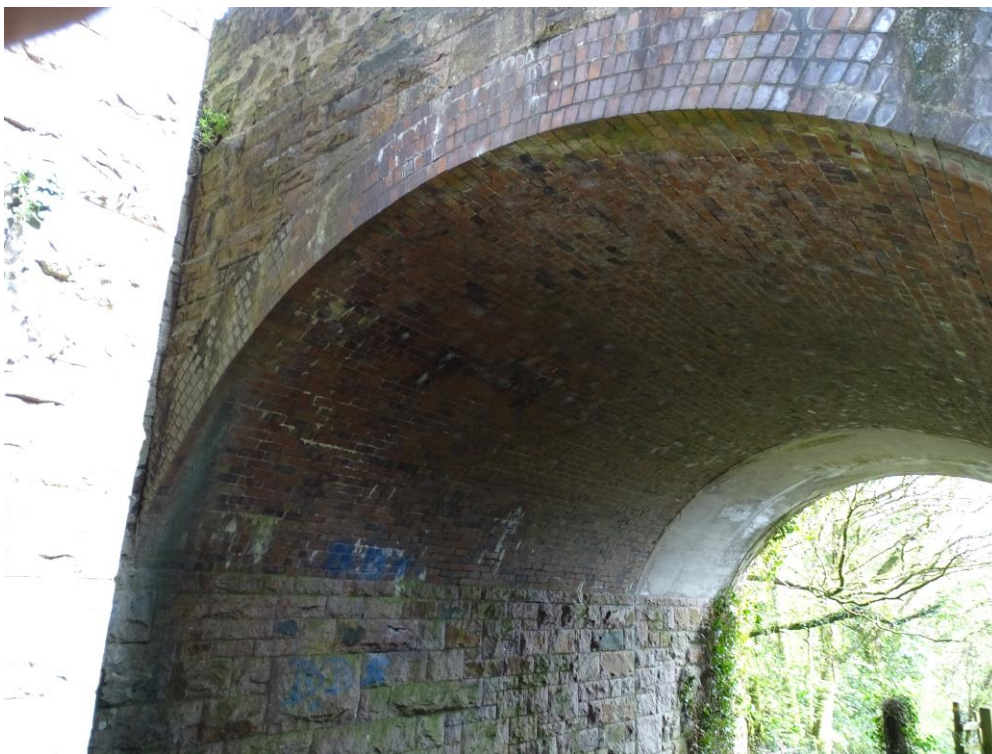
Brightly lit, to the left is the pier of the Railway viaduct. The arches (both brick and concrete) support the road.

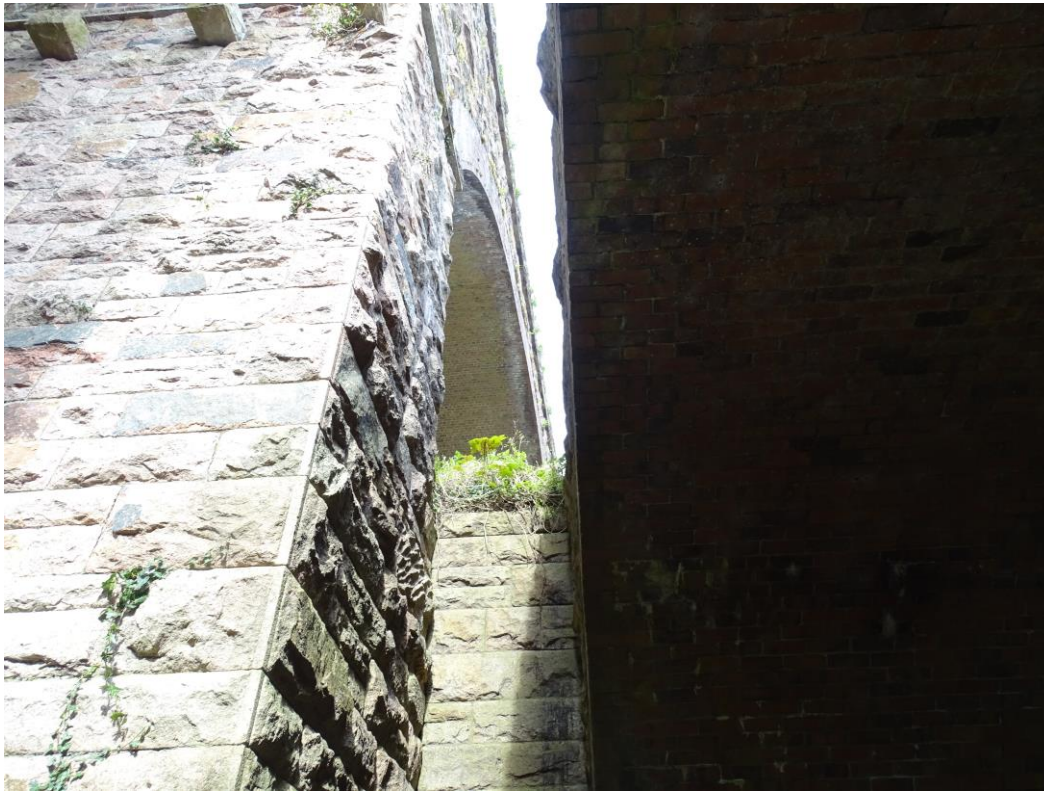
There is a retaining wall butting up against the railway pier, which is more clearly discerned here.

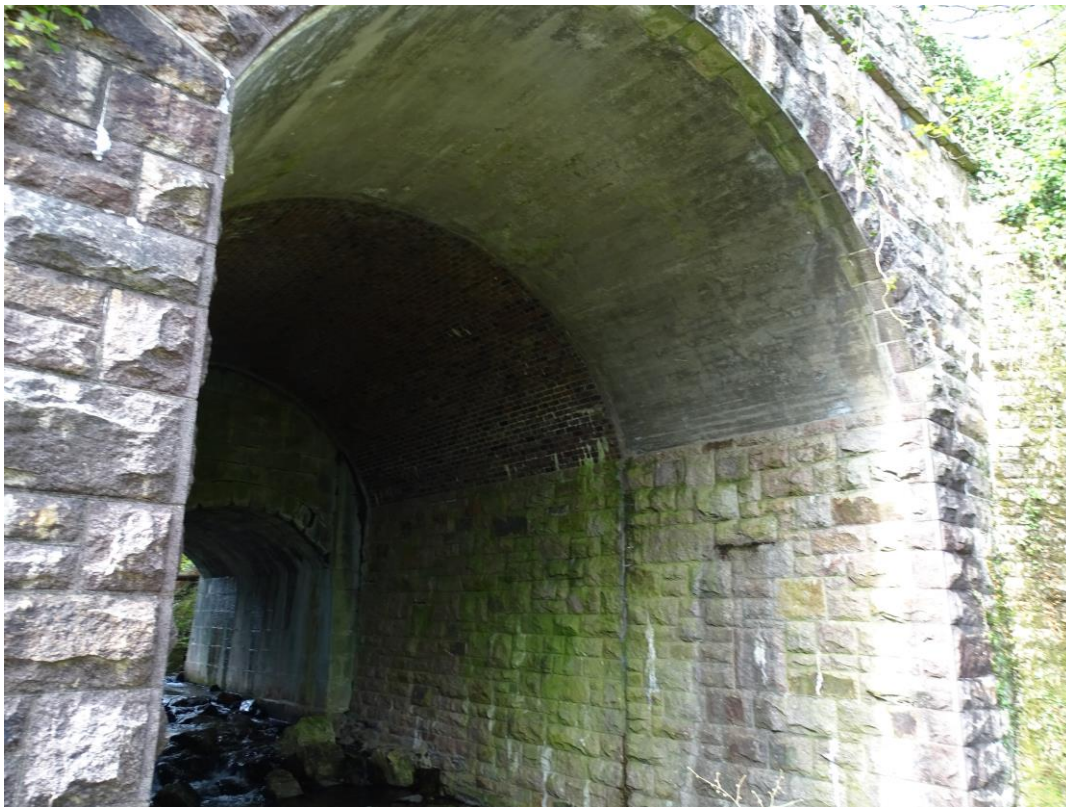
Three arches, one of which is clearly under the viaduct.

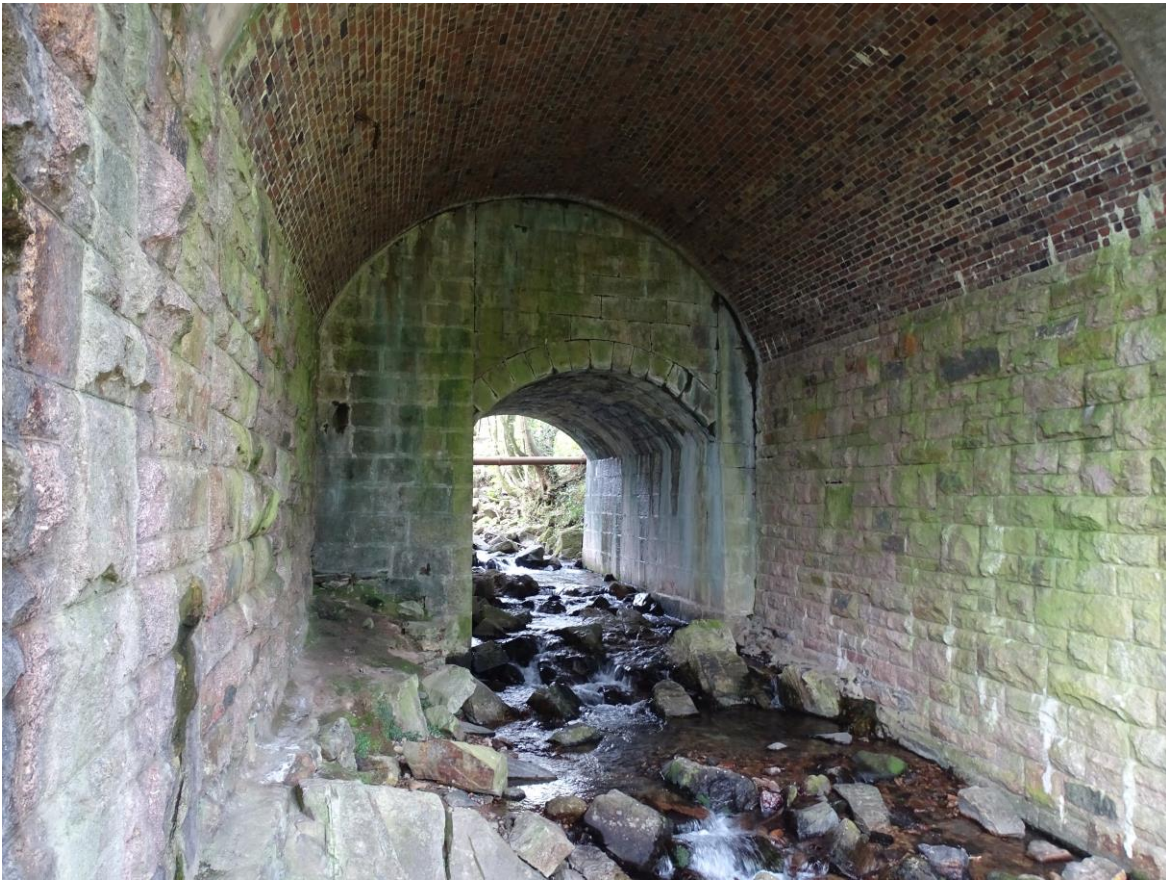
So, get back to the upstream side and we find that the other side of this older arch butts on to the viaduct pier.

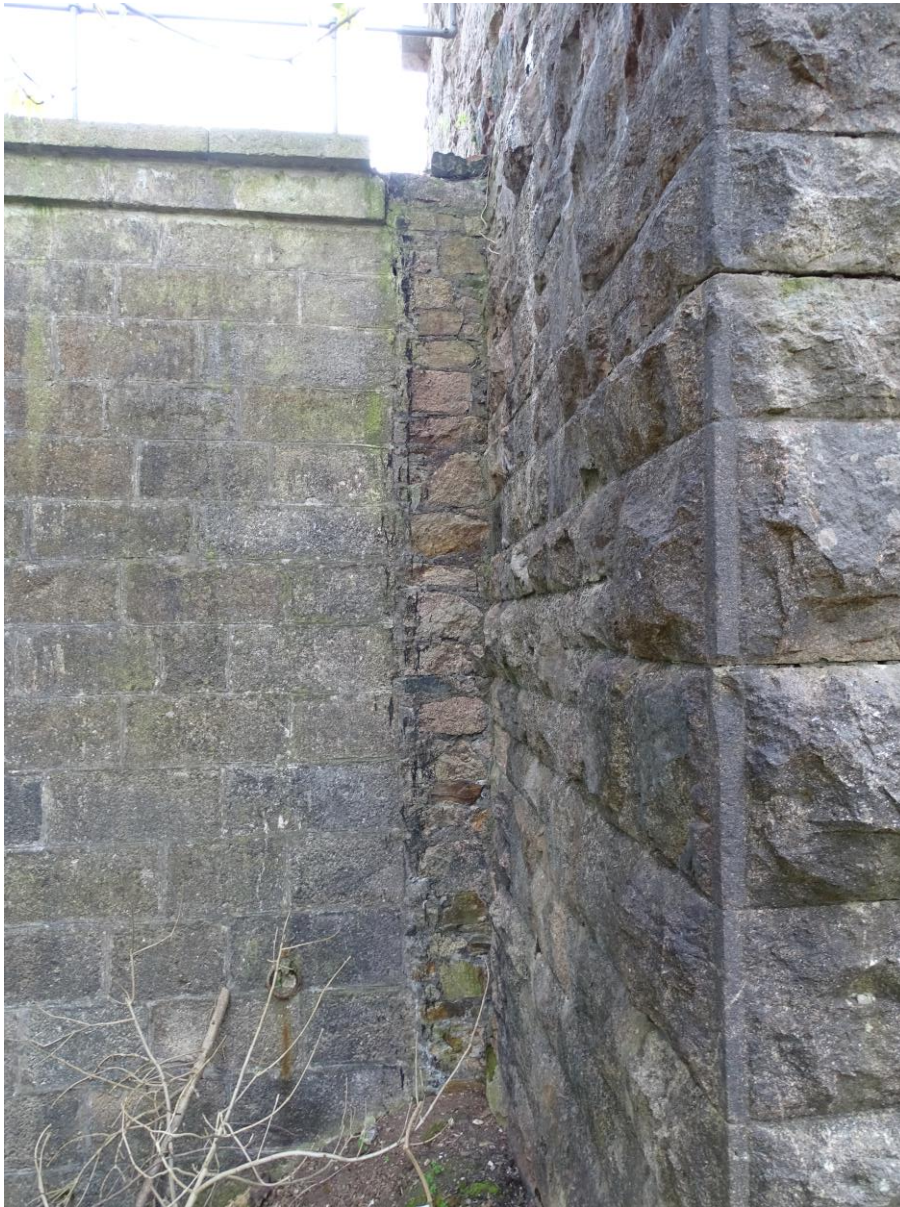
In the span where the path goes, there is a double wall. The perspective here doesn't show well, but the rear, rubble wall is the parapet of the present road and off the line of the viaduct and the dressed stone wall is the causeway approaching the stone arch of the old, much narrower road. Here we have two older versions of what is now the A38 road to Plymouth. The newer one is a dual carriageway and runs about 300m away lower down the valley.

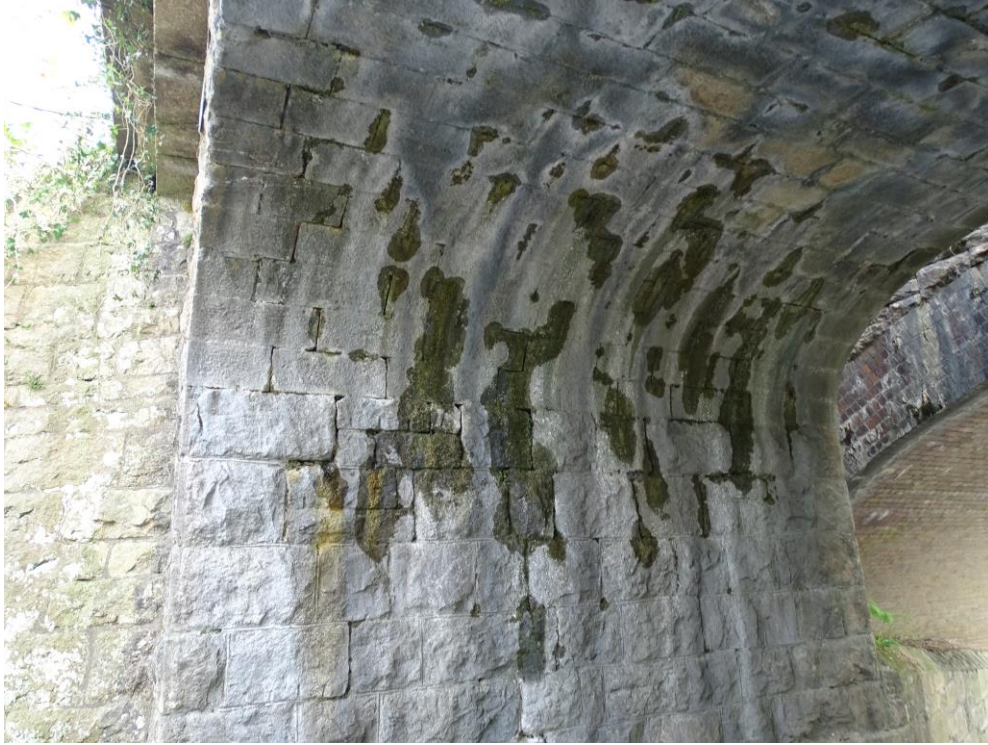
There has been a lot of mortar washed out, but the joints were thin and there has been little enough displacement of the stones. The extent of the string-course up there to the left is quite impressive. Look back to the one on last month's bridge, which was also a Brunel design. Both by the man himself or the same able assistant?

Let's begin with that elliptical arch, disused and neglected it remains in remarkably good condition.

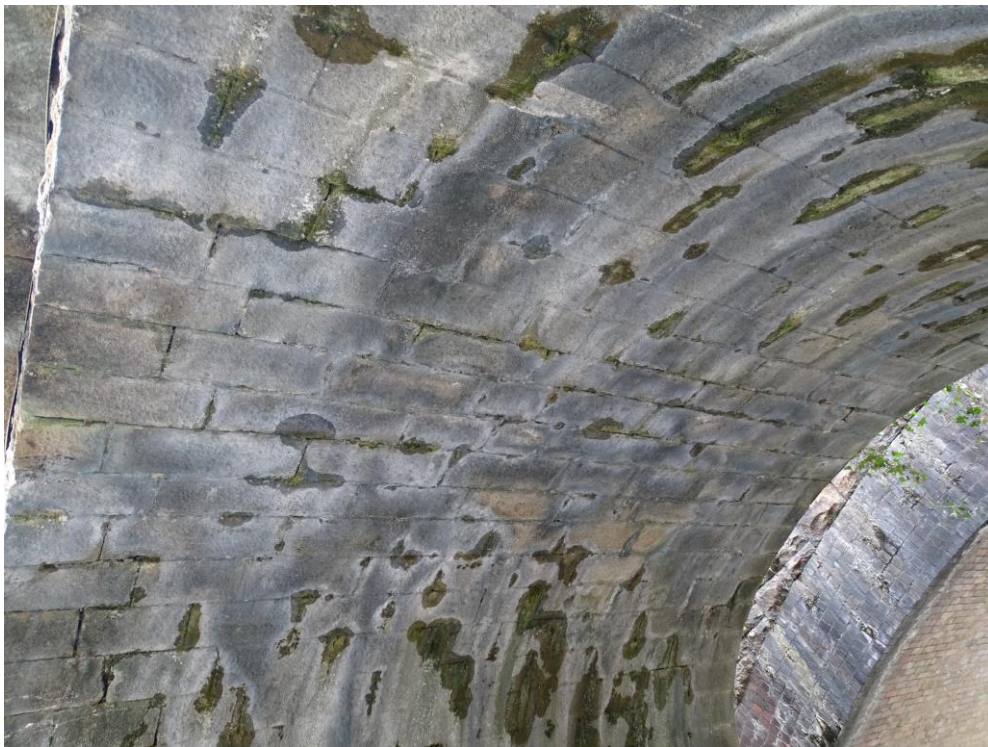
It's not obvious that this is the crown, but there is a definite open joint there, not really surprising in so flat and short an arch.
