And now to Pultney Bridge.

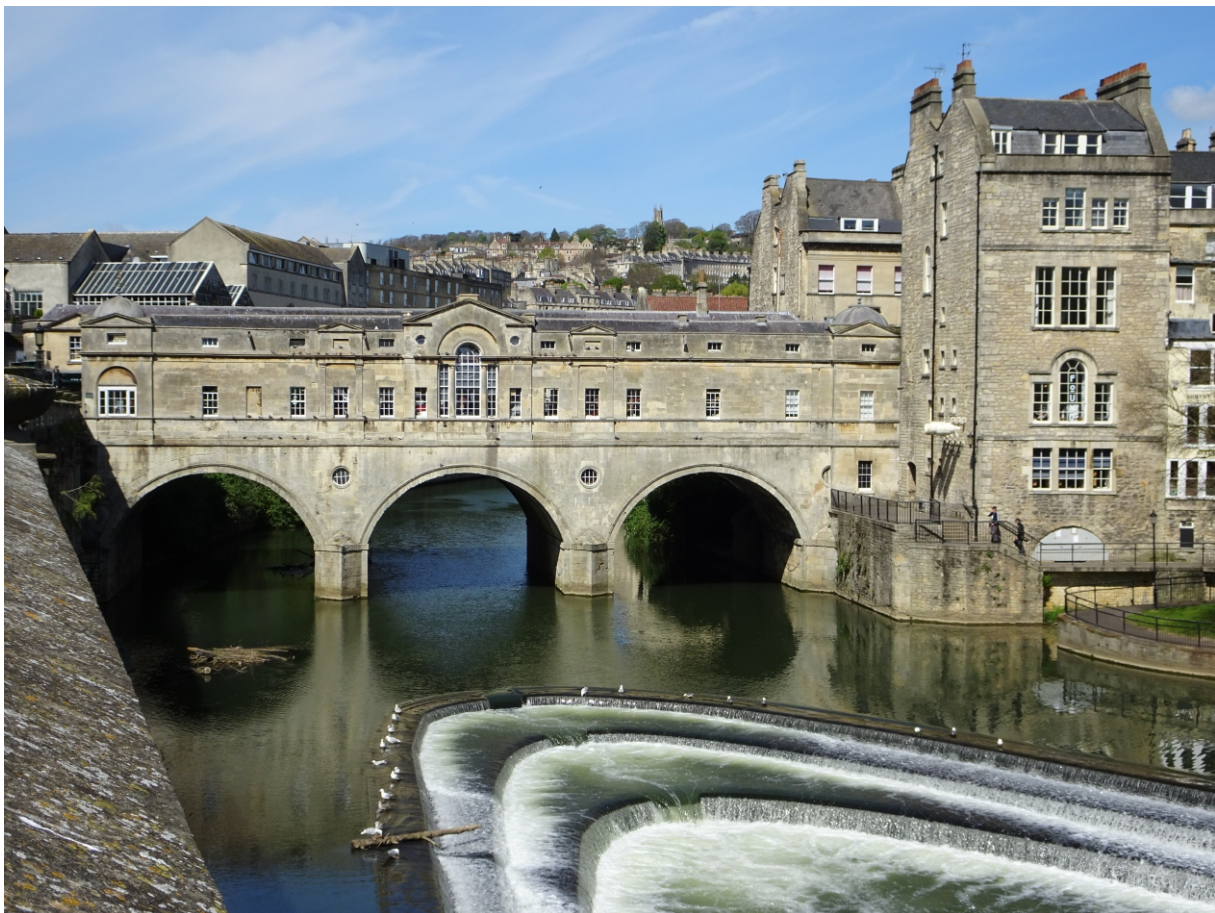
It is a rather more elegant thing than most bridges I deal with, designed by Robert Adam. At first glance, and to be honest, over many “glances” for me, it looks like an elegant piece of Palladian symmetry. In fact, a close look reveals it to be far from symmetrical. The domed pavilions at the two ends are different and very differently placed.

This photo is taken from the Grand Parade which was built long after the bridge. It turns out that the asymmetry stems from alterations made in 1902 when the right bank pavilion was taken down and replaced to a new design (ref Michael Forsyth, Pevsner Architectural Guide of Bath). The next surprise on this visit was to notice, well, look below.

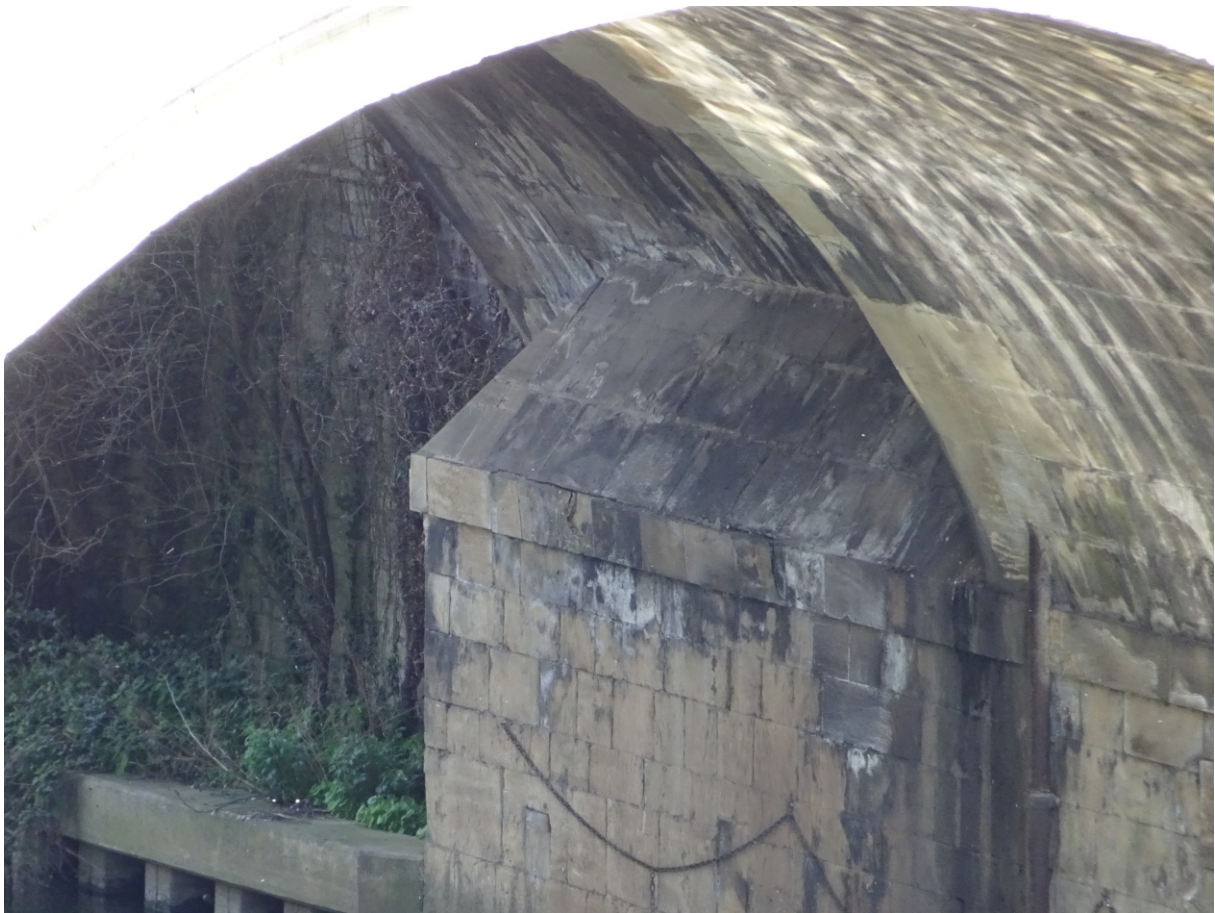
The upstream half has a bigger span on the left bank. Forsyth, again, tells us that the upstream end of the right (west) pier collapsed in 1800. The other side span is the same, but why? They are clearly built on the original abutments

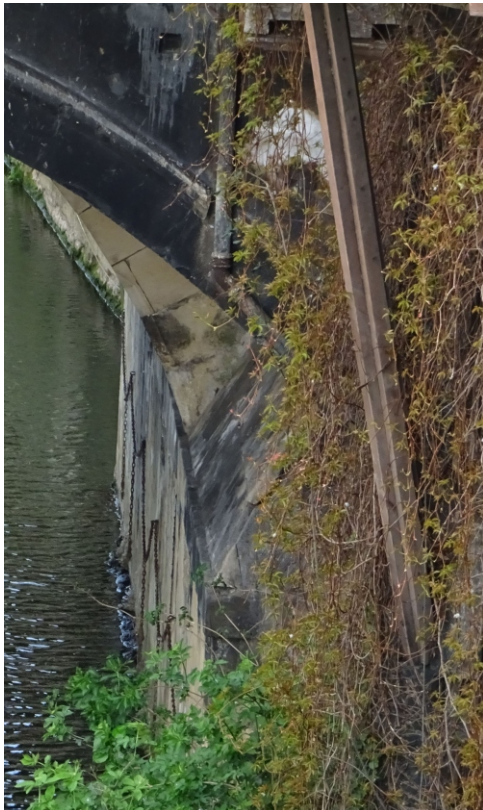
Here is the upstream right hand springing. The battered springing cover is clearly visible. On the downstream face, the three spans are the same. Upstream, the side spans are substantially bigger, though I haven't been able to work out how much.

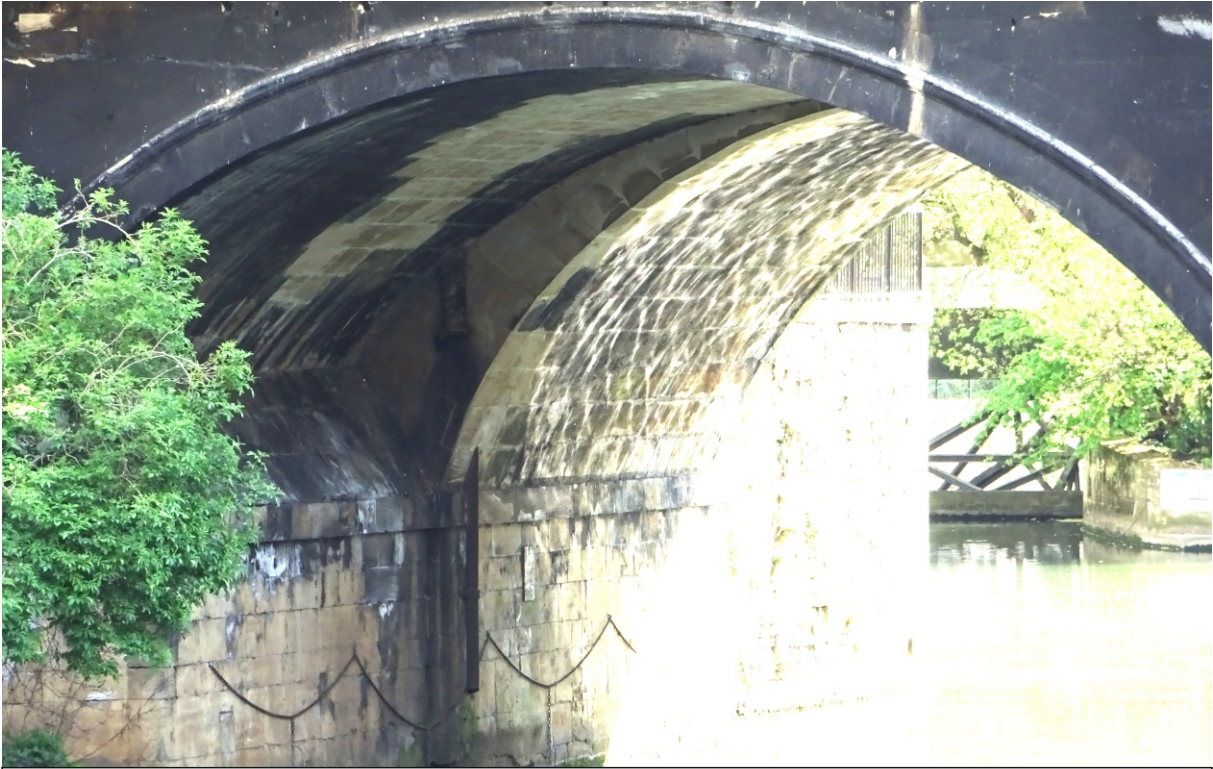
A long shot from upstream (below) shows that the crown level is the same. The span is perhaps 5 or 6 feet (1.5-1.8m) bigger. Interesting place to see a drain too.

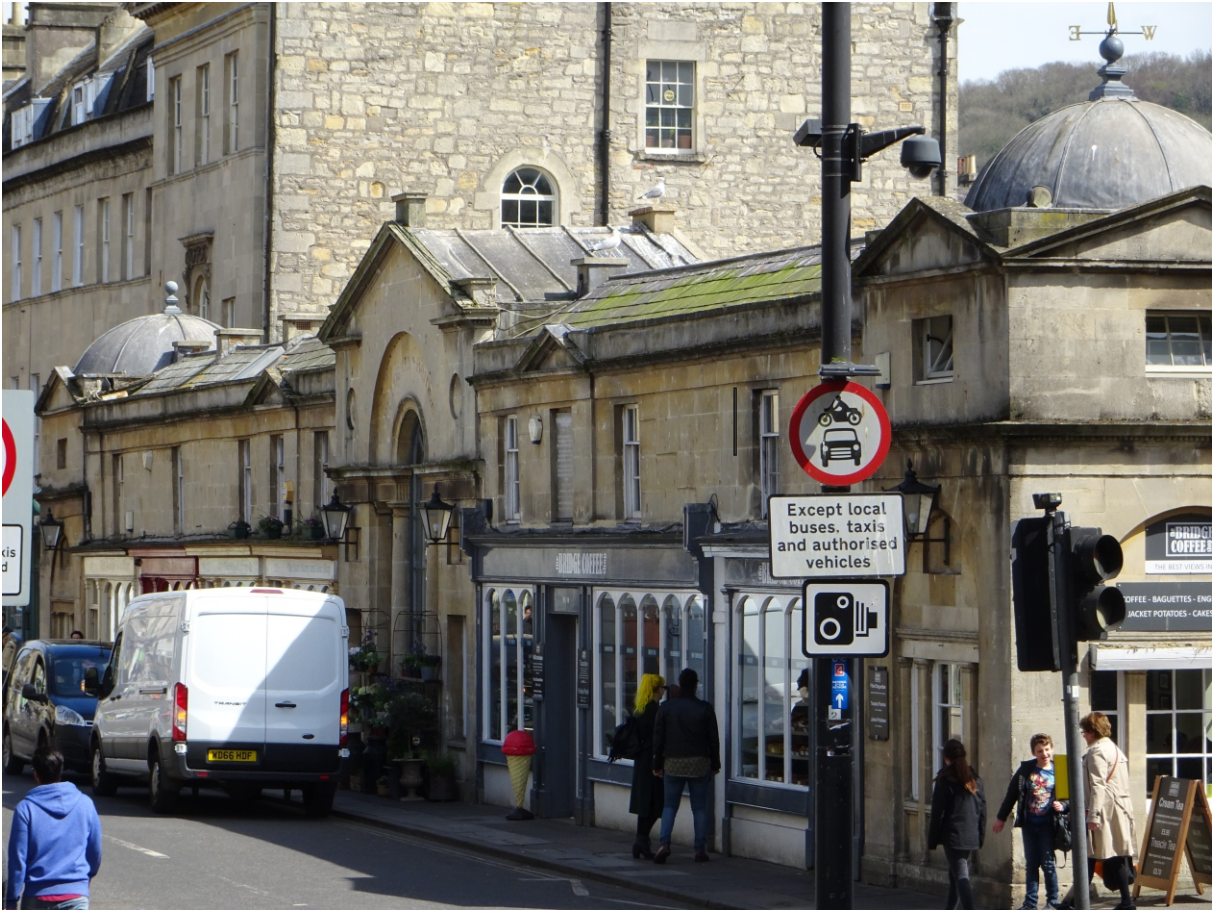
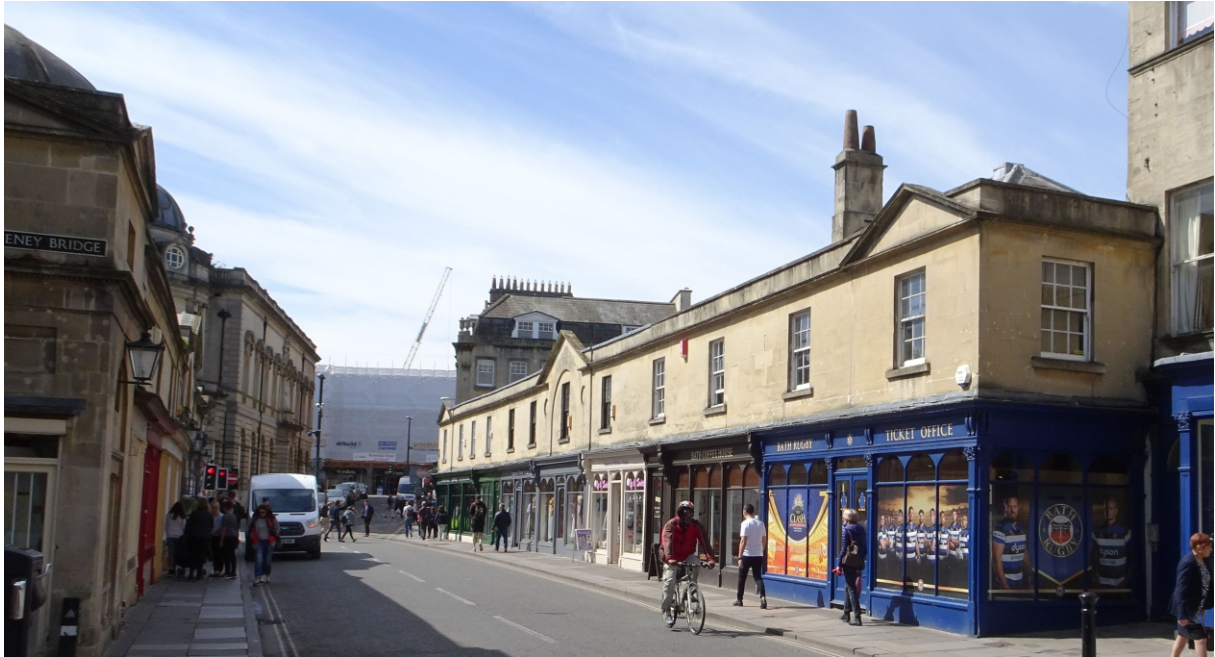
Forsyth also tells us that “in 1792 Thomas Baldwin added a storey. For a while, I thought that was just squeezing a floor into existing space but looking more closely, the pavilions and central section could all have stopped at the first frieze and the rest of the building at the top of the shop windows.

The design on the north side is much plainer, but that has been rebuilt, of course. Go round the back of this, though and there is a remarkable sight.

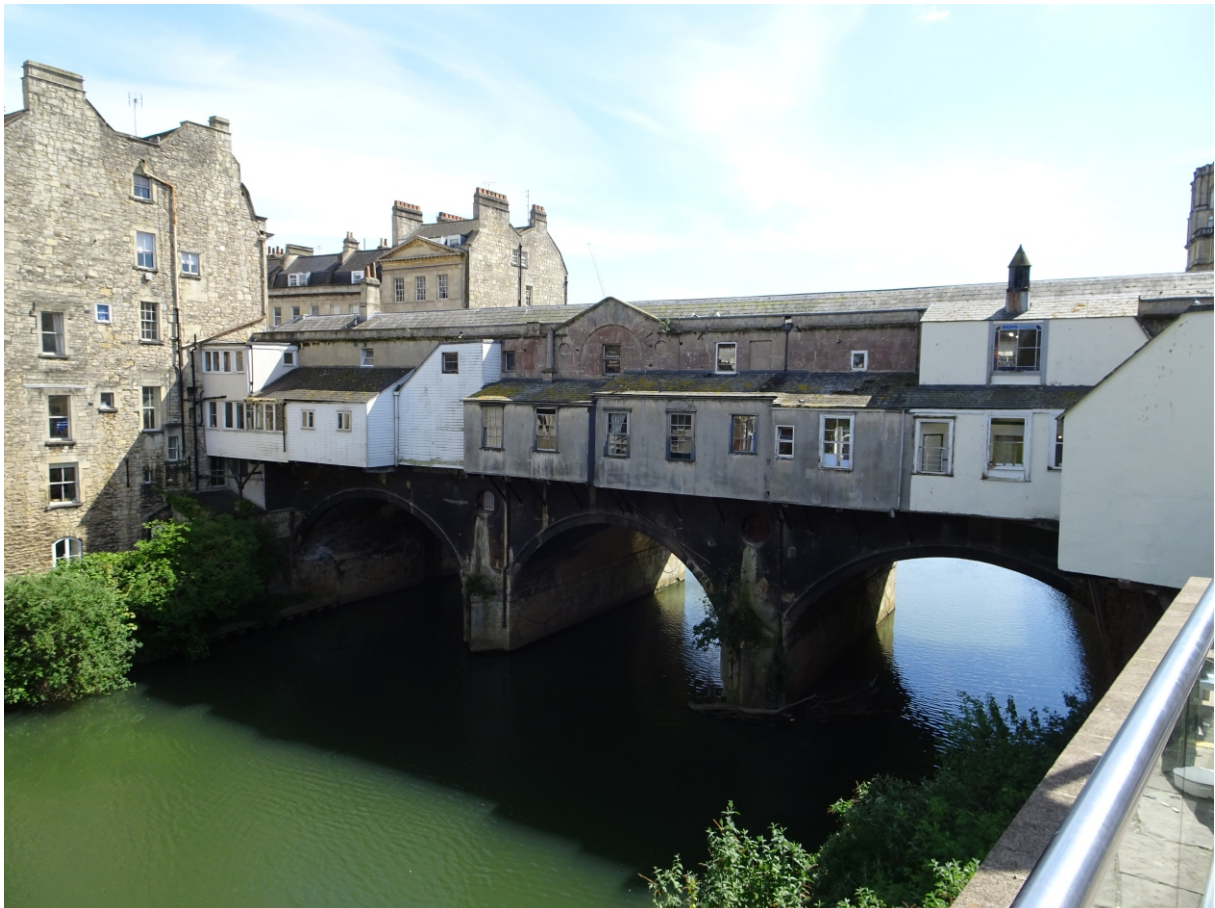
This looks positively medieval. All those sheds are supported on cantilever joists with diagonal props. The most spectacular are beneath the wide white section at the far side.

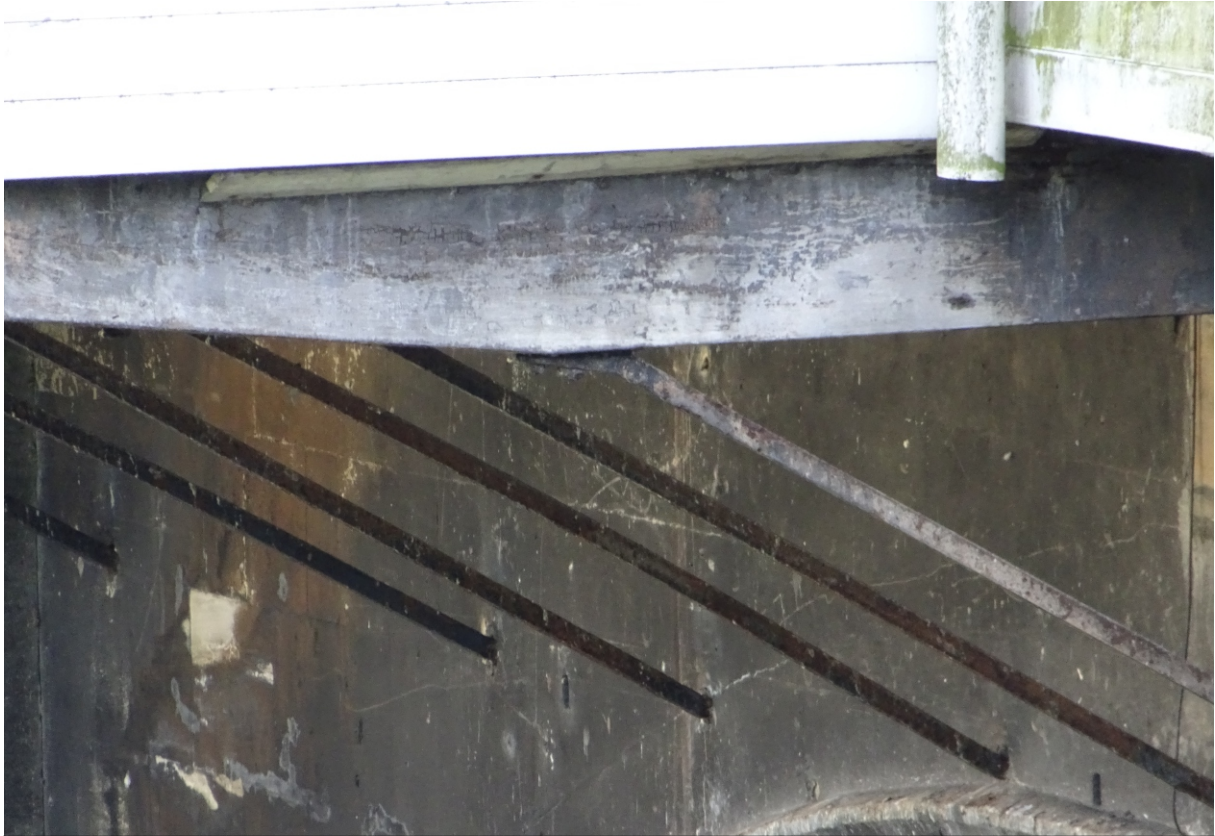
They look like blacksmithed iron so are presumably early 19<sup>th</sup> Century. I wonder how long after the rebuild?

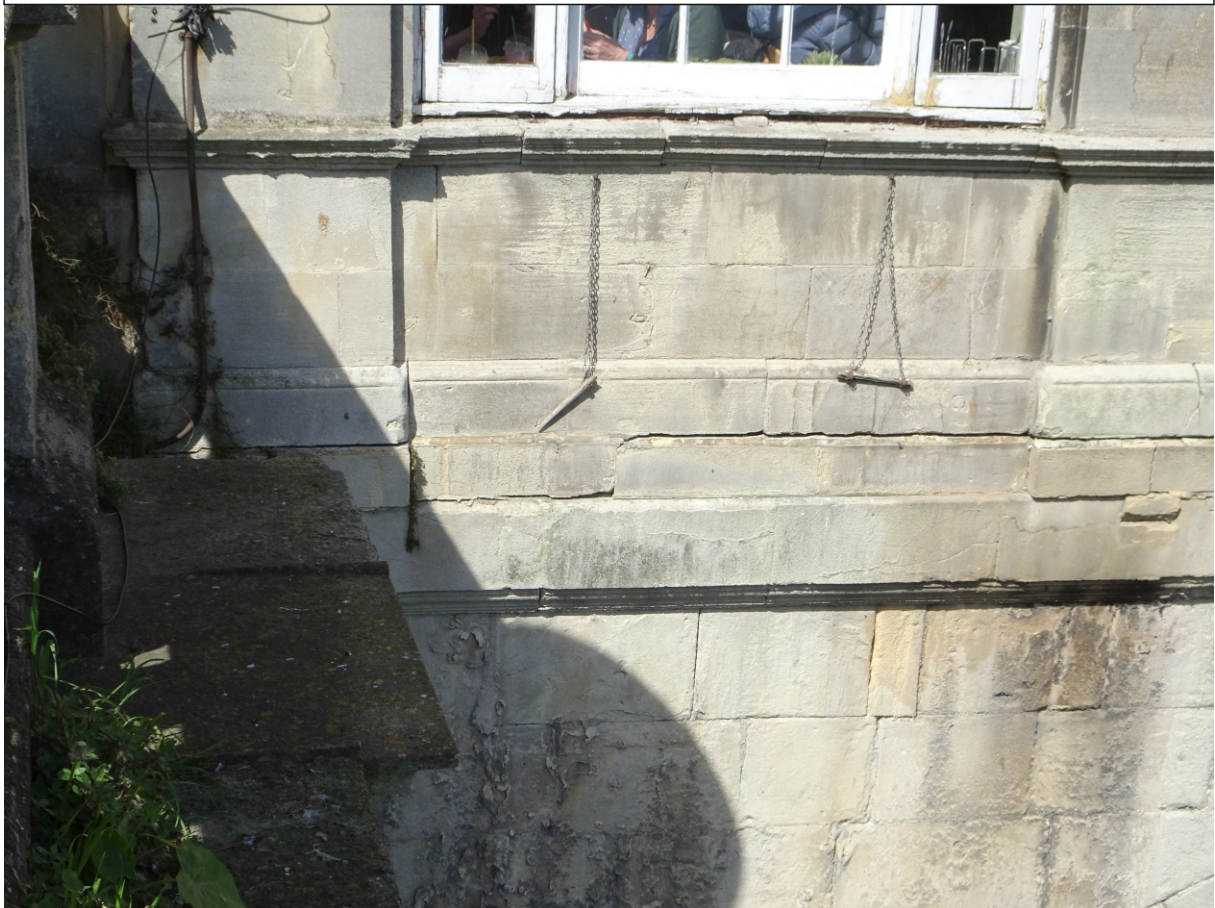
The rebuilt pavilion from 1902 seems to be flying!

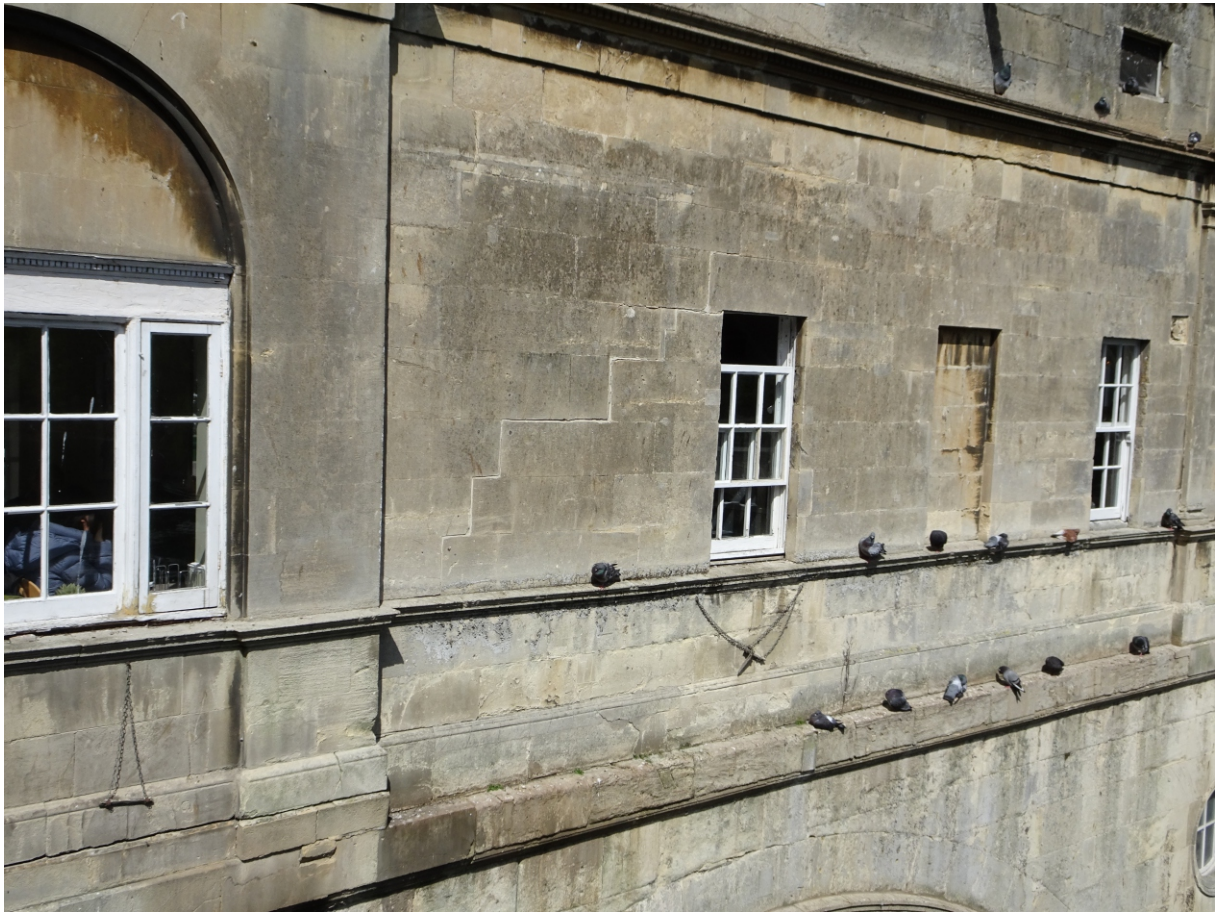
Those cracks step upwards between the windows creating an obvious arch.

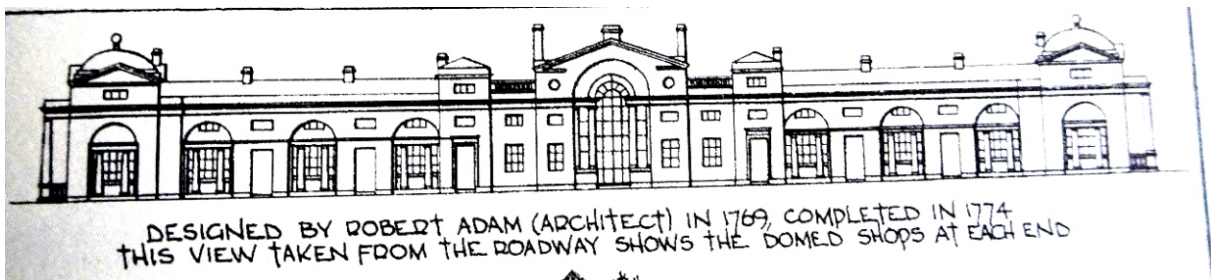
If you are ever going to Bath do seek out: Exploring Bath by Keith Dallimore. This shows Adam's original street frontage. It has been much altered.
